Profile/Photo Observation Report

Street:	E 34TH LN	Flow Control:	Not Controlled
City:	Hobart, IN	Year Renewed:	
Location:	Other	Tape/Media #:	
Purpose:	Not Known	Dia/Height:	10"
Use:	Sanitary	Material:	VCP
Drain Area:	NA	Lining:	
Category:	NA		
Comment:

Location Details:		Direction of Survey:	Upstream
US MH:	M-902-009	DS MH:	M-902-008
		Total Length Surveyed (ft):	5.5

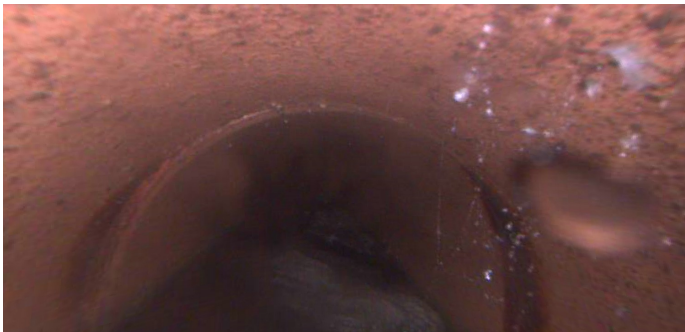
Code:	IW
Description:	Infil Weeper

Distance (ft):	1.0
Structural Grade:	0
O&M Grade:	2
Clock Start/From:	8
Clock To:	4
1st Value:	
2nd Value:	
Value Percent:	
Continuous Index:	
Within 8" of Joint:	YES
Remarks:

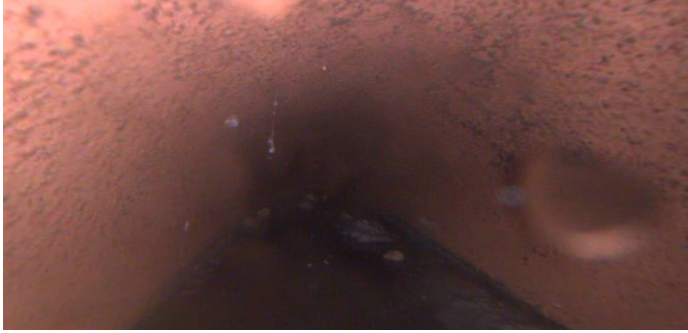
Code:	MSA
Description:	Abandoned Survey
Distance (ft):	5.5
Structural Grade:	0
O&M Grade:	0
Clock Start/From:	
Clock To:	
1st Value:	
2nd Value:	
Value Percent:	
Continuous Index:	
Within 8" of Joint:	NO
Remarks:	DEBRIS UNDER WATER
