Profile/Photo Observation Report

Street:	e 34th In	Flow Control:	Not Controlled
City:	Hobart, IN	Year Renewed:	
Location:	Other	Tape/Media #:	
Purpose:	Not Known	Dia/Height:	10"
Use:	Sanitary	Material:	VCP
Drain Area:	NA	Lining:	
Category:	NA		
Comment:

Location Details:		Direction of Survey:	Upstream
US MH:	M-902-009	DS MH:	M-902-008
		Total Length Surveyed (ft):	5.5

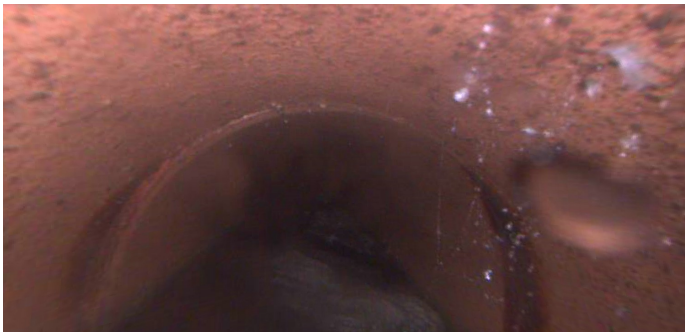
Code:	IW
Description:	Infil Weeper

Distance (ft):	1.0
Structural Grade:	0
O&M Grade:	2
Clock Start/From:	8
Clock To:	4
1st Value:	
2nd Value:	
Value Percent:	
Continuous Index:	
Within 8" of Joint:	YES
Remarks:

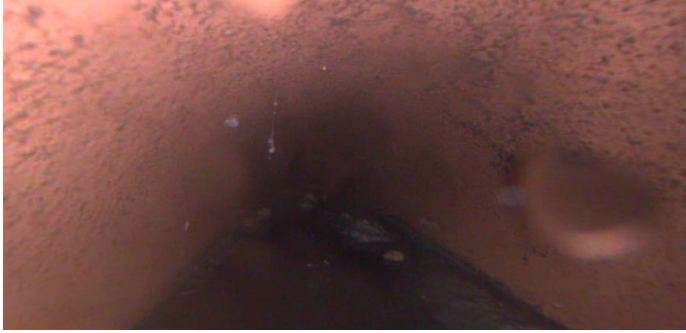
Code:	MSA
Description:	Abandoned Survey
Distance (ft):	5.5
Structural Grade:	0
O&M Grade:	0
Clock Start/From:	
Clock To:	
1st Value:	
2nd Value:	
Value Percent:	
Continuous Index:	
Within 8" of Joint:	NO
Remarks:	DEBRIS UNDER WATER
