Profile/Photo Observation Report

Street:	Off 34th Lane	Flow Control:	
City:	Hobart, IN	Year Renewed:	
Location:	Yard	Tape/Media #:	972
Purpose:	Reversal	Dia/Height:	12"
Use:	Sanitary	Material:	VCP
Drain Area:		Lining:	
Category:	NA		
Comment:

Location Details:		Direction of Survey:	Upstream
US MH:	M-902-9	DS MH:	M-902-45
		Total Length Surveyed (ft):	22.5

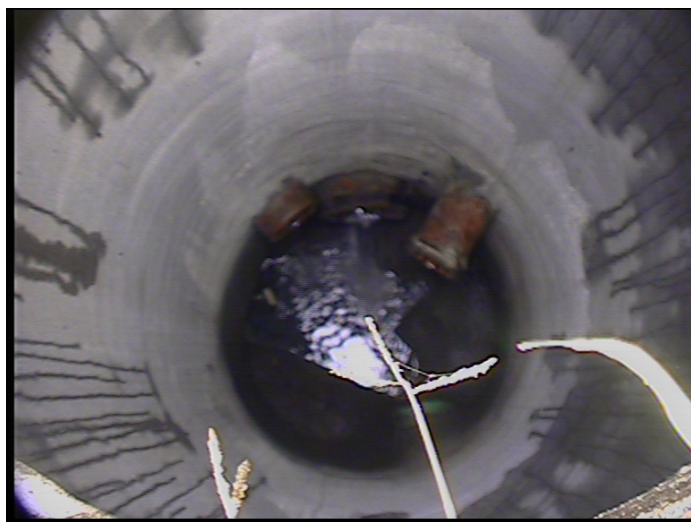
Code: **AMH**
Description: **Manhole**

Distance (ft): **.0**
Structural Grade: **0**
O&M Grade: **0**
Clock Start/From:
Clock To:
1st Value:
2nd Value:
Value Percent:
Continuous Index:
Within 8" of Joint: **NO**
Remarks: **M-902-45**

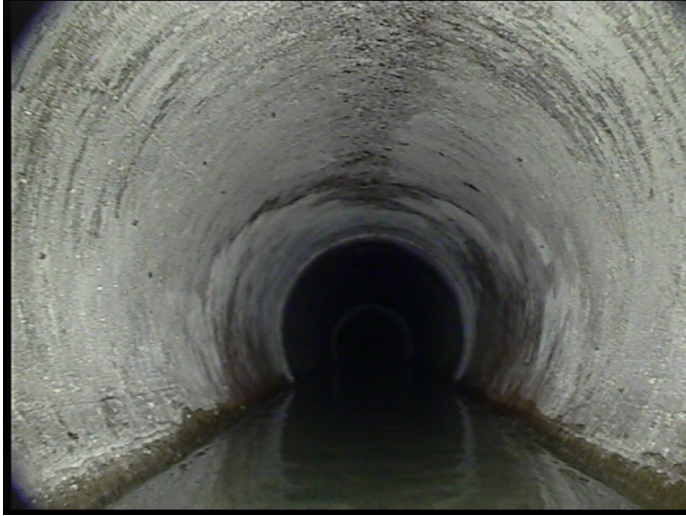
Code: **MWL**
Description: **Water Level**

Distance (ft): **.0**
Structural Grade: **0**
O&M Grade: **0**
Clock Start/From:
Clock To:
1st Value:
2nd Value:
Value Percent: **10.000**
Continuous Index:
Within 8" of Joint: **NO**
Remarks:

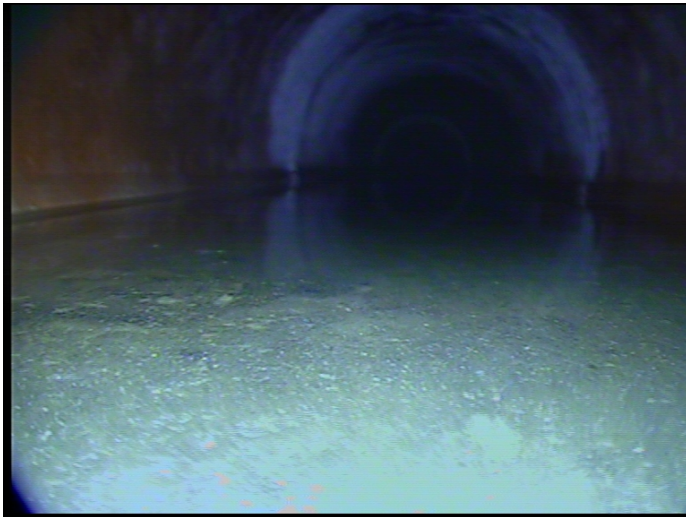
Code: **DSF**
Description: **Deposits Settled Fine**

Distance (ft): **19.1**
Structural Grade: **0**
O&M Grade: **2**
Clock Start/From: **4**
Clock To: **8**
1st Value:
2nd Value:
Value Percent: **10.000**
Continuous Index: **S01**
Within 8" of Joint: **YES**
Remarks:

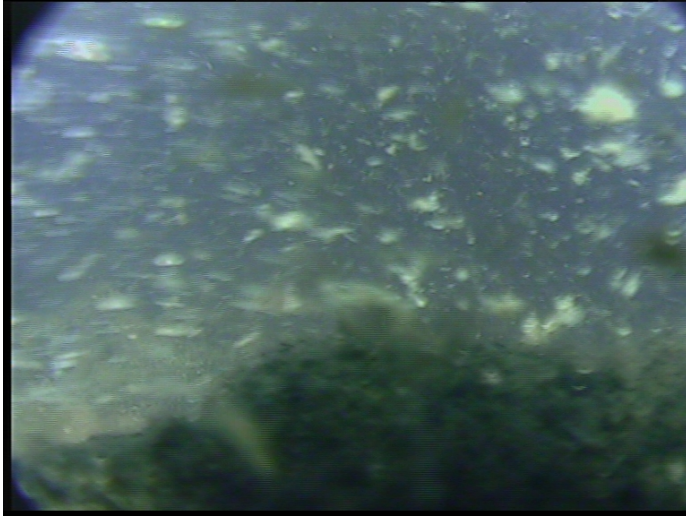
Code: **DSF**
Description: **Deposits Settled Fine**

Distance (ft): **22.5**
Structural Grade: **0**
O&M Grade: **3**
Clock Start/From: **4**
Clock To: **8**
1st Value:
2nd Value:
Value Percent: **20.000**
Continuous Index: **F01**
Within 8" of Joint: **NO**
Remarks:

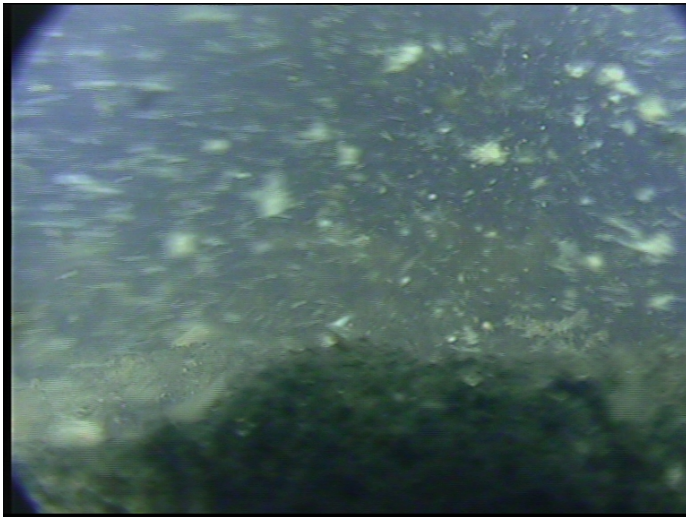
Code: **MSA**
Description: **Abandoned Survey**

Distance (ft): **22.5**
Structural Grade: **0**
O&M Grade: **0**
Clock Start/From:
Clock To:
1st Value:
2nd Value:
Value Percent:
Continuous Index:
Within 8" of Joint: **NO**
Remarks: **deep sediment**
