Profile/Photo Observation Report

Date:	08/02/2023	Weather:		Coding:	PACP 7.0
Pipe Length (ft):	106.0	Owner:	City of Hobart	Pre Clean:	Heavy Cleaning
P.O.#:	YES502259	Surveyor:	S. Bucklin	PSR:	P-902-014-017.1
Customer:	City of Hobart	Clean Date:	07/19/2023	Shape:	C

Street:	East 34th Court	Flow Control:	Not Controlled
City:	Hobart, IN	Year Renewed:	
Location:	Easement/Right of Way	Tape/Media #:	
Purpose:	Routine Assessment	Dia/Height:	8"
Use:	Sanitary Sewage Pipe	Material:	VCP
Drain Area:		Lining:	None
Category:	NA		
Comment:

Location Details:		Direction of Survey:	Upstream
US MH:	M-902-014	DS MH:	M-902-017.1
		Total Length Surveyed (ft):	106.3

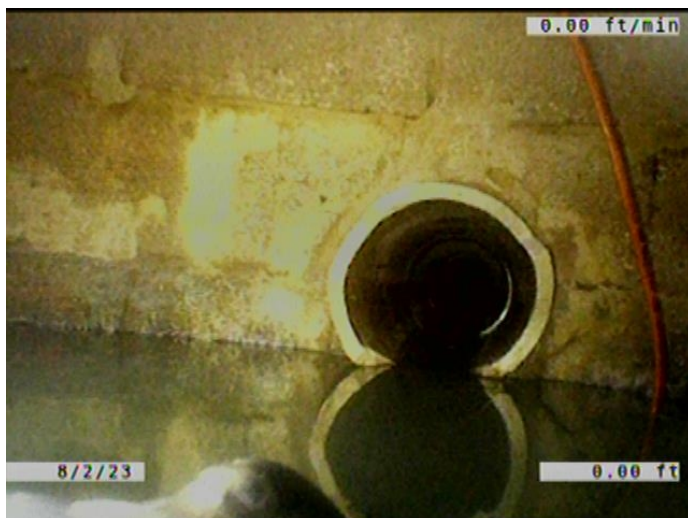
Code: **AMH**
Description: **Manhole**

Distance (ft): **.0**
Structural Grade: **0**
O&M Grade: **0**
Clock Start/From:
Clock To:
1st Value:
2nd Value:
Value Percent:
Continuous Index:
Within 8" of Joint: **NO**
Remarks: **M-902-017.1**

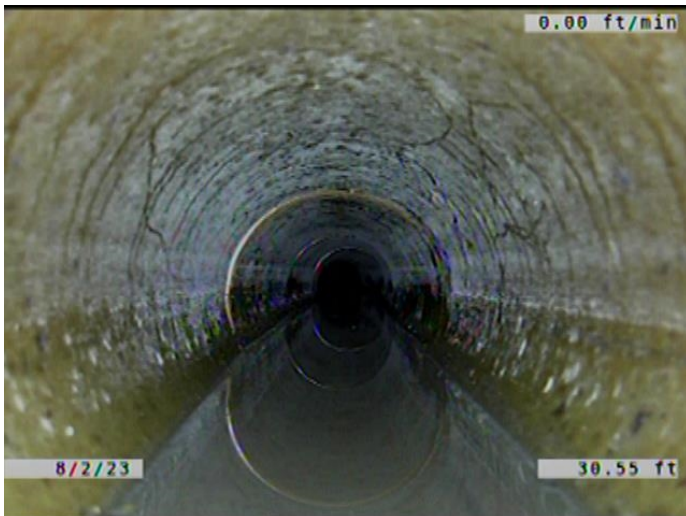
Code: **MWL**
Description: **Miscellaneous Water Level**

Distance (ft): **30.6**
Structural Grade: **0**
O&M Grade: **0**
Clock Start/From:
Clock To:
1st Value:
2nd Value:
Value Percent: **15.000**
Continuous Index:
Within 8" of Joint: **NO**
Remarks:

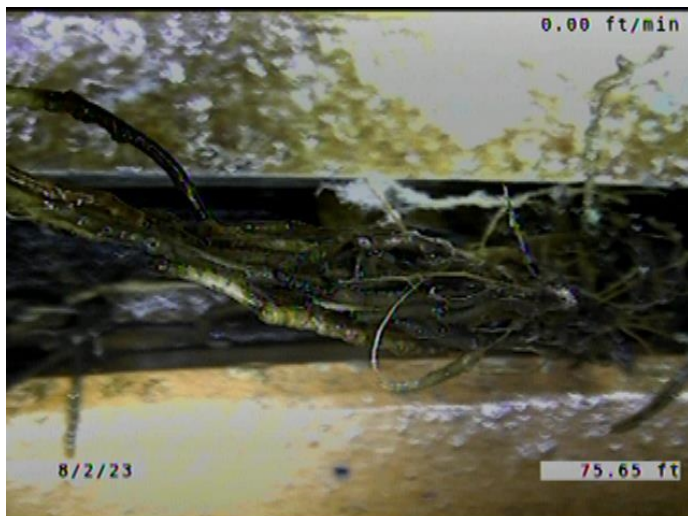
Code: **RFJ**
Description: **Roots Fine Joint**

Distance (ft): **75.6**
Structural Grade: **0**
O&M Grade: **1**
Clock Start/From: **8**
Clock To: **4**
1st Value:
2nd Value:
Value Percent:
Continuous Index: **S02**
Within 8" of Joint: **YES**
Remarks:

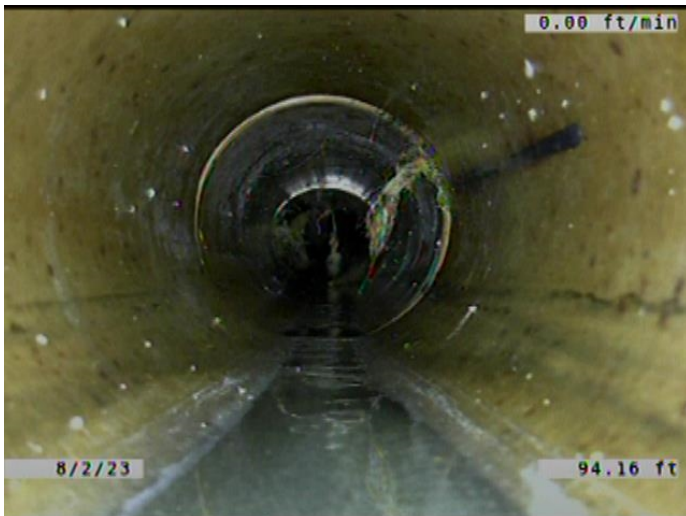
Code: **MWL**
Description: **Miscellaneous Water Level**

Distance (ft): **94.2**
Structural Grade: **0**
O&M Grade: **0**
Clock Start/From:
Clock To:
1st Value:
2nd Value:
Value Percent: **5.000**
Continuous Index:
Within 8" of Joint: **NO**
Remarks:

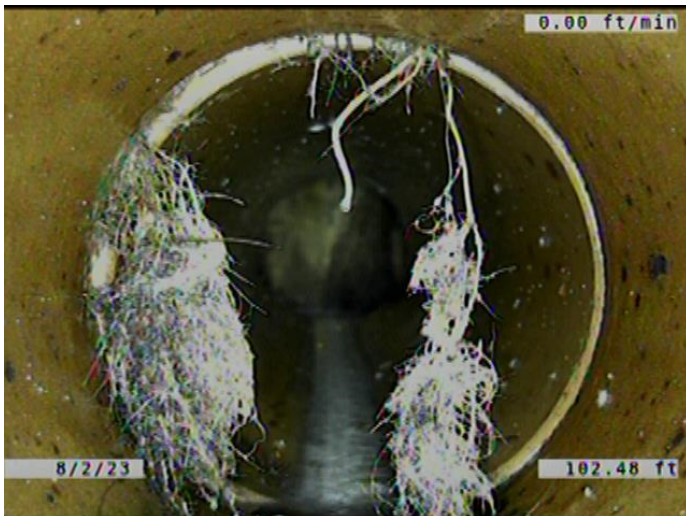
Code: **RMJ**
 Description: **Roots Medium Joint**

Distance (ft): **102.5**
 Structural Grade: **0**
 O&M Grade: **3**
 Clock Start/From: **7**
 Clock To: **1**
 1st Value:
 2nd Value:
 Value Percent: **15.000**
 Continuous Index:
 Within 8" of Joint: **YES**
 Remarks:

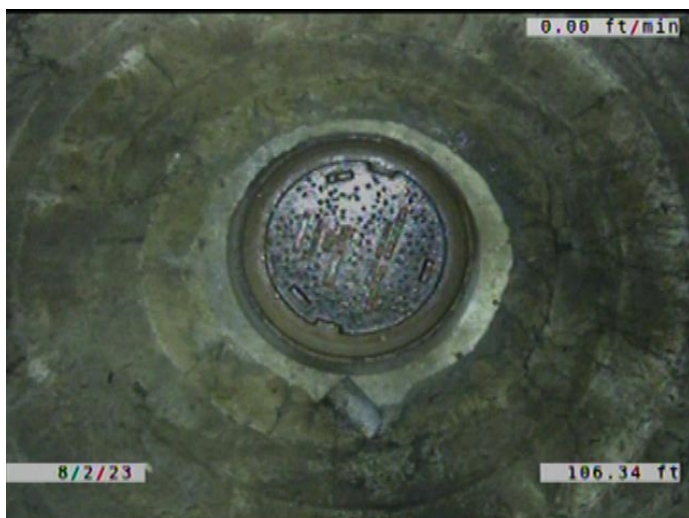
Code:	AMH
Description:	Manhole
Distance (ft):	106.3
Structural Grade:	0
O&M Grade:	0
Clock Start/From:	
Clock To:	
1st Value:	
2nd Value:	
Value Percent:	
Continuous Index:	
Within 8" of Joint:	NO
Remarks:	M-902-014
