## Profile/Photo Observation Report

Date:	<b>08/01/2023</b>	Weather:		Coding:	<b>PACP 7.0</b>
Pipe Length (ft):	<b>196.7</b>	Owner:	<b>City of Hobart</b>	Pre Clean:	<b>Heavy Cleaning</b>
P.O.#:	<b>YES502259</b>	Surveyor:	<b>S. Bucklin</b>	PSR:	<b>P-902-015-019B</b>
Customer:	<b>City of Hobart</b>	Clean Date:	<b>07/20/2023</b>	Shape:	<b>C</b>

Street:	<b>East 34th Court</b>	Flow Control:	<b>Not Controlled</b>
City:	<b>Hobart, IN</b>	Year Renewed:	
Location:	<b>Easement/Right of Way</b>	Tape/Media #:	
Purpose:	<b>Routine Assessment</b>	Dia/Height:	<b>10"</b>
Use:	<b>Sanitary Sewage Pipe</b>	Material:	<b>VCP</b>
Drain Area:		Lining:	<b>None</b>
Category:	<b>NA</b>		
Comment:			
Location Details:		Direction of Survey:	<b>Downstream</b>
US MH:	<b>M-902-015</b>	DS MH:	<b>M-902-019B</b>
		Total Length Surveyed (ft):	<b>338.5</b>

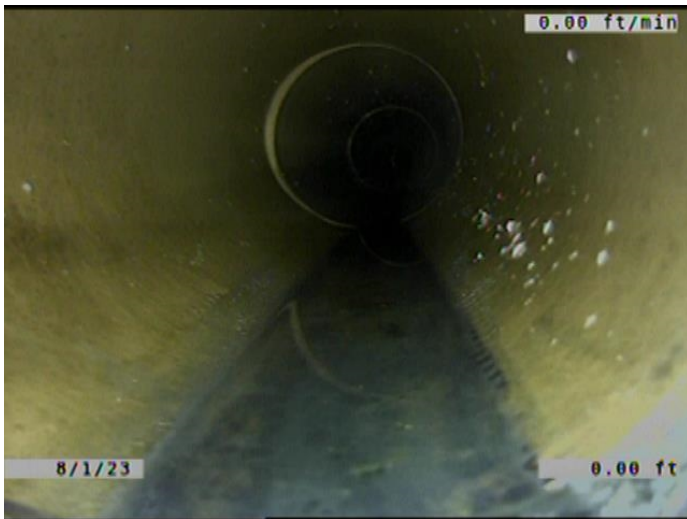
Code: **MWL**  
Description: **Miscellaneous Water Level**

Distance (ft): **.0**  
Structural Grade: **0**  
O&M Grade: **0**  
Clock Start/From:  
Clock To:  
1st Value:  
2nd Value:  
Value Percent: **5.000**  
Continuous Index:  
Within 8" of Joint: **NO**  
Remarks:

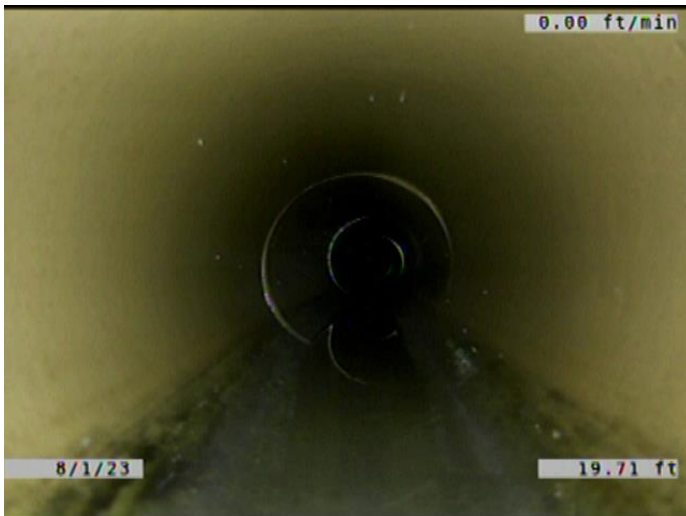
Code:	<b>MWLS</b>
Description:	<b>Miscellaneous Water Level Sag</b>
Distance (ft):	<b>19.7</b>
Structural Grade:	<b>2</b>
O&M Grade:	<b>0</b>
Clock Start/From:	
Clock To:	
1st Value:	
2nd Value:	
Value Percent:	<b>5.000</b>
Continuous Index:	<b>S02</b>
Within 8" of Joint:	<b>NO</b>
Remarks:

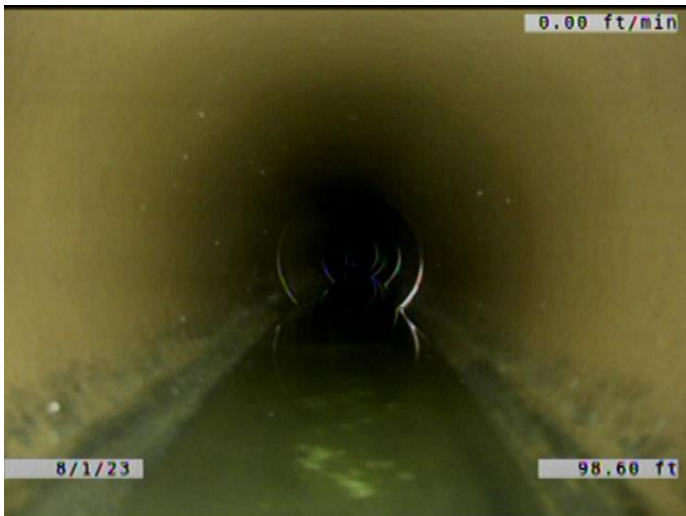
Code: **DSF**  
Description: **Deposits Settled Fine**

Distance (ft): **98.6**  
Structural Grade: **0**  
O&M Grade: **2**  
Clock Start/From: **5**  
Clock To: **7**  
1st Value:  
2nd Value:  
Value Percent: **5.000**  
Continuous Index: **S04**  
Within 8" of Joint: **YES**  
Remarks:

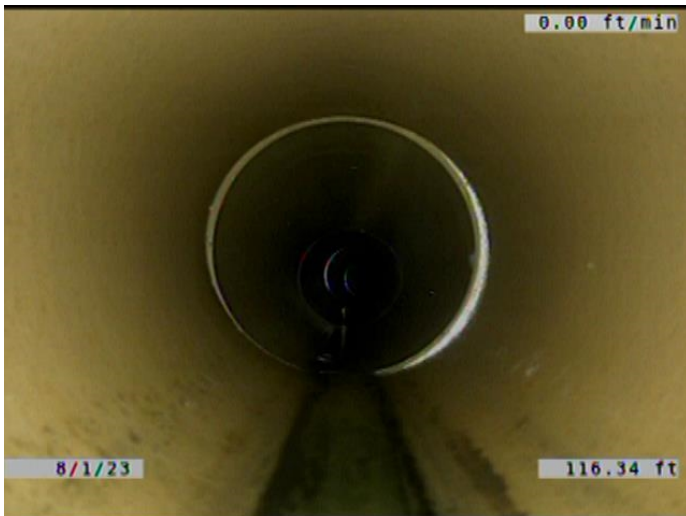
Code: **DSF**  
Description: **Deposits Settled Fine**

Distance (ft): **116.3**  
Structural Grade: **0**  
O&M Grade: **2**  
Clock Start/From: **5**  
Clock To: **7**  
1st Value:  
2nd Value:  
Value Percent: **5.000**  
Continuous Index: **F04**  
Within 8" of Joint: **YES**  
Remarks:

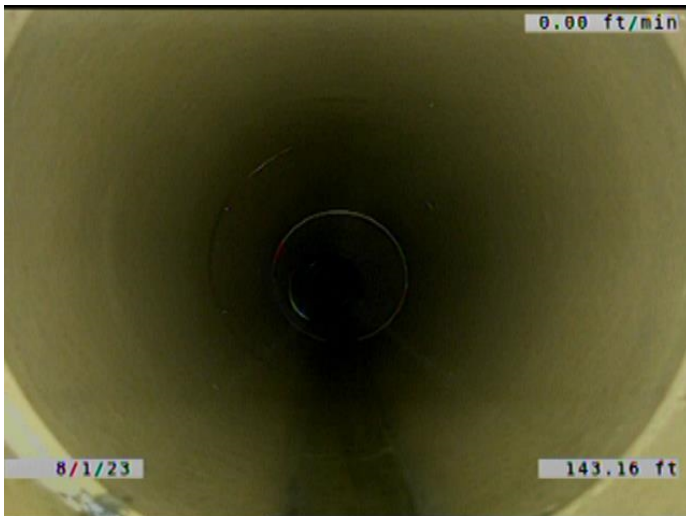
Code: **MWLS**  
Description: **Miscellaneous Water Level Sag**

Distance (ft): **143.2**  
Structural Grade: **2**  
O&M Grade: **0**  
Clock Start/From:  
Clock To:  
1st Value:  
2nd Value:  
Value Percent: **5.000**  
Continuous Index: **F05**  
Within 8" of Joint: **NO**  
Remarks:

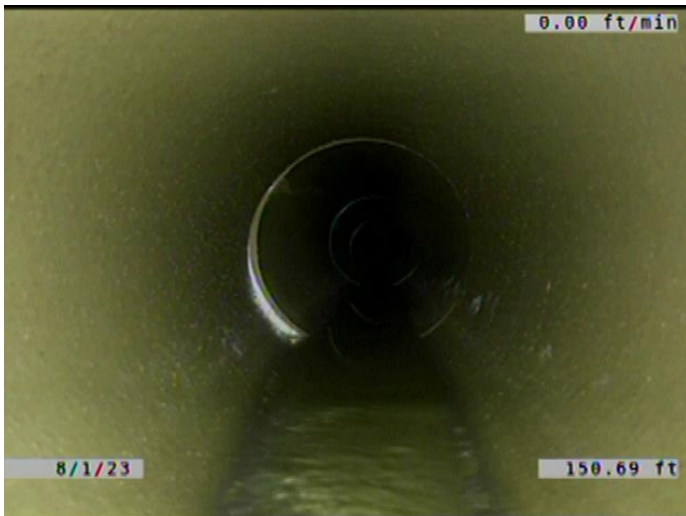
Code:	<b>MWLS</b>
Description:	<b>Miscellaneous Water Level Sag</b>
Distance (ft):	<b>150.7</b>
Structural Grade:	<b>2</b>
O&M Grade:	<b>0</b>
Clock Start/From:	
Clock To:	
1st Value:	
2nd Value:	
Value Percent:	<b>10.000</b>
Continuous Index:	<b>S06</b>
Within 8" of Joint:	<b>NO</b>
Remarks:

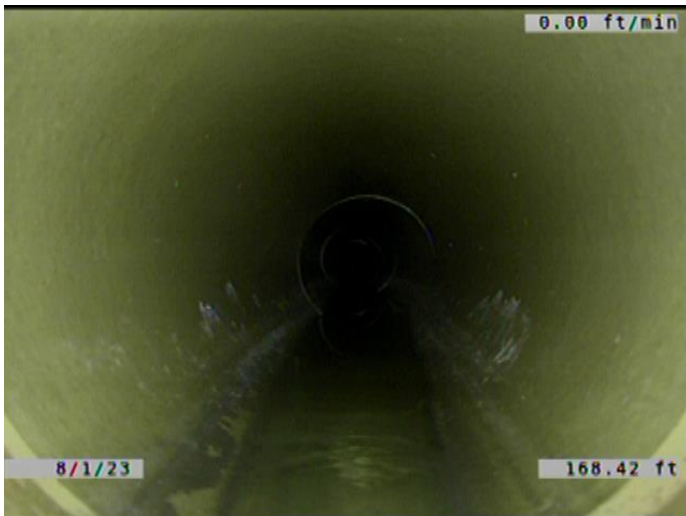
Code: **MWLS**  
Description: **Miscellaneous Water Level Sag**

Distance (ft): **168.4**  
Structural Grade: **2**  
O&M Grade: **0**  
Clock Start/From:  
Clock To:  
1st Value:  
2nd Value:  
Value Percent: **10.000**  
Continuous Index: **S07**  
Within 8" of Joint: **NO**  
Remarks:

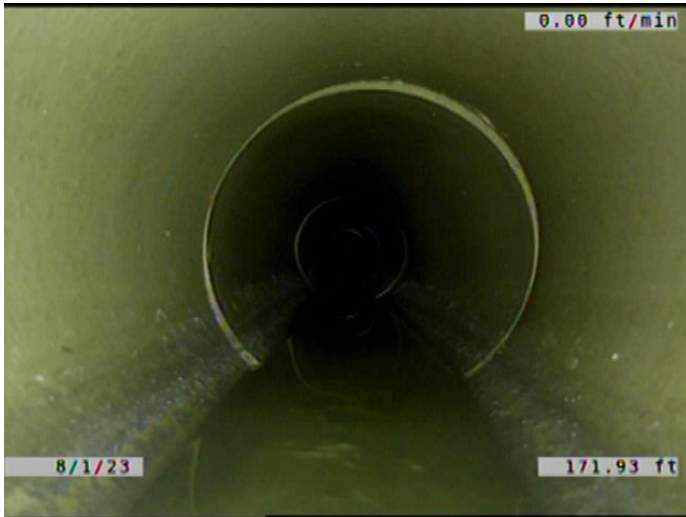
Code: **DSF**  
Description: **Deposits Settled Fine**

Distance (ft): **171.9**  
Structural Grade: **0**  
O&M Grade: **2**  
Clock Start/From: **5**  
Clock To: **7**  
1st Value:  
2nd Value:  
Value Percent: **5.000**  
Continuous Index: **S08**  
Within 8" of Joint: **YES**  
Remarks:

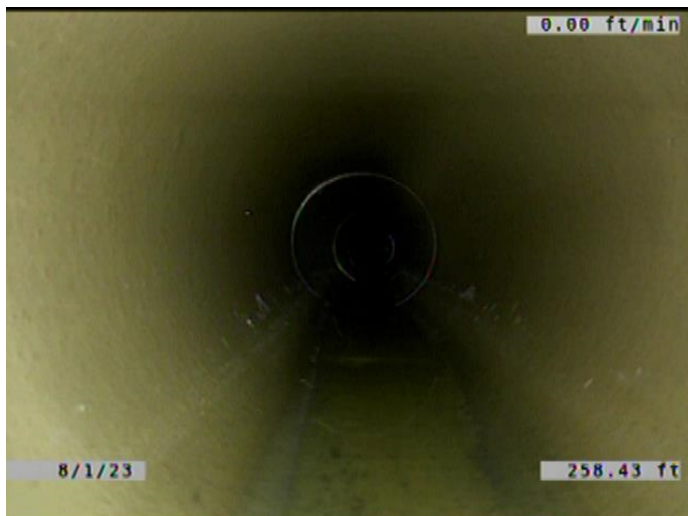
Code: **MWLS**  
Description: **Miscellaneous Water Level Sag**

Distance (ft): **258.4**  
Structural Grade: **2**  
O&M Grade: **0**  
Clock Start/From:  
Clock To:  
1st Value:  
2nd Value:  
Value Percent: **5.000**  
Continuous Index: **S10**  
Within 8" of Joint: **NO**  
Remarks:

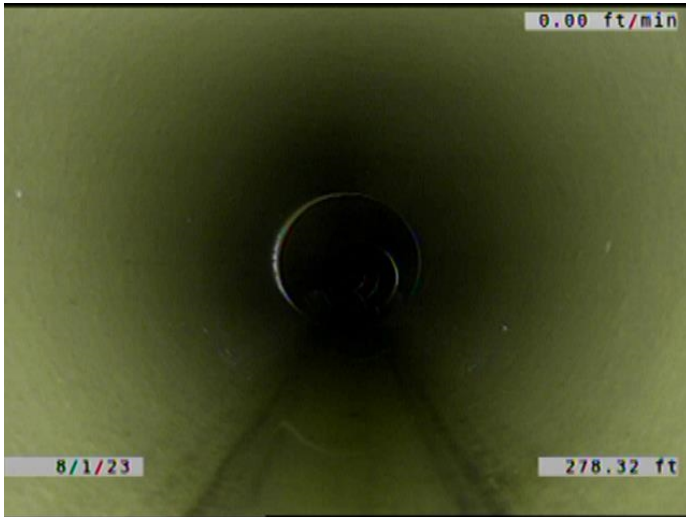
Code: **MWLS**  
Description: **Miscellaneous Water Level Sag**

Distance (ft): **278.3**  
Structural Grade: **2**  
O&M Grade: **0**  
Clock Start/From:  
Clock To:  
1st Value:  
2nd Value:  
Value Percent: **5.000**  
Continuous Index: **F10**  
Within 8" of Joint: **NO**  
Remarks:

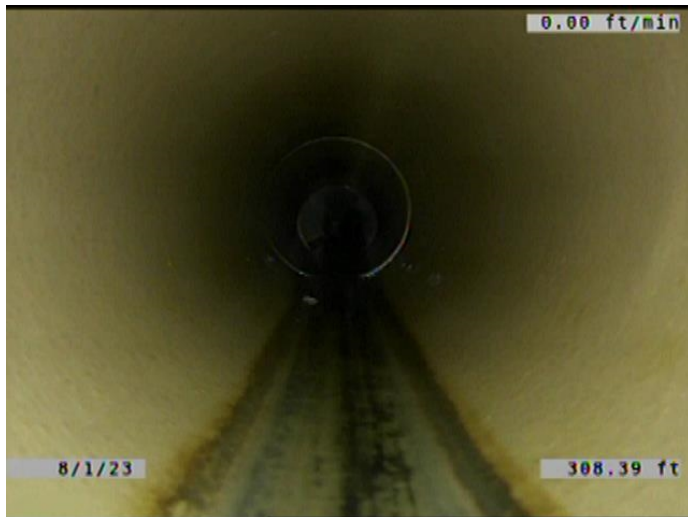
Code: **MWLS**  
Description: **Miscellaneous Water Level Sag**

Distance (ft): **308.4**  
Structural Grade: **2**  
O&M Grade: **0**  
Clock Start/From:  
Clock To:  
1st Value:  
2nd Value:  
Value Percent: **10.000**  
Continuous Index: **F11**  
Within 8" of Joint: **NO**  
Remarks:

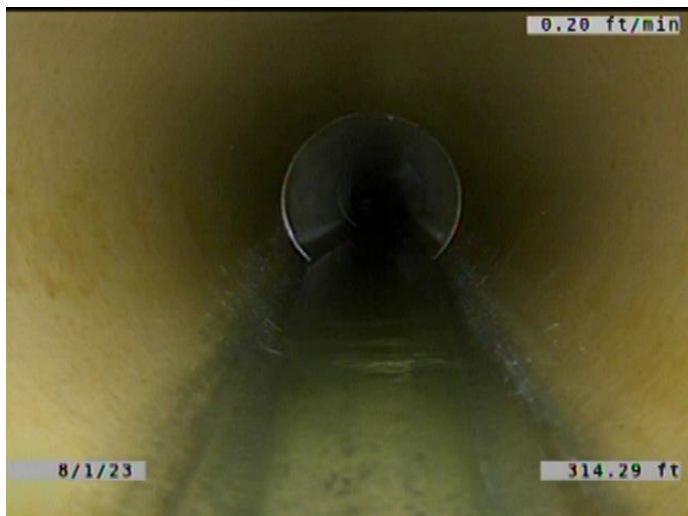
Code: **MWLS**  
Description: **Miscellaneous Water Level Sag**

Distance (ft): **314.2**  
Structural Grade: **2**  
O&M Grade: **0**  
Clock Start/From:  
Clock To:  
1st Value:  
2nd Value:  
Value Percent: **10.000**  
Continuous Index: **S12**  
Within 8" of Joint: **NO**  
Remarks:

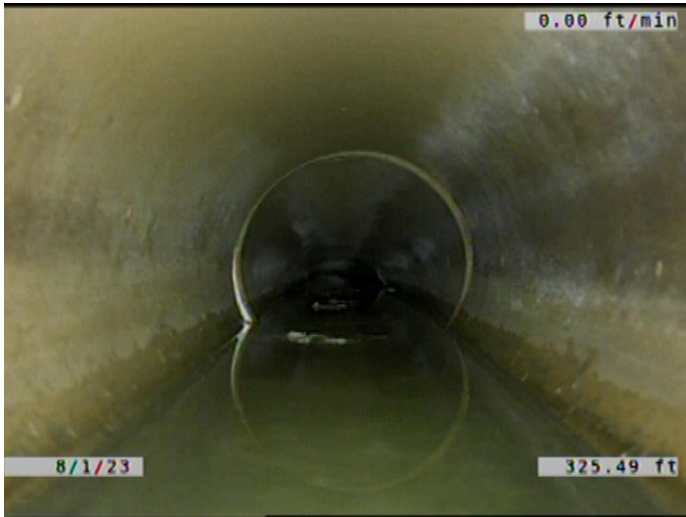
Code: **DSF**  
Description: **Deposits Settled Fine**

Distance (ft): **325.5**  
Structural Grade: **0**  
O&M Grade: **2**  
Clock Start/From: **5**  
Clock To: **7**  
1st Value:  
2nd Value:  
Value Percent: **5.000**  
Continuous Index: **S14**  
Within 8" of Joint: **YES**  
Remarks:

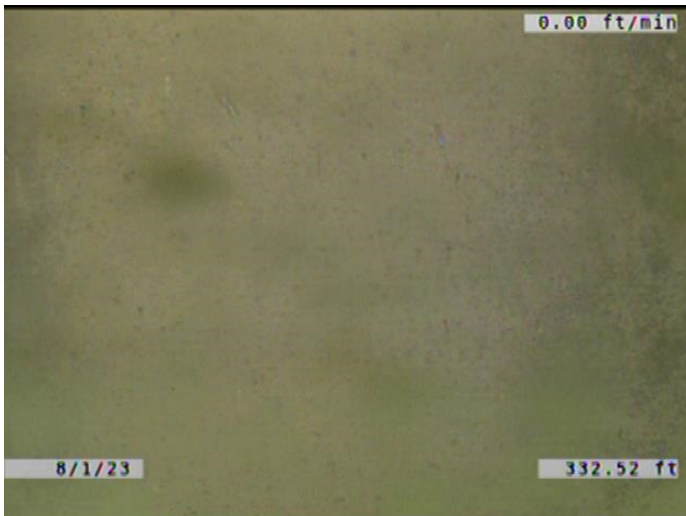
Code: **MCU**  
Description: **Miscellaneous Camera Underwater**

Distance (ft): **332.5**  
Structural Grade: **0**  
O&M Grade: **4**  
Clock Start/From:  
Clock To:  
1st Value:  
2nd Value:  
Value Percent:  
Continuous Index: **S15**  
Within 8" of Joint: **NO**  
Remarks:

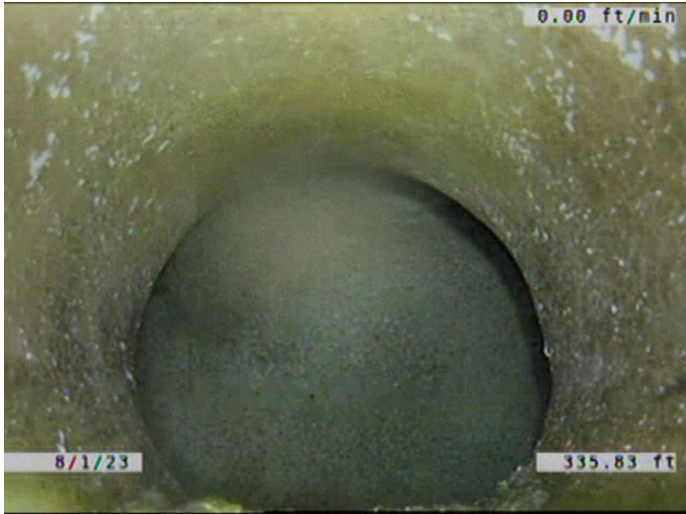
Code:	<b>MCU</b>
Description:	<b>Miscellaneous Camera Underwater</b>
Distance (ft):	<b>335.8</b>
Structural Grade:	<b>0</b>
O&M Grade:	<b>4</b>
Clock Start/From:	
Clock To:	
1st Value:	
2nd Value:	
Value Percent:	
Continuous Index:	<b>F15</b>
Within 8" of Joint:	<b>NO</b>
Remarks:

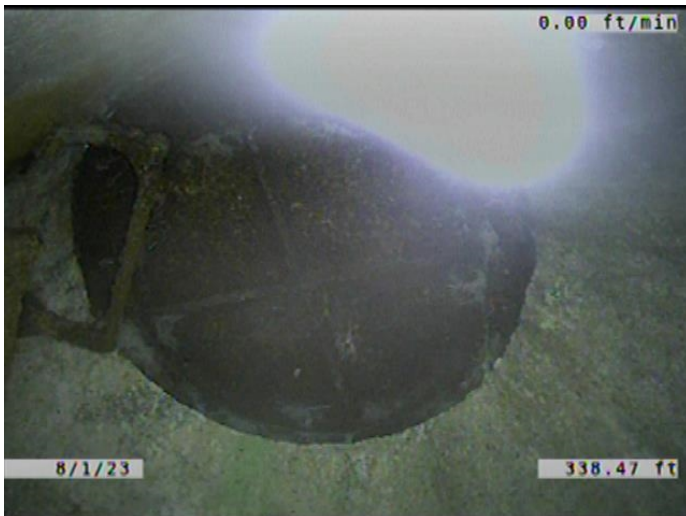
Code: **AMH**  
Description: **Manhole**

Distance (ft): **338.5**  
Structural Grade: **0**  
O&M Grade: **0**  
Clock Start/From:  
Clock To:  
1st Value:  
2nd Value:  
Value Percent:  
Continuous Index:  
Within 8" of Joint: **NO**  
Remarks: **M-902-019B**
