Profile/Photo Observation Report

Street:	RANDOLPH PL	Flow Control:	Not Controlled
City:	Hobart, IN	Year Renewed:	
Location:	Main Highway - Suburban/Rural	Tape/Media #:	
Purpose:	Resurvey	Dia/Height:	10"
Use:	Sanitary	Material:	VCP
Drain Area:	NA	Lining:	
Category:	NA		
Comment:

Location Details:		Direction of Survey:	Upstream
US MH:	M-902-026	DS MH:	M-902-025
		Total Length Surveyed (ft):	122.5

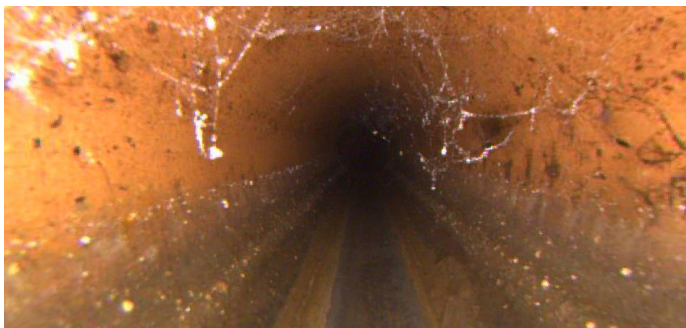
Code: **AMH**
Description: **Manhole**

Distance (ft): **.0**
Structural Grade: **0**
O&M Grade: **0**
Clock Start/From:
Clock To:
1st Value:
2nd Value:
Value Percent:
Continuous Index:
Within 8" of Joint: **NO**
Remarks: **M-902-025**

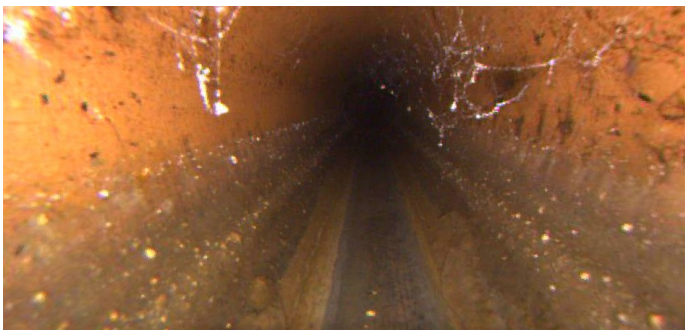
Code:	DAZ
Description:	Deposits Attached Other

Distance (ft):	.0
Structural Grade:	0
O&M Grade:	2
Clock Start/From:	3
Clock To:	9
1st Value:	
2nd Value:	
Value Percent:	10.000
Continuous Index:	S01
Within 8" of Joint:	NO
Remarks:	Mixed materials

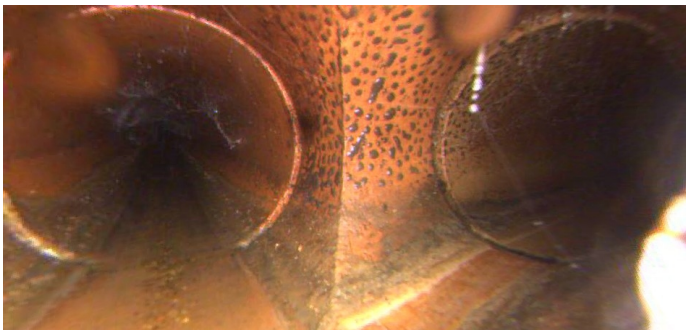
Code: **TF**
Description: **Tap Factory**

Distance (ft): **38.7**
Structural Grade: **0**
O&M Grade: **0**
Clock Start/From: **3**
Clock To:
1st Value: **4.000**
2nd Value:
Value Percent:
Continuous Index:
Within 8" of Joint:
Remarks:

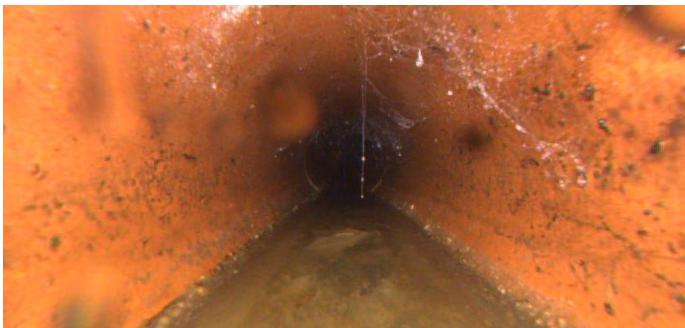
Code: **DAZ**
Description: **Deposits Attached Other**

Distance (ft): **47.1**
Structural Grade: **0**
O&M Grade: **2**
Clock Start/From: **3**
Clock To: **9**
1st Value:
2nd Value:
Value Percent: **10.000**
Continuous Index: **F01**
Within 8" of Joint: **NO**
Remarks: **Mixed materials / Clock positions vary**

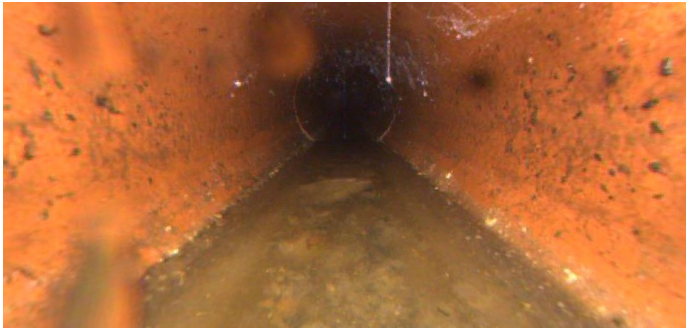
Code: **MWL**
Description: **Water Level**

Distance (ft): **47.6**
Structural Grade: **0**
O&M Grade: **0**
Clock Start/From:
Clock To:
1st Value:
2nd Value:
Value Percent: **15.000**
Continuous Index:
Within 8" of Joint: **NO**
Remarks:

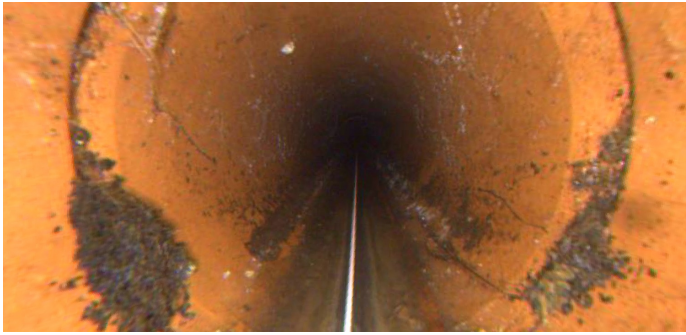
Code: **RMJ**
Description: **Roots Medium Joint**

Distance (ft): **89.3**
Structural Grade: **0**
O&M Grade: **3**
Clock Start/From: **8**
Clock To: **4**
1st Value:
2nd Value:
Value Percent: **5.000**
Continuous Index:
Within 8" of Joint: **YES**
Remarks:

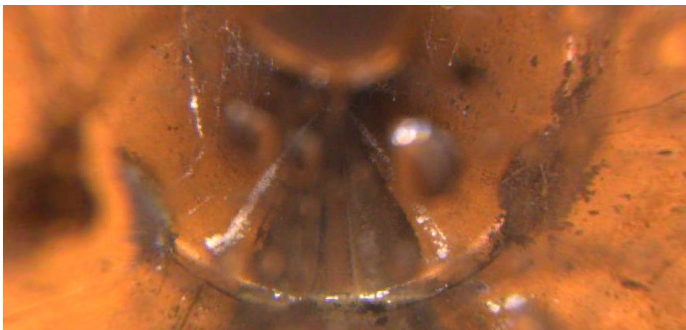
Code: **RFJ**
Description: **Roots Fine Joint**

Distance (ft): **118.2**
Structural Grade: **0**
O&M Grade: **1**
Clock Start/From: **3**
Clock To: **8**
1st Value:
2nd Value:
Value Percent:
Continuous Index:
Within 8" of Joint: **YES**
Remarks:
