## Profile/Photo Observation Report

Date:	<b>03/20/2018</b>	Weather:		Coding:	<b>PACP 6.0</b>
Pipe Length (ft):	<b>128.8</b>	Owner:	<b>NA</b>	Pre Clean:	<b>Not Known</b>
P.O.#:		Surveyor:	<b>John Kuglmaier</b>	PSR:	<b>P-902-026-025</b>
Customer:		Clean Date:	<b>01/01/1900</b>	Shape:	<b>C</b>

Street:	<b>Randolph Pl</b>	Flow Control:	<b>Not Controlled</b>
City:	<b>Hobart, IN</b>	Year Renewed:	
Location:	<b>Main Highway - Suburban/Rural</b>	Tape/Media #:	
Purpose:	<b>Resurvey</b>	Dia/Height:	<b>10"</b>
Use:	<b>Sanitary</b>	Material:	<b>VCP</b>
Drain Area:	<b>NA</b>	Lining:	
Category:	<b>NA</b>		
Comment:

Location Details:		Direction of Survey:	<b>Upstream</b>
US MH:	<b>M-902-026</b>	DS MH:	<b>M-902-025</b>
		Total Length Surveyed (ft):	<b>122.5</b>

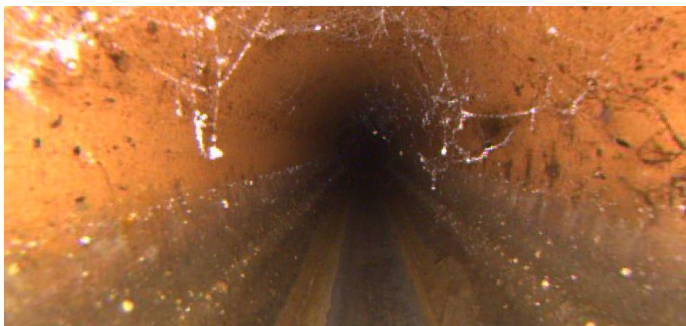
Code: **AMH**  
Description: **Manhole**

Distance (ft): **.0**  
Structural Grade: **0**  
O&M Grade: **0**  
Clock Start/From:  
Clock To:  
1st Value:  
2nd Value:  
Value Percent:  
Continuous Index:  
Within 8" of Joint: **NO**  
Remarks: **M-902-025**

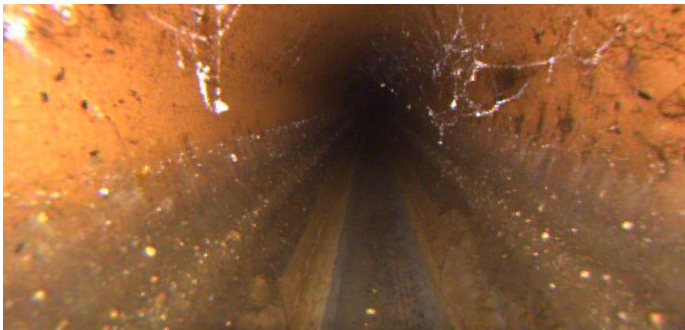
Code:	<b>DAZ</b>
Description:	<b>Deposits Attached Other</b>

Distance (ft):	<b>.0</b>
Structural Grade:	<b>0</b>
O&M Grade:	<b>2</b>
Clock Start/From:	<b>3</b>
Clock To:	<b>9</b>
1st Value:	
2nd Value:	
Value Percent:	<b>10.000</b>
Continuous Index:	<b>S01</b>
Within 8" of Joint:	<b>NO</b>
Remarks:	<b>Mixed materials</b>

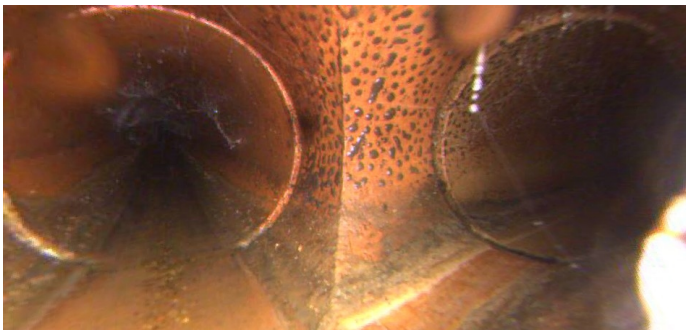
Code: **TF**  
Description: **Tap Factory**

Distance (ft): **38.7**  
Structural Grade: **0**  
O&M Grade: **0**  
Clock Start/From: **3**  
Clock To:  
1st Value: **4.000**  
2nd Value:  
Value Percent:  
Continuous Index:  
Within 8" of Joint:  
Remarks:

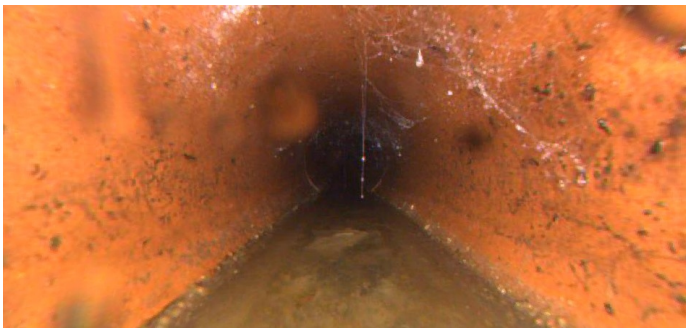
Code: **DAZ**  
Description: **Deposits Attached Other**

Distance (ft): **47.1**  
Structural Grade: **0**  
O&M Grade: **2**  
Clock Start/From: **3**  
Clock To: **9**  
1st Value:  
2nd Value:  
Value Percent: **10.000**  
Continuous Index: **F01**  
Within 8" of Joint: **NO**  
Remarks: **Mixed materials / Clock positions vary**

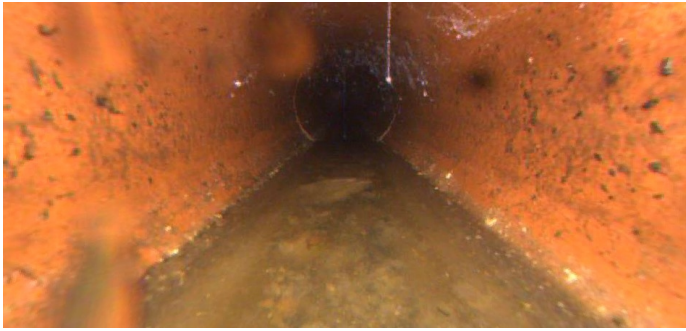
Code: **MWL**  
Description: **Water Level**

Distance (ft): **47.6**  
Structural Grade: **0**  
O&M Grade: **0**  
Clock Start/From:  
Clock To:  
1st Value:  
2nd Value:  
Value Percent: **15.000**  
Continuous Index:  
Within 8" of Joint: **NO**  
Remarks:

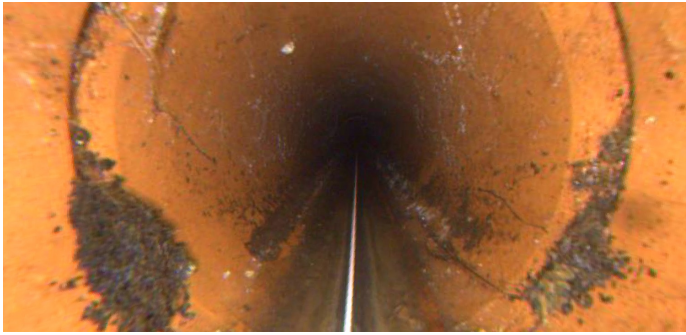
Code: **RMJ**  
Description: **Roots Medium Joint**

Distance (ft): **89.3**  
Structural Grade: **0**  
O&M Grade: **3**  
Clock Start/From: **8**  
Clock To: **4**  
1st Value:  
2nd Value:  
Value Percent: **5.000**  
Continuous Index:  
Within 8" of Joint: **YES**  
Remarks:

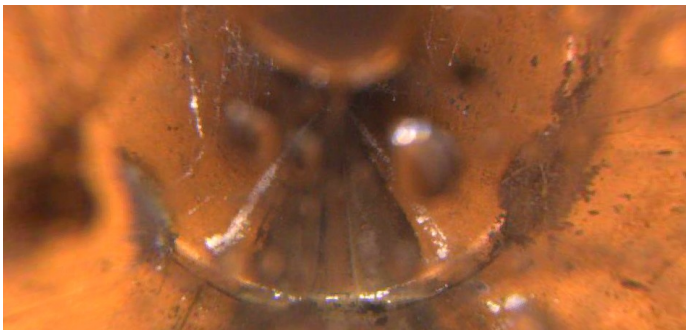
Code: **RFJ**  
Description: **Roots Fine Joint**

Distance (ft): **118.2**  
Structural Grade: **0**  
O&M Grade: **1**  
Clock Start/From: **3**  
Clock To: **8**  
1st Value:  
2nd Value:  
Value Percent:  
Continuous Index:  
Within 8" of Joint: **YES**  
Remarks:
