Profile/Photo Observation Report

Street:	ALLEY BETWEEN E 34TH AVE & E 34T	Flow Control:	Not Controlled
City:	Hobart, IN	Year Renewed:	
Location:	Other	Tape/Media #:	
Purpose:	Not Known	Dia/Height:	10"
Use:	Sanitary	Material:	VCP
Drain Area:	NA	Lining:	
Category:	NA		
Comment:

Location Details:		Direction of Survey:	Downstream
US MH:	M-902-040	DS MH:	M-902-039
		Total Length Surveyed (ft):	7.3

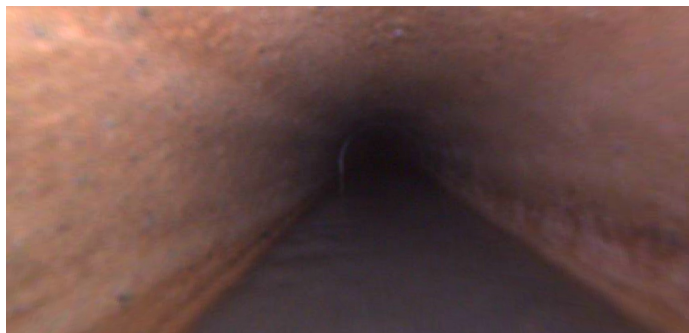
Code: **AMH**
 Description: **Manhole**
 Distance (ft): **.0**
 Structural Grade: **0**
 O&M Grade: **0**
 Clock Start/From:
 Clock To:
 1st Value:
 2nd Value:
 Value Percent:
 Continuous Index:
 Within 8" of Joint: **NO**
 Remarks: **M-902-040**

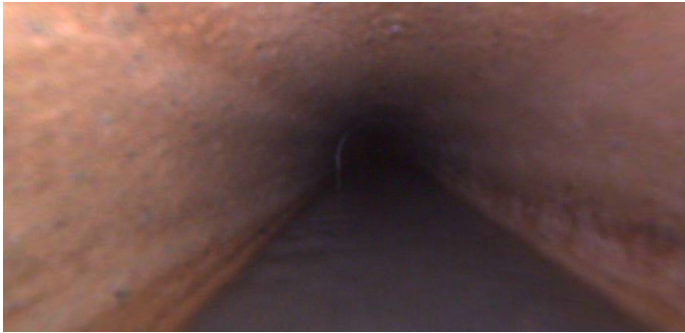
Code:	MWL
Description:	Water Level

Distance (ft):	.0
Structural Grade:	0
O&M Grade:	0
Clock Start/From:	
Clock To:	
1st Value:	
2nd Value:	
Value Percent:	10.000
Continuous Index:	
Within 8" of Joint:	NO
Remarks:
