Profile/Photo Observation Report

Street:	e 34th st	Flow Control:	Not Controlled
City:	Hobart, IN	Year Renewed:	
Location:	Other	Tape/Media #:	
Purpose:	Not Known	Dia/Height:	10"
Use:	Sanitary	Material:	VCP
Drain Area:	NA	Lining:	
Category:	NA		
Comment:

Location Details:		Direction of Survey:	Downstream
US MH:	M-902-040	DS MH:	M-902-039
		Total Length Surveyed (ft):	7.3

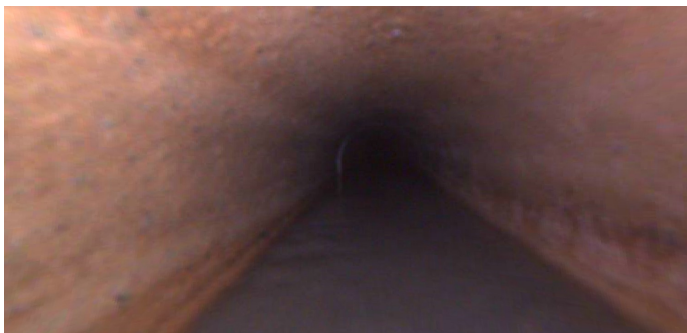
Code: **AMH**
Description: **Manhole**

Distance (ft): **.0**
Structural Grade: **0**
O&M Grade: **0**
Clock Start/From:
Clock To:
1st Value:
2nd Value:
Value Percent:
Continuous Index:
Within 8" of Joint: **NO**
Remarks: **M-902-040**

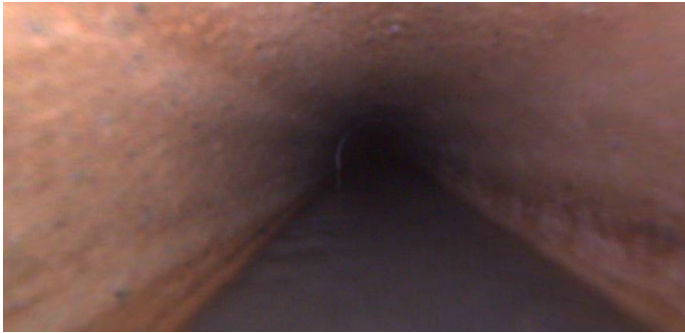
Code:	MWL
Description:	Water Level

Distance (ft):	.0
Structural Grade:	0
O&M Grade:	0
Clock Start/From:	
Clock To:	
1st Value:	
2nd Value:	
Value Percent:	10.000
Continuous Index:	
Within 8" of Joint:	NO
Remarks:
