Profile/Photo Observation Report

Date:	03/24/2018	Weather:		Coding:	PACP 6.0
Pipe Length (ft):	204.6	Owner:	NA	Pre Clean:	Not Known
P.O.#:		Surveyor:	Byrd Fitzgerald	PSR:	P-902-044-038
Customer:		Clean Date:	01/01/1900	Shape:	C

Street:	RANDOLPH PL	Flow Control:	Not Controlled
City:	Hobart, IN	Year Renewed:	
Location:	Other	Tape/Media #:	
Purpose:	Not Known	Dia/Height:	10"
Use:	Sanitary	Material:	VCP
Drain Area:	NA	Lining:	
Category:	NA		
Comment:	null-cnl

Location Details:		Direction of Survey:	Downstream
US MH:	M-902-044	DS MH:	M-902-038
		Total Length Surveyed (ft):	2.2

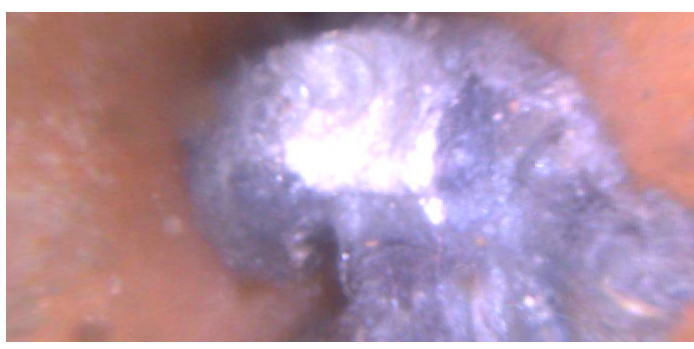
Code: **AMH**
Description: **Manhole**

Distance (ft): **.0**
Structural Grade: **0**
O&M Grade: **0**
Clock Start/From:
Clock To:
1st Value:
2nd Value:
Value Percent:
Continuous Index:
Within 8" of Joint: **NO**
Remarks: **M-902-044**

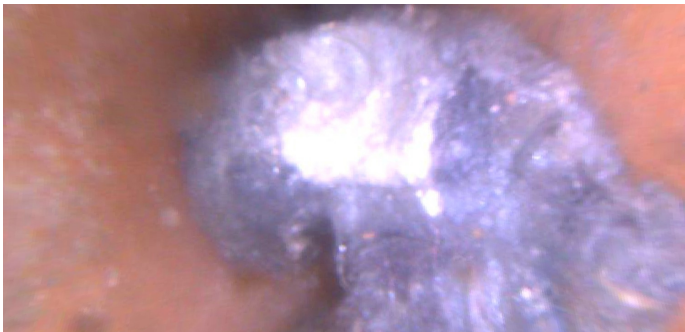
Code:	RBB
Description:	Roots Ball Barrel

Distance (ft):	.0
Structural Grade:	0
O&M Grade:	5
Clock Start/From:	12
Clock To:	12
1st Value:	
2nd Value:	
Value Percent:	80.000
Continuous Index:	
Within 8" of Joint:	NO
Remarks:
