Profile/Photo Observation Report

Street:	saint joesph pl	Flow Control:	Not Controlled
City:	Hobart, IN	Year Renewed:	
Location:	Other	Tape/Media #:	
Purpose:	Not Known	Dia/Height:	10"
Use:	Sanitary	Material:	PVC
Drain Area:	NA	Lining:	
Category:	NA		
Comment:

Location Details:		Direction of Survey:	Upstream
US MH:	M-902-045	DS MH:	M-902-078
		Total Length Surveyed (ft):	82.7

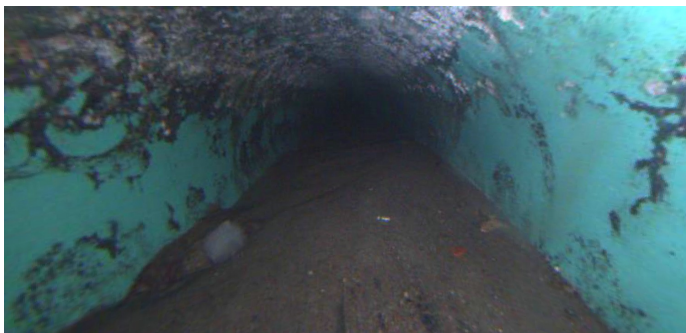
Code: **DSF**
Description: **Deposits Settled Fine**

Distance (ft): **.0**
Structural Grade: **0**
O&M Grade: **3**
Clock Start/From: **4**
Clock To: **8**
1st Value:
2nd Value:
Value Percent: **20.000**
Continuous Index: **S02**
Within 8" of Joint: **NO**
Remarks:

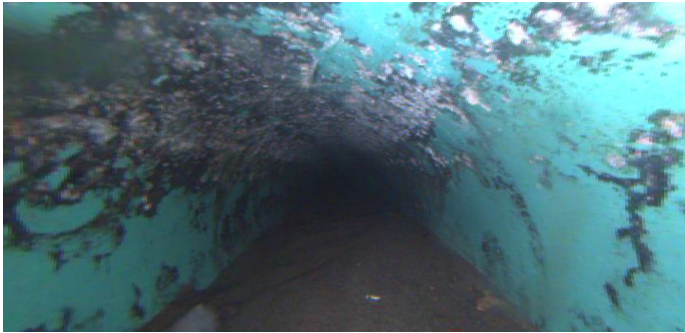
Code:	AMH
Description:	Manhole

Distance (ft):	.0
Structural Grade:	0
O&M Grade:	0
Clock Start/From:	
Clock To:	
1st Value:	
2nd Value:	
Value Percent:	
Continuous Index:	
Within 8" of Joint:	NO
Remarks:	M-902-078

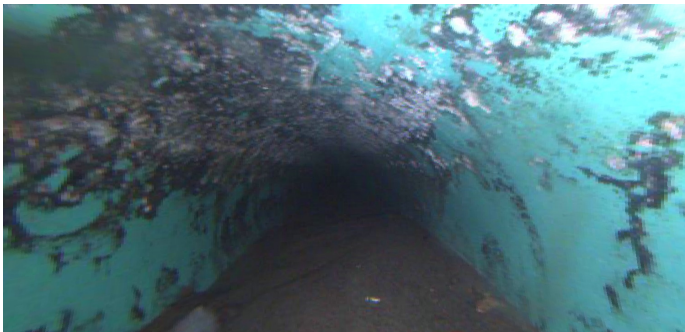
Code:	MWL
Description:	Water Level

Distance (ft):	.0
Structural Grade:	0
O&M Grade:	0
Clock Start/From:	
Clock To:	
1st Value:	
2nd Value:	
Value Percent:	0.000
Continuous Index:	
Within 8" of Joint:	NO
Remarks:

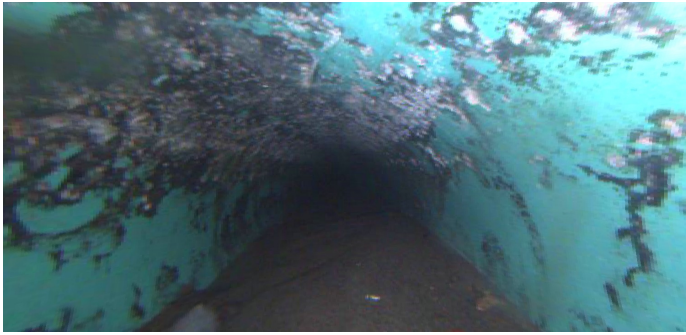
Code: **DAGS**
Description: **Deposits Attached Grease**

Distance (ft): **.0**
Structural Grade: **0**
O&M Grade: **2**
Clock Start/From: **7**
Clock To: **5**
1st Value:
2nd Value:
Value Percent: **5.000**
Continuous Index: **S01**
Within 8" of Joint: **NO**
Remarks:

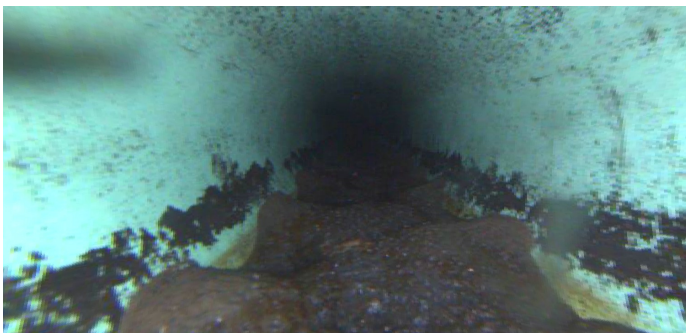
Code: **DAGS**
Description: **Deposits Attached Grease**

Distance (ft): **30.5**
Structural Grade: **0**
O&M Grade: **2**
Clock Start/From: **7**
Clock To: **5**
1st Value:
2nd Value:
Value Percent: **5.000**
Continuous Index: **F01**
Within 8" of Joint: **NO**
Remarks:

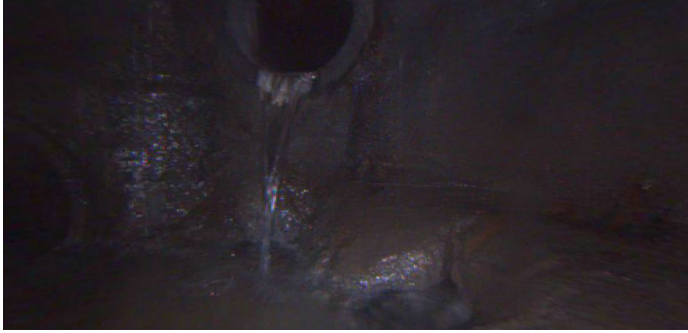
Code:	AMH
Description:	Manhole
Distance (ft):	82.7
Structural Grade:	0
O&M Grade:	0
Clock Start/From:	
Clock To:	
1st Value:	
2nd Value:	
Value Percent:	
Continuous Index:	
Within 8" of Joint:	NO
Remarks:	M-902-045
