Profile/Photo Observation Report

Date:	03/20/2018	Weather:		Coding:	PACP 6.0
Pipe Length (ft):	247.0	Owner:	NA	Pre Clean:	Not Known
P.O.#:		Surveyor:	John Kuglmaier	PSR:	P-902-056-046
Customer:		Clean Date:	01/01/1900	Shape:	O

Street:	RUSH PL	Flow Control:	Not Controlled
City:	Hobart, IN	Year Renewed:	
Location:	Main Highway - Suburban/Rural	Tape/Media #:	
Purpose:	Resurvey	Dia/Height:	12"
Use:	Sanitary	Material:	PVC
Drain Area:	NA	Lining:	
Category:	NA		
Comment:

Location Details:		Direction of Survey:	Downstream
US MH:	M-902-046	DS MH:	M-902-056
		Total Length Surveyed (ft):	8.6

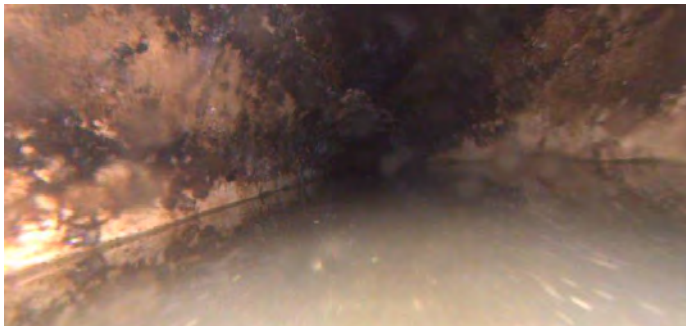
Code: **AMH**
Description: **Manhole**

Distance (ft): **.0**
Structural Grade: **0**
O&M Grade: **0**
Clock Start/From:
Clock To:
1st Value:
2nd Value:
Value Percent:
Continuous Index:
Within 8" of Joint: **NO**
Remarks: **M-902-046**

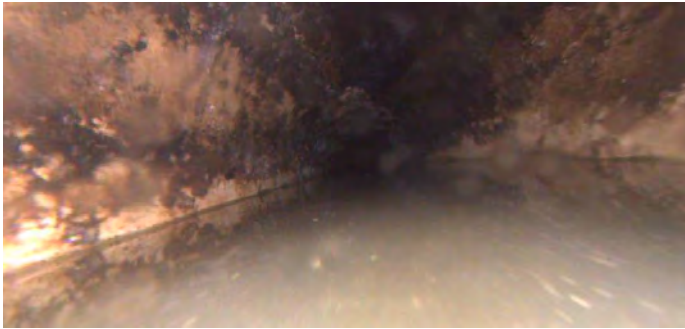
Code:	MWL
Description:	Water Level

Distance (ft):	.0
Structural Grade:	0
O&M Grade:	0
Clock Start/From:	
Clock To:	
1st Value:	
2nd Value:	
Value Percent:	30.000
Continuous Index:	
Within 8" of Joint:	NO
Remarks:

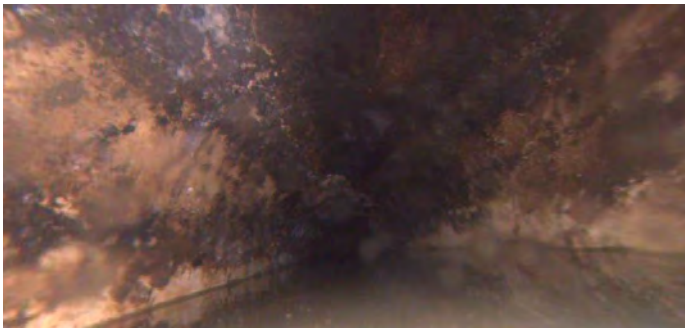
Code:	DAZ
Description:	Deposits Attached Other

Distance (ft):	.0
Structural Grade:	0
O&M Grade:	2
Clock Start/From:	9
Clock To:	3
1st Value:	
2nd Value:	
Value Percent:	5.000
Continuous Index:	S01
Within 8" of Joint:	NO
Remarks:	Mixed materials

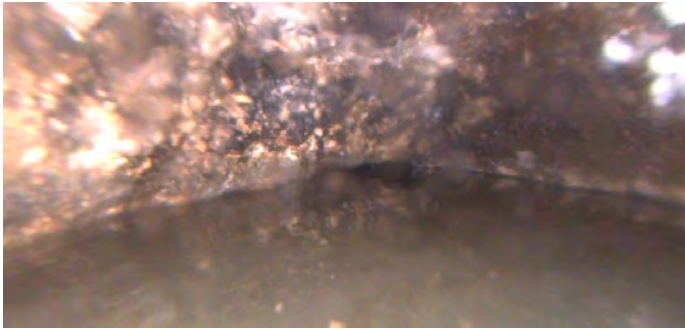
Code: **MWL**
Description: **Water Level**

Distance (ft): **7.2**
Structural Grade: **0**
O&M Grade: **0**
Clock Start/From:
Clock To:
1st Value:
2nd Value:
Value Percent: **70.000**
Continuous Index:
Within 8" of Joint: **NO**
Remarks:

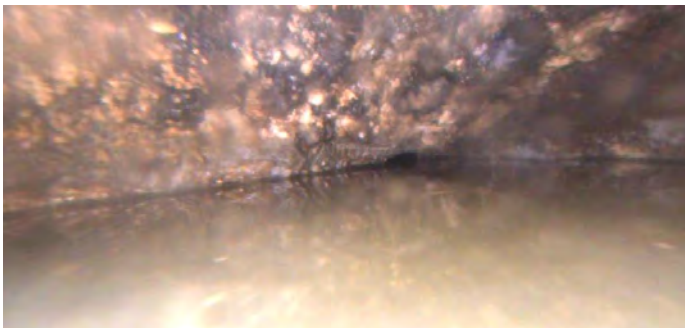
Code: **DAZ**
Description: **Deposits Attached Other**

Distance (ft): **7.4**
Structural Grade: **0**
O&M Grade: **2**
Clock Start/From: **9**
Clock To: **3**
1st Value:
2nd Value:
Value Percent: **5.000**
Continuous Index: **F01**
Within 8" of Joint: **NO**
Remarks: **Mixed materials / Clock positions vary**

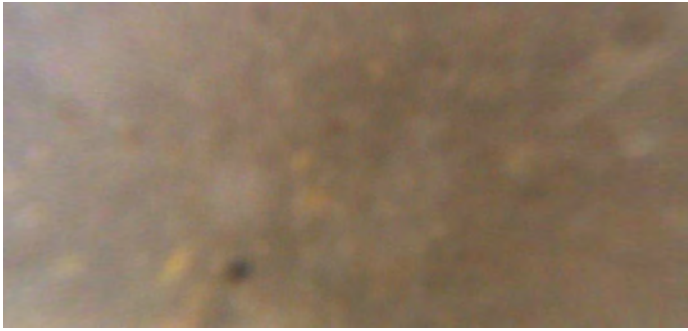
Code:	MSA
Description:	Abandoned Survey
Distance (ft):	8.6
Structural Grade:	0
O&M Grade:	0
Clock Start/From:	
Clock To:	
1st Value:	
2nd Value:	
Value Percent:	
Continuous Index:	
Within 8" of Joint:	NO
Remarks:	DAZ
