Profile/Photo Observation Report

Date:	03/20/2018	Weather:		Coding:	PACP 6.0
Pipe Length (ft):	192.5	Owner:	NA	Pre Clean:	Not Known
P.O.#:		Surveyor:	John Kuglmaier	PSR:	P-902-070-046
Customer:		Clean Date:	01/01/1900	Shape:	C

Street:	ALLEY BETWEEN SAINT JOSEPH PL &	Flow Control:	Not Controlled
City:	Hobart, IN	Year Renewed:	
Location:	Main Highway - Suburban/Rural	Tape/Media #:	
Purpose:	Resurvey	Dia/Height:	8"
Use:	Sanitary	Material:	VCP
Drain Area:	NA	Lining:	Cured in Place
Category:	NA		
Comment:

Location Details:		Direction of Survey:	Downstream
US MH:	M-902-046	DS MH:	M-902-070
		Total Length Surveyed (ft):	190.2

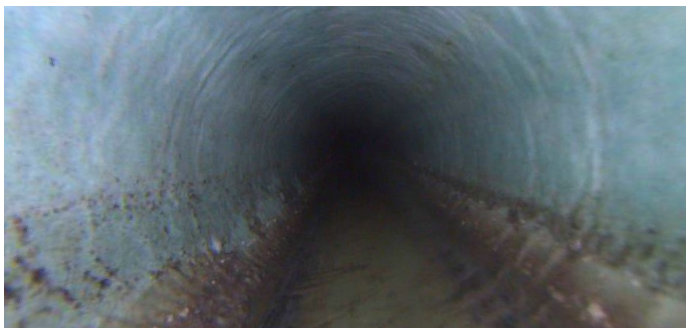
Code: **AMH**
Description: **Manhole**

Distance (ft): **.0**
Structural Grade: **0**
O&M Grade: **0**
Clock Start/From:
Clock To:
1st Value:
2nd Value:
Value Percent:
Continuous Index:
Within 8" of Joint: **NO**
Remarks: **M-902-046**

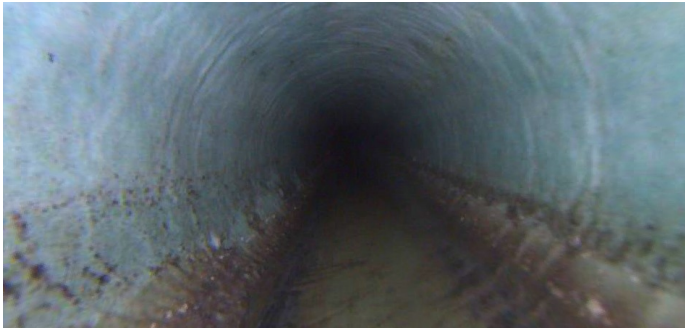
Code:	MWL
Description:	Water Level

Distance (ft):	.0
Structural Grade:	0
O&M Grade:	0
Clock Start/From:	
Clock To:	
1st Value:	
2nd Value:	
Value Percent:	10.000
Continuous Index:	
Within 8" of Joint:	NO
Remarks:

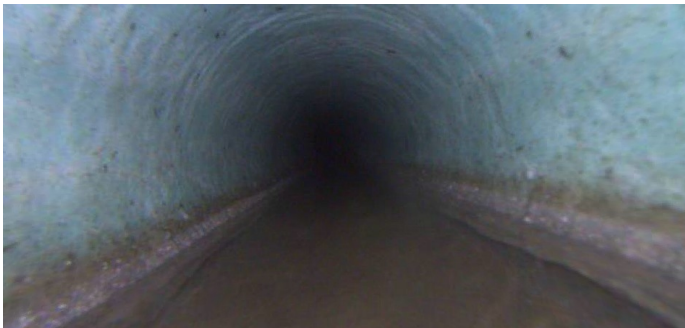
Code:	MWL
Description:	Water Level

Distance (ft):	4.9
Structural Grade:	0
O&M Grade:	0
Clock Start/From:	
Clock To:	
1st Value:	
2nd Value:	
Value Percent:	25.000
Continuous Index:	
Within 8" of Joint:	NO
Remarks:

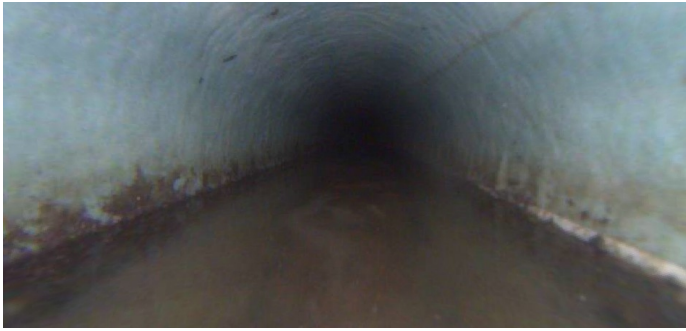
Code: **MWL**
Description: **Water Level**

Distance (ft): **30.5**
Structural Grade: **0**
O&M Grade: **0**
Clock Start/From:
Clock To:
1st Value:
2nd Value:
Value Percent: **35.000**
Continuous Index:
Within 8" of Joint: **NO**
Remarks:

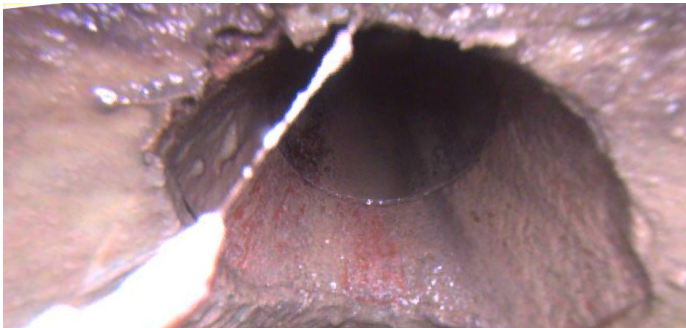
Code: **TF**
Description: **Tap Factory**

Distance (ft): **75.2**
Structural Grade: **0**
O&M Grade: **0**
Clock Start/From: **1**
Clock To:
1st Value: **4.000**
2nd Value:
Value Percent:
Continuous Index:
Within 8" of Joint:
Remarks:

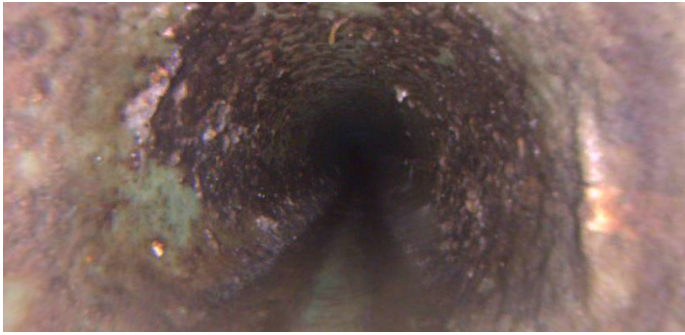
Code: **DAGS**
Description: **Deposits Attached Grease**

Distance (ft): **75.7**
Structural Grade: **0**
O&M Grade: **2**
Clock Start/From: **8**
Clock To: **4**
1st Value:
2nd Value:
Value Percent: **5.000**
Continuous Index:
Within 8" of Joint: **NO**
Remarks:

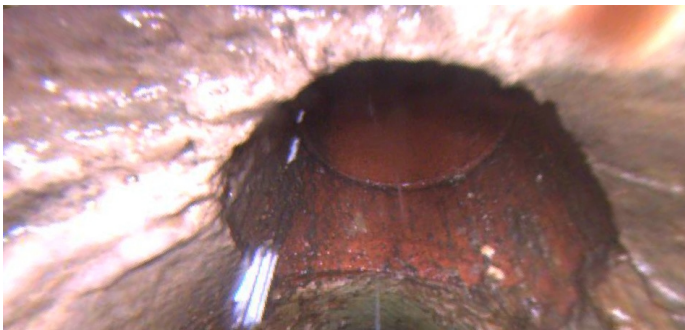
Code: **TF**
Description: **Tap Factory**

Distance (ft): **117.0**
Structural Grade: **0**
O&M Grade: **0**
Clock Start/From: **1**
Clock To:
1st Value: **4.000**
2nd Value:
Value Percent:
Continuous Index:
Within 8" of Joint:
Remarks:

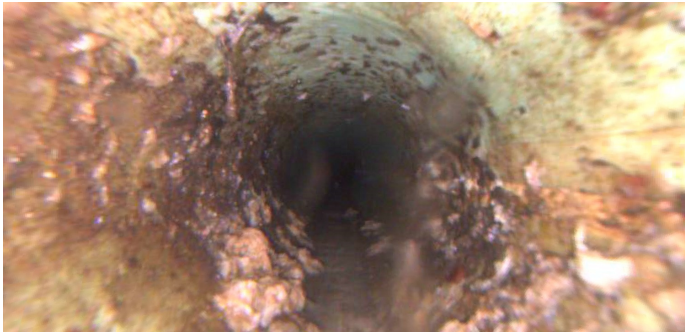
Code: **DAGS**
Description: **Deposits Attached Grease**

Distance (ft): **117.6**
Structural Grade: **0**
O&M Grade: **2**
Clock Start/From: **7**
Clock To: **5**
1st Value:
2nd Value:
Value Percent: **5.000**
Continuous Index:
Within 8" of Joint: **NO**
Remarks:

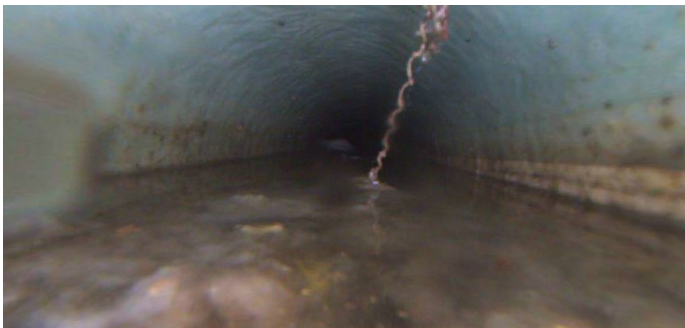
Code: **MWL**
Description: **Water Level**

Distance (ft): **136.5**
Structural Grade: **0**
O&M Grade: **0**
Clock Start/From:
Clock To:
1st Value:
2nd Value:
Value Percent: **45.000**
Continuous Index:
Within 8" of Joint: **NO**
Remarks:

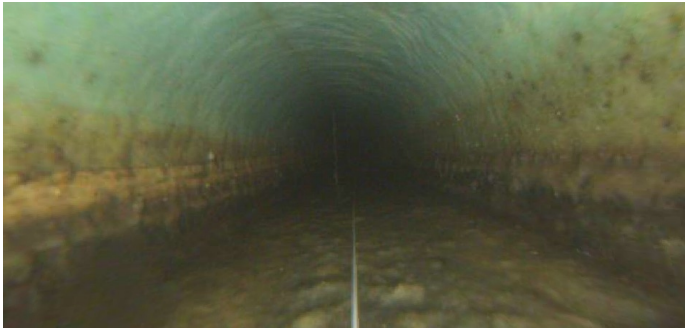
Code: **MGO**
Description: **General Observation**

Distance (ft): **138.4**
Structural Grade: **0**
O&M Grade: **0**
Clock Start/From:
Clock To:
1st Value:
2nd Value:
Value Percent:
Continuous Index:
Within 8" of Joint: **NO**
Remarks: **Switching to rear camera**

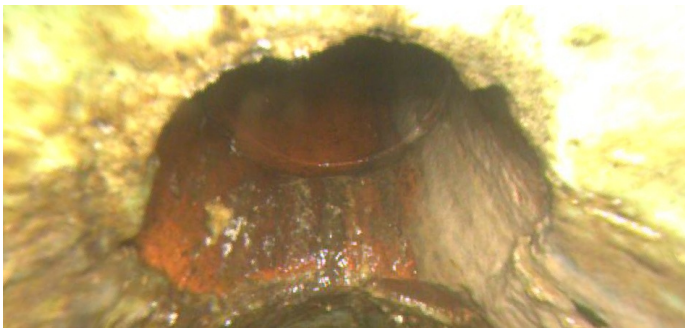
Code: **TF**
Description: **Tap Factory**

Distance (ft): **183.6**
Structural Grade: **0**
O&M Grade: **0**
Clock Start/From: **12**
Clock To:
1st Value: **4.000**
2nd Value:
Value Percent:
Continuous Index:
Within 8" of Joint:
Remarks:

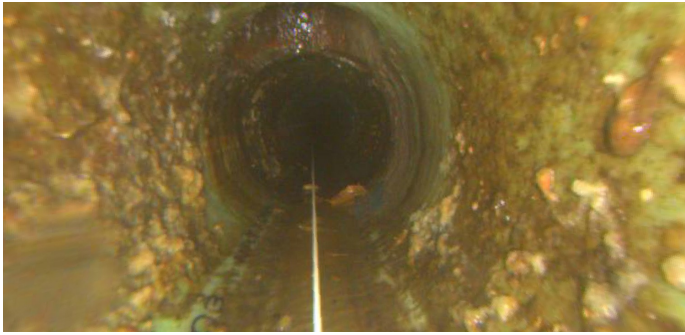
Code: **DAGS**
Description: **Deposits Attached Grease**

Distance (ft): **184.3**
Structural Grade: **0**
O&M Grade: **2**
Clock Start/From: **8**
Clock To: **4**
1st Value:
2nd Value:
Value Percent: **5.000**
Continuous Index:
Within 8" of Joint: **NO**
Remarks:

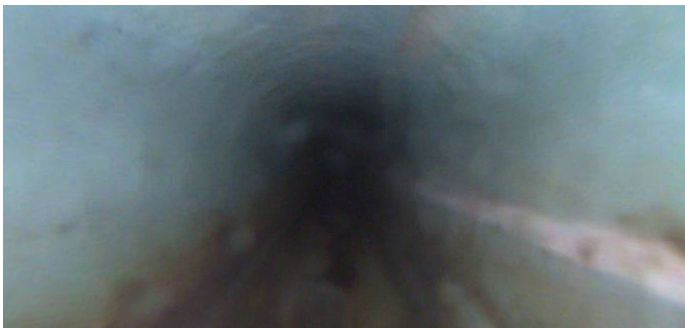
Code: **MGO**
Description: **General Observation**

Distance (ft): **185.9**
Structural Grade: **0**
O&M Grade: **0**
Clock Start/From:
Clock To:
1st Value:
2nd Value:
Value Percent:
Continuous Index:
Within 8" of Joint: **NO**
Remarks: **Switching to front camera**

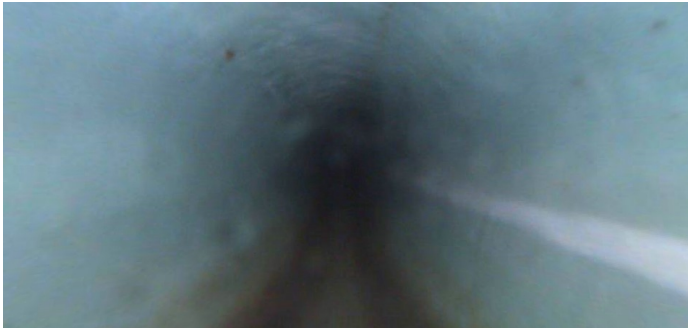
Code:	MSA
Description:	Abandoned Survey
Distance (ft):	190.2
Structural Grade:	0
O&M Grade:	0
Clock Start/From:	
Clock To:	
1st Value:	
2nd Value:	
Value Percent:	
Continuous Index:	
Within 8" of Joint:	NO
Remarks:	Unknown
