## Profile/Photo Observation Report

| Street: | <b>N Hobart Rd</b> | Flow Control: | <b>Not Controlled</b> |
| City: | <b>Hobart, IN</b> | Year Renewed: | |

| US MH: | <b>M-902-046</b> | DS MH: | <b>M-902-070</b> |

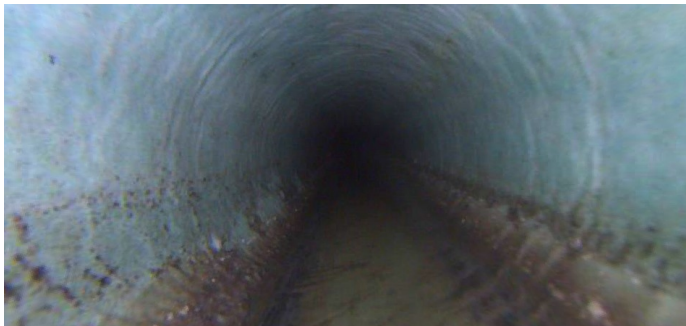
Code: **AMH**  
Description: **Manhole**

Distance (ft): **.0**  
Structural Grade: **0**  
O&M Grade: **0**  
Clock Start/From:  
Clock To:  
1st Value:  
2nd Value:  
Value Percent:  
Continuous Index:  
Within 8" of Joint: **NO**  
Remarks: **M-902-046**

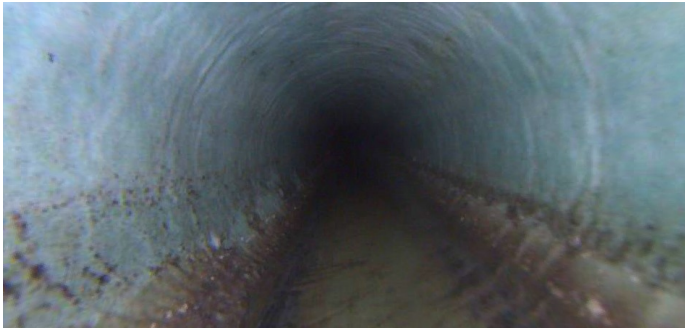
| Code: | <b>MWL</b> |
| Description: | <b>Water Level</b> |

| Distance (ft): | <b>.0</b> |
| Value Percent: | <b>10.000</b> |

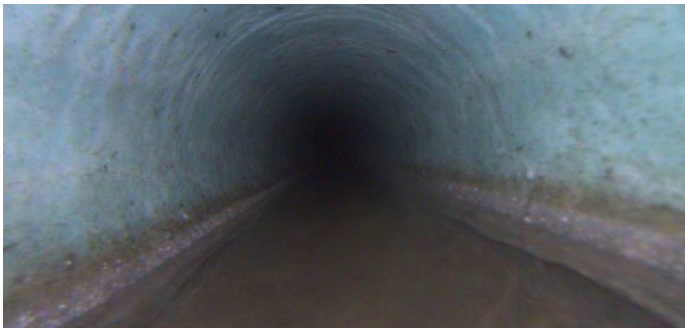
| Code: | <b>MWL</b> |
| Description: | <b>Water Level</b> |

| Distance (ft): | <b>4.9</b> |
| Value Percent: | <b>25.000</b> |

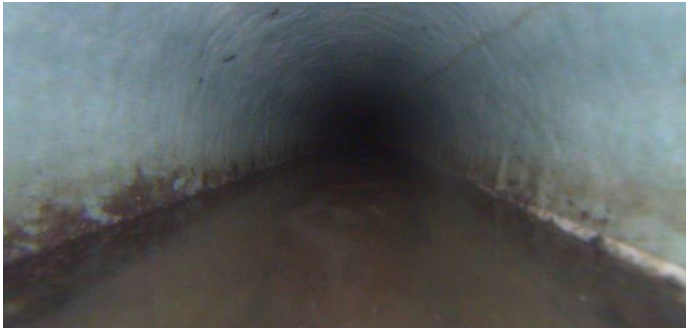
Code: **MWL**  
Description: **Water Level**

Distance (ft): **30.5**  
Structural Grade: **0**  
O&M Grade: **0**  
Clock Start/From:  
Clock To:  
1st Value:  
2nd Value:  
Value Percent: **35.000**  
Continuous Index:  
Within 8" of Joint: **NO**  
Remarks:

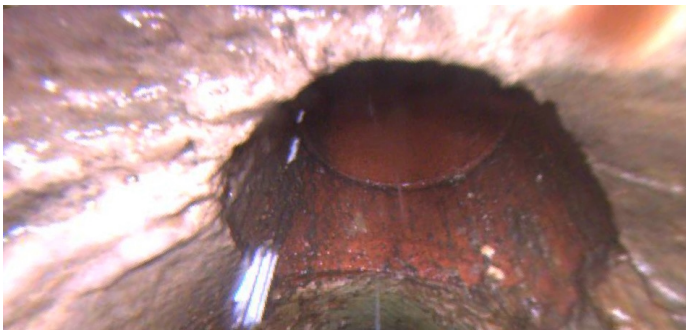
Code: **TF**  
Description: **Tap Factory**

Distance (ft): **117.0**  
Structural Grade: **0**  
O&M Grade: **0**  
Clock Start/From: **1**  
Clock To:  
1st Value: **4.000**  
2nd Value:  
Value Percent:  
Continuous Index:  
Within 8" of Joint:  
Remarks:

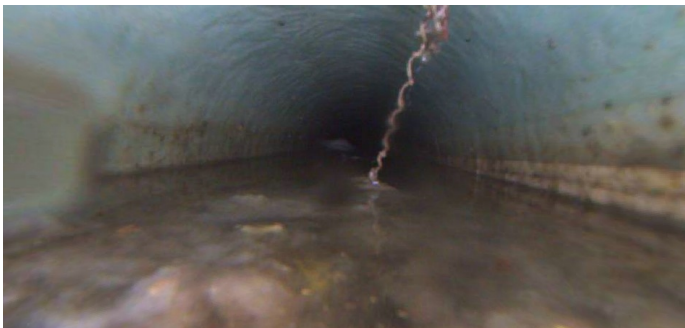
Code: **MWL**  
Description: **Water Level**

Distance (ft): **136.5**  
Structural Grade: **0**  
O&M Grade: **0**  
Clock Start/From:  
Clock To:  
1st Value:  
2nd Value:  
Value Percent: **45.000**  
Continuous Index:  
Within 8" of Joint: **NO**  
Remarks:

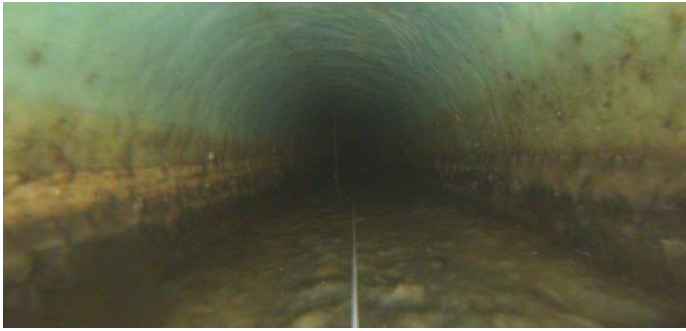
Code: **MGO**  
Description: **General Observation**

Distance (ft): **138.4**  
Structural Grade: **0**  
O&M Grade: **0**  
Clock Start/From:  
Clock To:  
1st Value:  
2nd Value:  
Value Percent:  
Continuous Index:  
Within 8" of Joint: **NO**  
Remarks: **Switching to rear camera**

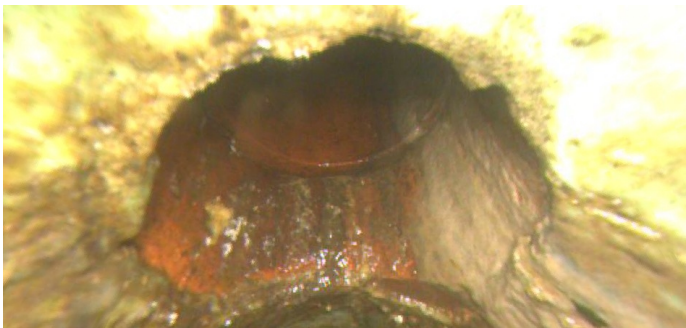
Code: **TF**  
Description: **Tap Factory**

Distance (ft): **183.6**  
Structural Grade: **0**  
O&M Grade: **0**  
Clock Start/From: **12**  
Clock To:  
1st Value: **4.000**  
2nd Value:  
Value Percent:  
Continuous Index:  
Within 8" of Joint:  
Remarks:

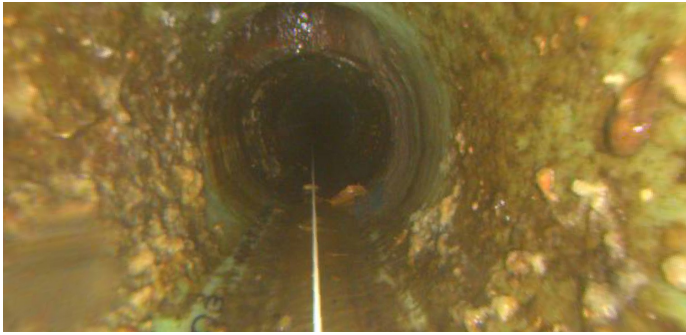
Code: **DAGS**  
Description: **Deposits Attached Grease**

Distance (ft): **184.3**  
Structural Grade: **0**  
O&M Grade: **2**  
Clock Start/From: **8**  
Clock To: **4**  
1st Value:  
2nd Value:  
Value Percent: **5.000**  
Continuous Index:  
Within 8" of Joint: **NO**  
Remarks:

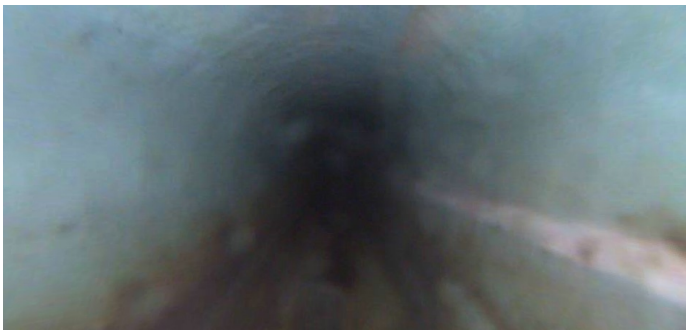
Code: **MGO**  
Description: **General Observation**

Distance (ft): **185.9**  
Structural Grade: **0**  
O&M Grade: **0**  
Clock Start/From:  
Clock To:  
1st Value:  
2nd Value:  
Value Percent:  
Continuous Index:  
Within 8" of Joint: **NO**  
Remarks: **Switching to front camera**
