## Profile/Photo Observation Report

| Street: | <b>1611 E 36th Ave</b> | Flow Control: | <b>Not Controlled</b> |
| US MH: | <b>M-902-067</b> | DS MH: | <b>M-902-053</b> |

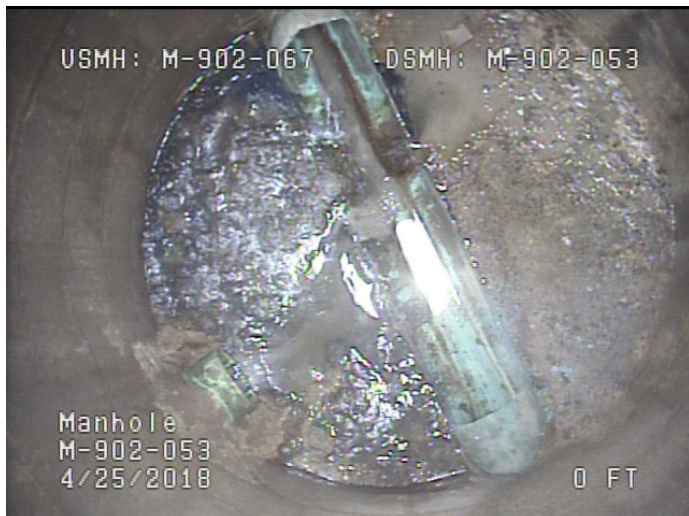
| Code: | <b>AMH</b> |
| Description: | <b>Manhole</b> |
| Distance (ft): | <b>.0</b> |
| Remarks: | <b>M-902-053</b> |

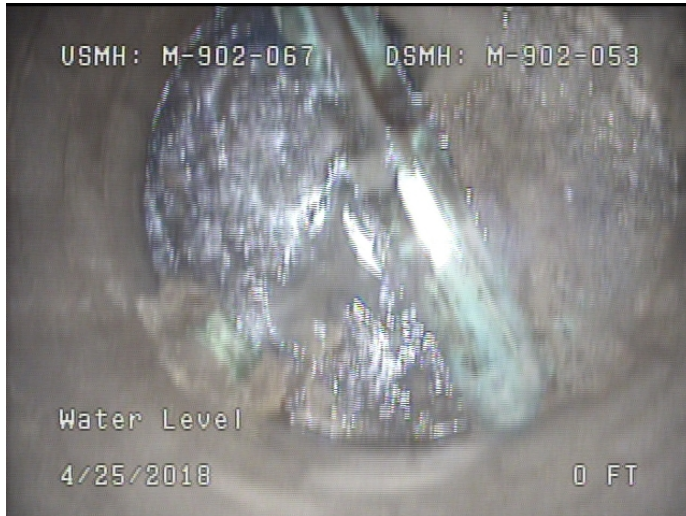
Code: **MWL**  
Description: **Water Level**

Distance (ft): **.0**  
Structural Grade: **0**  
O&M Grade: **0**  
Clock Start/From:  
Clock To:  
1st Value:  
2nd Value:  
Value Percent: **5.000**  
Continuous Index:  
Within 8" of Joint: **NO**  
Remarks:

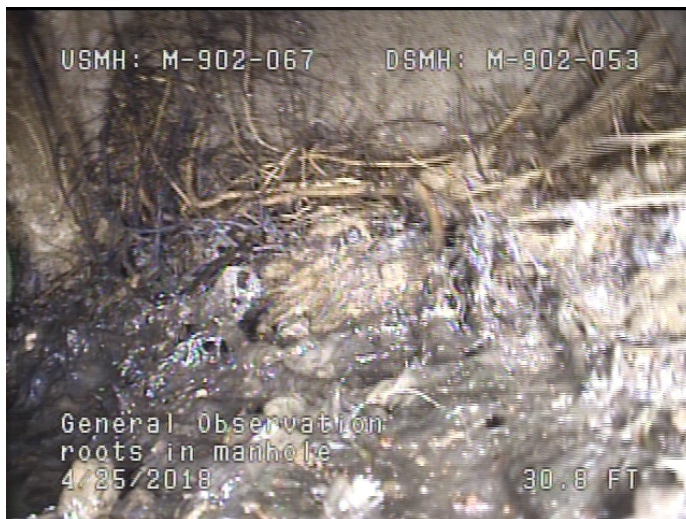
Code: **MGO**  
Description: **General Observation**

Distance (ft): **30.8**  
Structural Grade: **0**  
O&M Grade: **0**  
Clock Start/From:  
Clock To:  
1st Value:  
2nd Value:  
Value Percent:  
Continuous Index:  
Within 8" of Joint: **NO**  
Remarks: **roots in manhole**

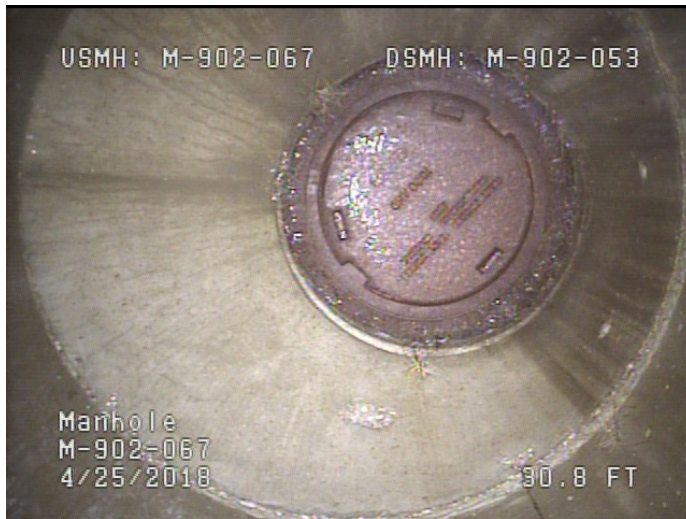
| Code: | AMH |
| Description: | Manhole |
| Distance (ft): | 30.8 |
| Remarks: | M-902-067 |
