Profile/Photo Observation Report

Street:	RUSH PL	Flow Control:	Not Controlled
City:	Hobart, IN	Year Renewed:	
Location:	Other	Tape/Media #:	
Purpose:	Not Known	Dia/Height:	10"
Use:	Sanitary	Material:	VCP
Drain Area:	NA	Lining:	
Category:	NA		
Comment:

Location Details:		Direction of Survey:	Upstream
US MH:	M-902-056	DS MH:	M-902-031
		Total Length Surveyed (ft):	6.8

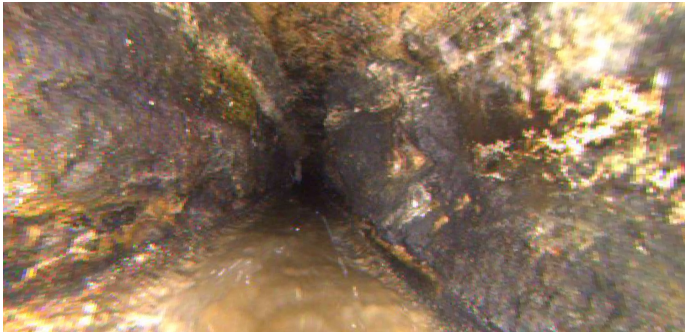
Code:	AMH
Description:	Manhole

Distance (ft):	.0
Structural Grade:	0
O&M Grade:	0
Clock Start/From:	
Clock To:	
1st Value:	
2nd Value:	
Value Percent:	
Continuous Index:	
Within 8" of Joint:	NO
Remarks:	M-902-031

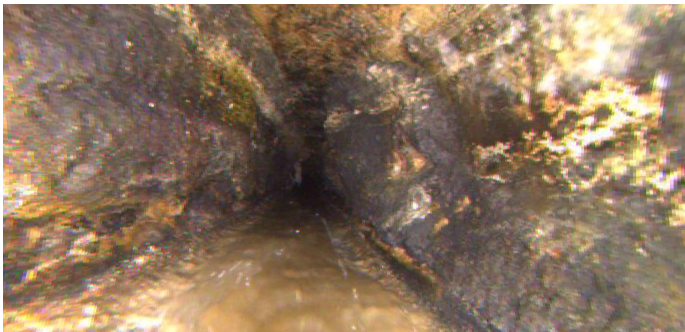
Code:	MWL
Description:	Water Level

Distance (ft):	.0
Structural Grade:	0
O&M Grade:	0
Clock Start/From:	
Clock To:	
1st Value:	
2nd Value:	
Value Percent:	5.000
Continuous Index:	
Within 8" of Joint:	NO
Remarks:

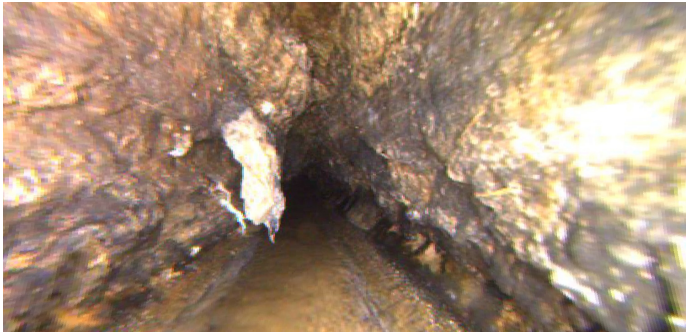
Code: **RFB**
Description: **Roots Fine Barrel**

Distance (ft): **4.4**
Structural Grade: **0**
O&M Grade: **2**
Clock Start/From: **10**
Clock To:
1st Value:
2nd Value:
Value Percent:
Continuous Index:
Within 8" of Joint: **NO**
Remarks:

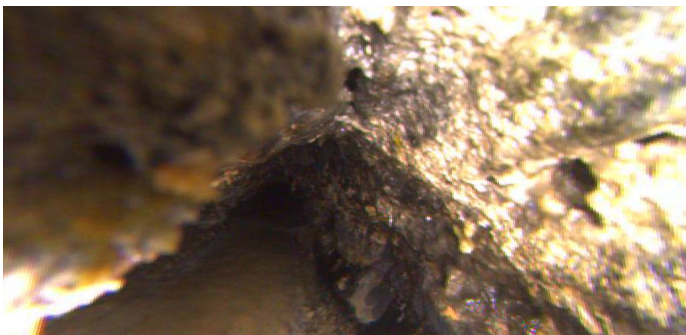
Code: **MSA**
Description: **Abandoned Survey**

Distance (ft): **6.8**
Structural Grade: **0**
O&M Grade: **0**
Clock Start/From:
Clock To:
1st Value:
2nd Value:
Value Percent:
Continuous Index:
Within 8" of Joint: **NO**
Remarks: **DAGS**
