Profile/Photo Observation Report

Street:	37th ave	Flow Control:	Not Controlled
City:	Hobart, IN	Year Renewed:	
Location:	Other	Tape/Media #:	
Purpose:	Not Known	Dia/Height:	10"
Use:	Sanitary	Material:	VCP
Drain Area:	NA	Lining:	
Category:	NA		
Comment:

Location Details:		Direction of Survey:	Upstream
US MH:	M-902-056	DS MH:	M-902-031
		Total Length Surveyed (ft):	6.8

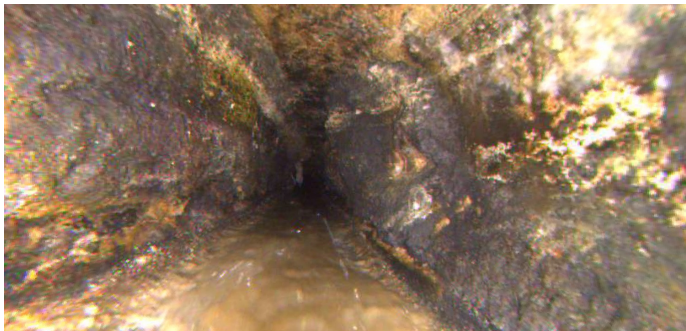
Code: **DAGS**
Description: **Deposits Attached Grease**

Distance (ft): **.0**
Structural Grade: **0**
O&M Grade: **4**
Clock Start/From: **7**
Clock To: **5**
1st Value:
2nd Value:
Value Percent: **30.000**
Continuous Index:
Within 8" of Joint: **NO**
Remarks:

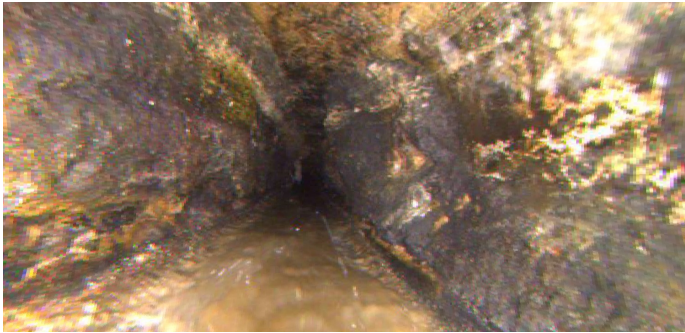
Code:	AMH
Description:	Manhole

Distance (ft):	.0
Structural Grade:	0
O&M Grade:	0
Clock Start/From:	
Clock To:	
1st Value:	
2nd Value:	
Value Percent:	
Continuous Index:	
Within 8" of Joint:	NO
Remarks:	M-902-031

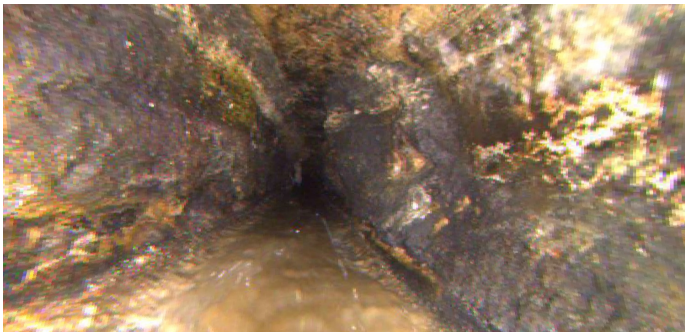
Code:	MWL
Description:	Water Level

Distance (ft):	.0
Structural Grade:	0
O&M Grade:	0
Clock Start/From:	
Clock To:	
1st Value:	
2nd Value:	
Value Percent:	5.000
Continuous Index:	
Within 8" of Joint:	NO
Remarks:

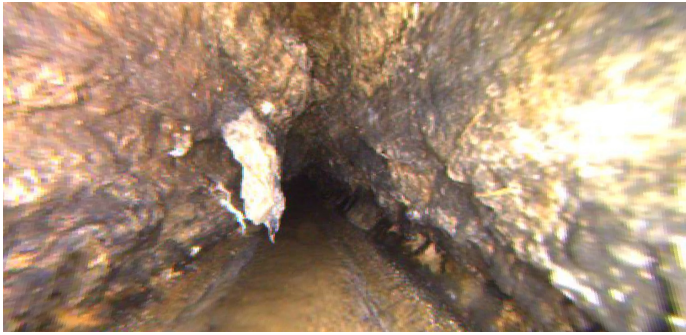
Code: **RFB**
Description: **Roots Fine Barrel**

Distance (ft): **4.4**
Structural Grade: **0**
O&M Grade: **2**
Clock Start/From: **10**
Clock To:
1st Value:
2nd Value:
Value Percent:
Continuous Index:
Within 8" of Joint: **NO**
Remarks:

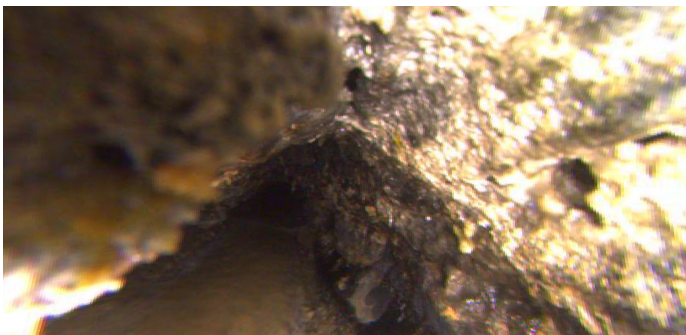
Code: **MSA**
Description: **Abandoned Survey**

Distance (ft): **6.8**
Structural Grade: **0**
O&M Grade: **0**
Clock Start/From:
Clock To:
1st Value:
2nd Value:
Value Percent:
Continuous Index:
Within 8" of Joint: **NO**
Remarks: **DAGS**
