Profile/Photo Observation Report

Street:	RUSH PL	Flow Control:	Not Controlled
City:	Hobart, IN	Year Renewed:	
Location:	Main Highway - Suburban/Rural	Tape/Media #:	
Purpose:	Resurvey	Dia/Height:	10"
Use:	Sanitary	Material:	PVC
Drain Area:	NA	Lining:	
Category:	NA		
Comment:

Location Details:		Direction of Survey:	Downstream
US MH:	M-902-056	DS MH:	M-902-057
		Total Length Surveyed (ft):	12.4

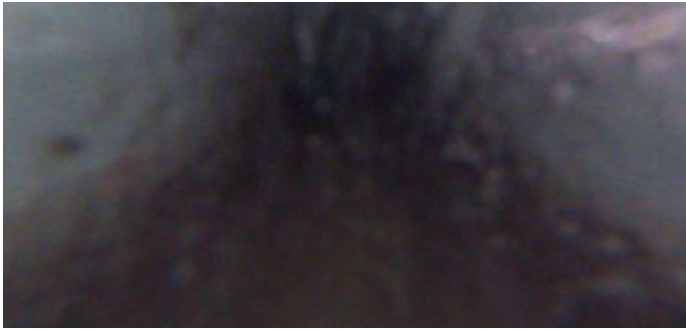
Code:	MWL
Description:	Water Level

Distance (ft):	.0
Structural Grade:	0
O&M Grade:	0
Clock Start/From:	
Clock To:	
1st Value:	
2nd Value:	
Value Percent:	15.000
Continuous Index:	
Within 8" of Joint:	NO
Remarks:

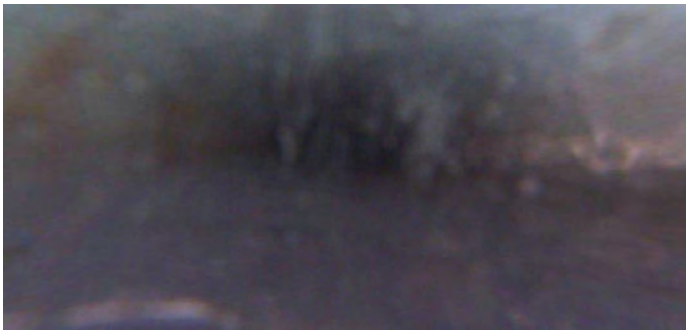
Code:	MWL
Description:	Water Level

Distance (ft):	9.4
Structural Grade:	0
O&M Grade:	0
Clock Start/From:	
Clock To:	
1st Value:	
2nd Value:	
Value Percent:	40.000
Continuous Index:	
Within 8" of Joint:	NO
Remarks:

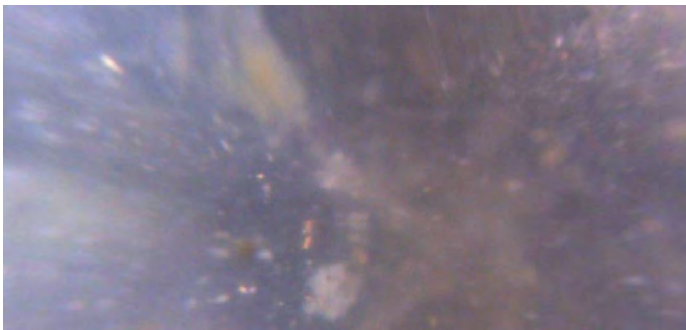
Code: **MSA**
Description: **Abandoned Survey**

Distance (ft): **12.4**
Structural Grade: **0**
O&M Grade: **0**
Clock Start/From:
Clock To:
1st Value:
2nd Value:
Value Percent:
Continuous Index:
Within 8" of Joint: **NO**
Remarks: **mcu**
