Profile/Photo Observation Report

Street:	N Hobart Rd	Flow Control:	Not Controlled
City:	Hobart, IN	Year Renewed:	
Location:	Main Highway - Suburban/Rural	Tape/Media #:	
Purpose:	Resurvey	Dia/Height:	10"
Use:	Sanitary	Material:	PVC
Drain Area:	NA	Lining:	
Category:	NA		
Comment:

Location Details:		Direction of Survey:	Downstream
US MH:	M-902-056	DS MH:	M-902-057
		Total Length Surveyed (ft):	12.4

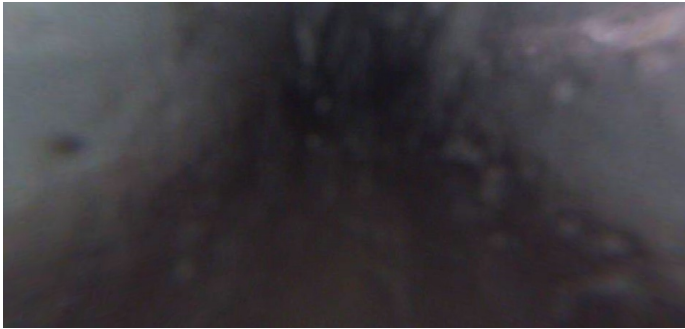
Code:	MWL
Description:	Water Level

Distance (ft):	.0
Structural Grade:	0
O&M Grade:	0
Clock Start/From:	
Clock To:	
1st Value:	
2nd Value:	
Value Percent:	15.000
Continuous Index:	
Within 8" of Joint:	NO
Remarks:

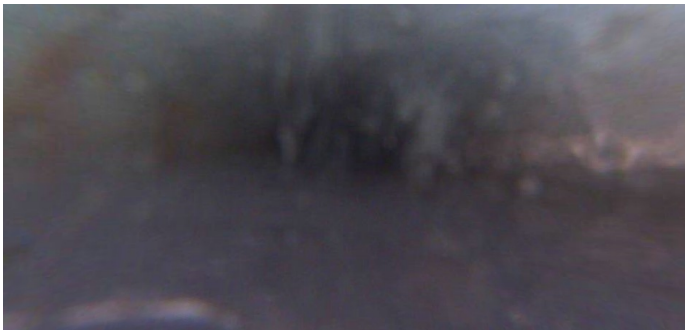
Code:	MWL
Description:	Water Level

Distance (ft):	9.4
Structural Grade:	0
O&M Grade:	0
Clock Start/From:	
Clock To:	
1st Value:	
2nd Value:	
Value Percent:	40.000
Continuous Index:	
Within 8" of Joint:	NO
Remarks:

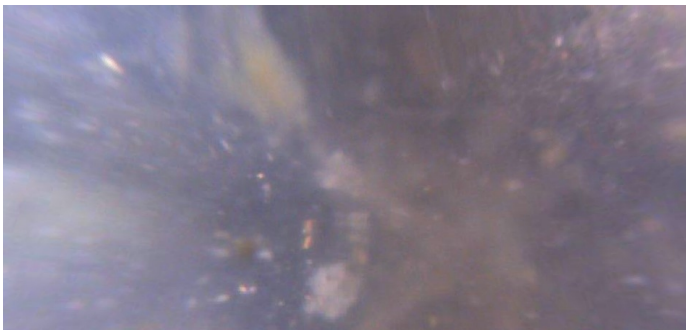
Code: **MSA**
Description: **Abandoned Survey**

Distance (ft): **12.4**
Structural Grade: **0**
O&M Grade: **0**
Clock Start/From:
Clock To:
1st Value:
2nd Value:
Value Percent:
Continuous Index:
Within 8" of Joint: **NO**
Remarks: **mcu**
