Profile/Photo Observation Report

Date:	03/21/2018	Weather:		Coding:	PACP 6.0
Pipe Length (ft):	181.7	Owner:	NA	Pre Clean:	Not Known
P.O.#:		Surveyor:	Selasie Honu	PSR:	P-902-058-057
Customer:		Clean Date:	01/01/1900	Shape:	C

Street:	RUSH PL	Flow Control:	Not Controlled
City:	Hobart, IN	Year Renewed:	
Location:	Other	Tape/Media #:	
Purpose:	Not Known	Dia/Height:	10"
Use:	Sanitary	Material:	VCP
Drain Area:	NA	Lining:	Cured in Place
Category:	NA		
Comment:

Location Details:		Direction of Survey:	Upstream
US MH:	M-902-057	DS MH:	M-902-058
		Total Length Surveyed (ft):	30.6

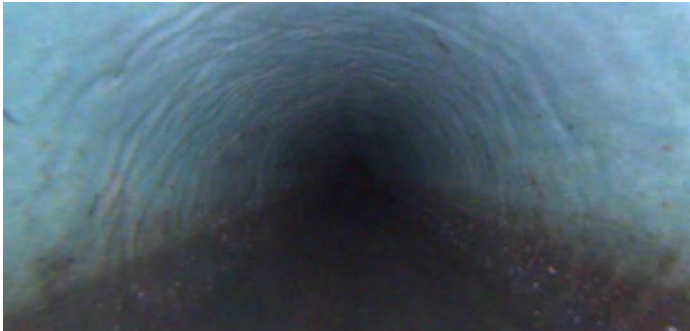
Code: AMH

Description: Manhole

Distance (ft): .0

Remarks: M-902-058

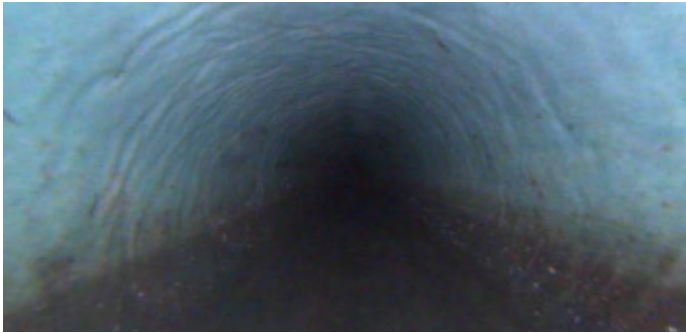
Code:	MWL
Description:	Water Level

Distance (ft):	.0
Structural Grade:	0
O&M Grade:	0
Clock Start/From:	
Clock To:	
1st Value:	
2nd Value:	
Value Percent:	5.000
Continuous Index:	
Within 8" of Joint:	NO
Remarks:

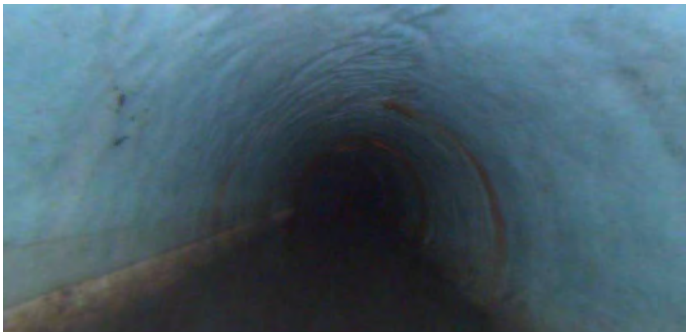
Code:	MSA
Description:	Abandoned Survey

Distance (ft):	30.6
Structural Grade:	0
O&M Grade:	0
Clock Start/From:	
Clock To:	
1st Value:	
2nd Value:	
Value Percent:	
Continuous Index:	
Within 8" of Joint:	NO
Remarks:	camera stopped
