Profile/Photo Observation Report

Street:	RUSH PL	Flow Control:	Not Controlled
City:	Hobart, IN	Year Renewed:	
Location:	Other	Tape/Media #:	
Purpose:	Not Known	Dia/Height:	10"
Use:	Sanitary	Material:	VCP
Drain Area:	NA	Lining:	
Category:	NA		
Comment:

Location Details:		Direction of Survey:	Downstream
US MH:	M-902-059	DS MH:	M-902-048
		Total Length Surveyed (ft):	17.6

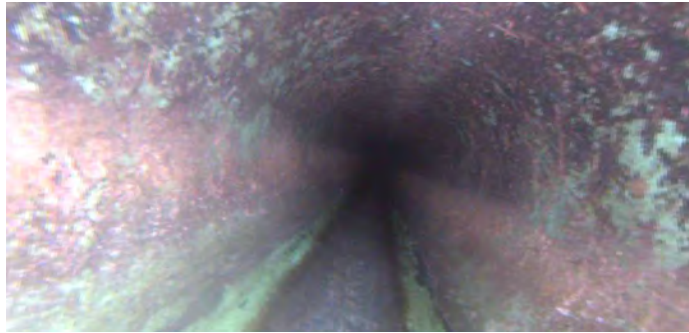
Code: **AMH**
Description: **Manhole**

Distance (ft):	.0
Structural Grade:	0
O&M Grade:	0
Clock Start/From:	
Clock To:	
1st Value:	
2nd Value:	
Value Percent:	
Continuous Index:	
Within 8" of Joint:	NO
Remarks:	M-902-059

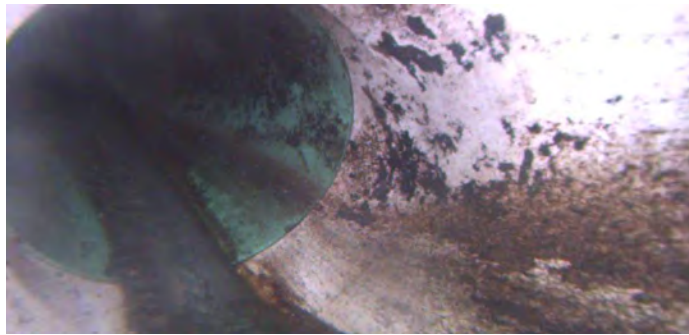
Code: **MWL**
Description: **Water Level**

Distance (ft): **.0**
Structural Grade: **0**
O&M Grade: **0**
Clock Start/From:
Clock To:
1st Value:
2nd Value:
Value Percent: **5.000**
Continuous Index:
Within 8" of Joint: **NO**
Remarks:

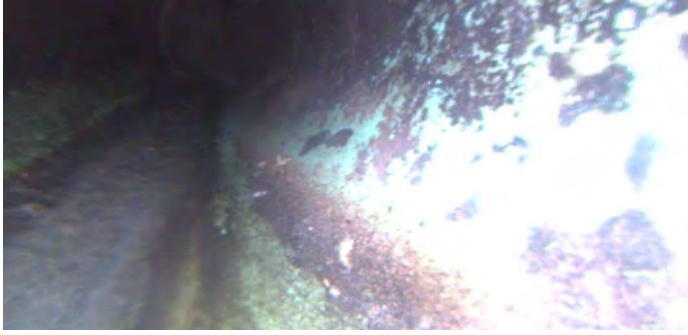
Code: **LLU**
Description: **Alignment Left Up**

Distance (ft): **15.9**
Structural Grade: **0**
O&M Grade: **1**
Clock Start/From:
Clock To:
1st Value:
2nd Value:
Value Percent: **10.000**
Continuous Index:
Within 8" of Joint: **NO**
Remarks:
