Date:	03/21/2018	Weather:		Coding:	PACP 6.0
Pipe Length (ft):	24.4	Owner:	NA	Pre Clean:	Not Known
P.O.#:	24.4	Surveyor:	Selasie Honu	PSR:	P-902-048-059
Customer:		Clean Date:		Shape:	C
Street:	RUSH PL		Flow Control:	Not Controlled	
City:	Hobart, IN		Year Renewed:		
Location:	Other		Tape/Media #:		
Purpose:	Not Known		Dia/Height:	10"	
Use:	Sanitary		Material:	PVC	
Drain Area:	NA		Lining:		
Category:	NA				
Comment:					
Location Details:			Direction of Surve	y: Upstream	
US MH: N	M-902-059	DS MH:	M-902-048	Total Length Surveyed (ft)	: <b>3.3</b>
D&M Index:	1.00	O&M Quick:	1100	O&M Rating:	1.00
Structural Index:	0.00	Structural Qu	uick: 0000	Structural Rating:	0.00
Overall Index:	1.00	Overall Quicl			1.00

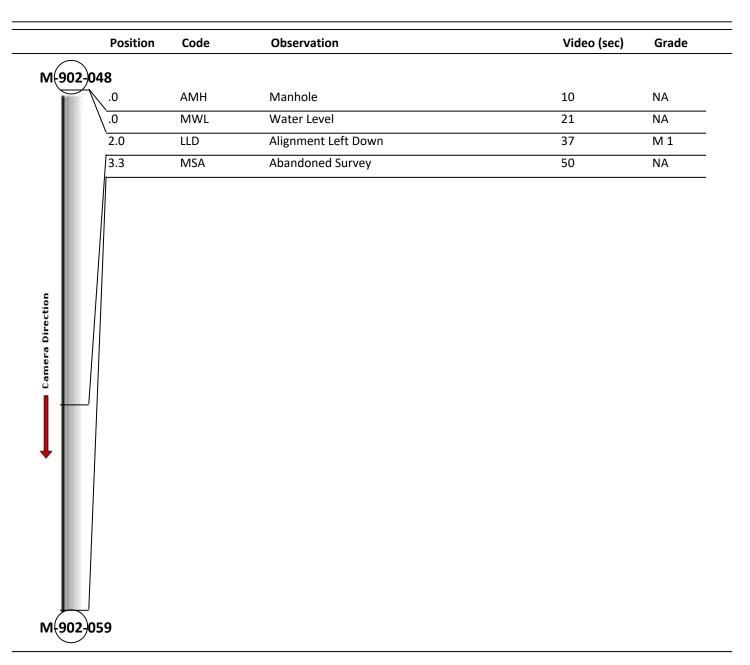
Code: MWL Description: Water Level

Distance (ft):	.0
Structural Grade:	0
O&M Grade:	0
Clock Start/From:	
Clock To:	
1st Value:	
2nd Value:	
Value Percent:	5.000
Continuous Index:	
Within 8" of Joint:	NO
Remarks:

Code: Description:	LLD Alignment Left Down
Distance (ft):	2.0
Structural Grade:	0
O&M Grade:	1
Clock Start/From:	
Clock To:	
1st Value:	
2nd Value:	
Value Percent:	10.000
Continuous Index:	
Within 8" of Joint:	NO
Remarks:

Code: Description: MSA Abandoned Survey

Distance (ft):	3.3
Structural Grade:	0
O&M Grade:	0
Clock Start/From:	
Clock To:	
1st Value:	
2nd Value:	
Value Percent:	
Continuous Index:	
Within 8" of Joint:	NO
Remarks:	bend
