Profile/Photo Observation Report

Street:	OFF E 37TH AVE	Flow Control:	Not Controlled
City:	Hobart, IN	Year Renewed:	
Location:	Other	Tape/Media #:	
Purpose:	Not Known	Dia/Height:	10"
Use:	Sanitary	Material:	PVC
Drain Area:	NA	Lining:	
Category:	NA		
Comment:

Location Details:		Direction of Survey:	Upstream
US MH:	M-902-063	DS MH:	M-902-064
		Total Length Surveyed (ft):	349.9

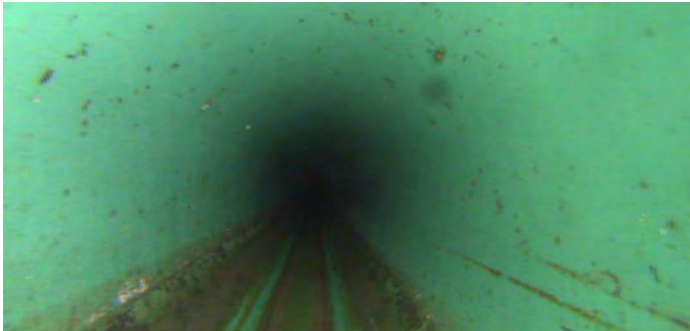
Code: AMH

Description: Manhole

Distance (ft): .0

Structural Grade: 0

O&M Grade: 0

Remarks: M-902-064

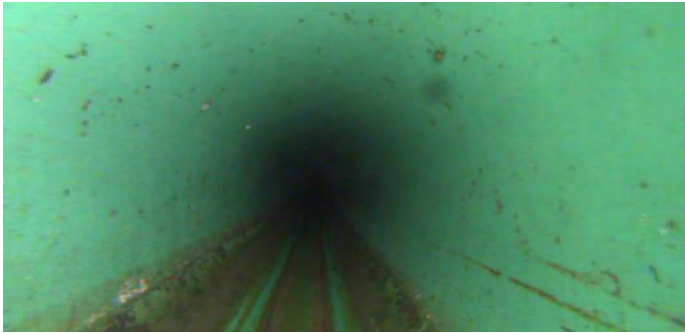
Code:	MWL
Description:	Water Level

Distance (ft):	.0
Structural Grade:	0
O&M Grade:	0
Clock Start/From:	
Clock To:	
1st Value:	
2nd Value:	
Value Percent:	5.000
Continuous Index:	
Within 8" of Joint:	NO
Remarks:

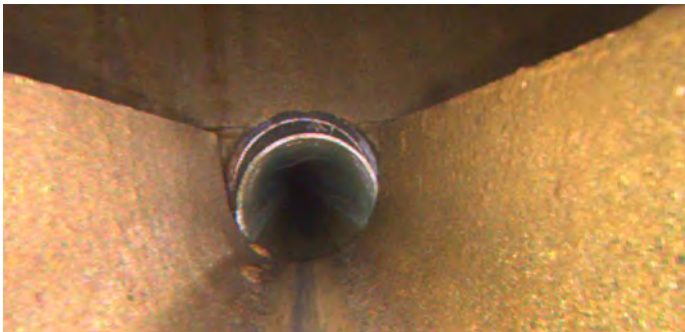
Code:	AMH
Description:	Manhole

Distance (ft):	349.9
Structural Grade:	0
O&M Grade:	0
Clock Start/From:	
Clock To:	
1st Value:	
2nd Value:	
Value Percent:	
Continuous Index:	
Within 8" of Joint:	NO
Remarks:	M-902-063
