Profile/Photo Observation Report

Street:	e 37th ave	Flow Control:	Not Controlled
City:	Hobart, IN	Year Renewed:	
Location:	Other	Tape/Media #:	
Purpose:	Not Known	Dia/Height:	10"
Use:	Sanitary	Material:	PVC
Drain Area:	NA	Lining:	
Category:	NA		
Comment:

Location Details:		Direction of Survey:	Upstream
US MH:	M-902-063	DS MH:	M-902-064
		Total Length Surveyed (ft):	349.9

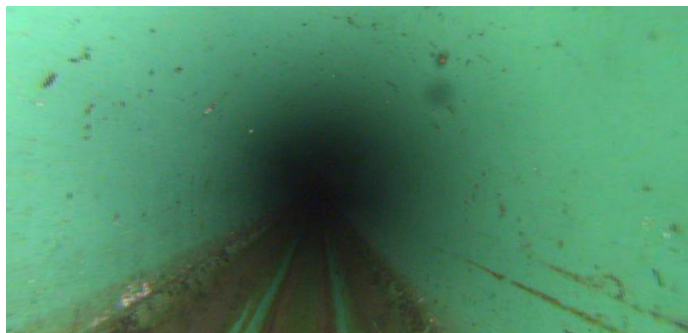
Code: **AMH**
Description: **Manhole**

Distance (ft): **.0**
Structural Grade: **0**
O&M Grade: **0**
Clock Start/From:
Clock To:
1st Value:
2nd Value:
Value Percent:
Continuous Index:
Within 8" of Joint: **NO**
Remarks: **M-902-064**

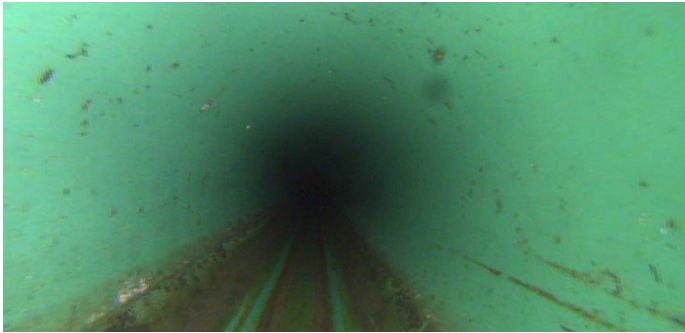
Code:	MWL
Description:	Water Level

Distance (ft):	.0
Structural Grade:	0
O&M Grade:	0
Clock Start/From:	
Clock To:	
1st Value:	
2nd Value:	
Value Percent:	5.000
Continuous Index:	
Within 8" of Joint:	NO
Remarks:

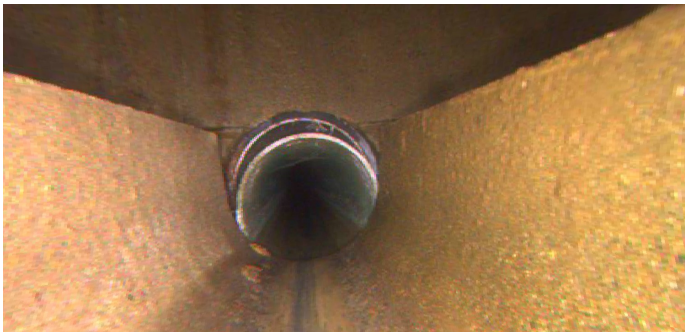
Code:	AMH
Description:	Manhole

Distance (ft):	349.9
Structural Grade:	0
O&M Grade:	0
Clock Start/From:	
Clock To:	
1st Value:	
2nd Value:	
Value Percent:	
Continuous Index:	
Within 8" of Joint:	NO
Remarks:	M-902-063
