Profile/Photo Observation Report

Date:	03/22/2018	Weather:		Coding:	PACP 6.0
Pipe Length (ft):	242.1	Owner:	NA	Pre Clean:	Not Known
P.O.#:		Surveyor:	Selasie Honu	PSR:	P-902-065-064
Customer:		Clean Date:	01/01/1900	Shape:	C

Street:	OFF E 37TH AVE	Flow Control:	Not Controlled
City:	Hobart, IN	Year Renewed:	
Location:	Other	Tape/Media #:	
Purpose:	Not Known	Dia/Height:	10"
Use:	Sanitary	Material:	PVC
Drain Area:	NA	Lining:	
Category:	NA		
Comment:

Location Details:		Direction of Survey:	Downstream
US MH:	M-902-064	DS MH:	M-902-065
		Total Length Surveyed (ft):	243.3

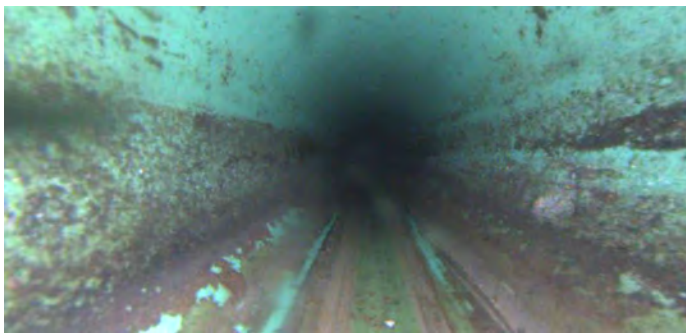
Code: **DAGS**
Description: **Deposits Attached Grease**

Distance (ft): **.0**
Structural Grade: **0**
O&M Grade: **2**
Clock Start/From: **8**
Clock To: **4**
1st Value:
2nd Value:
Value Percent: **5.000**
Continuous Index: **S01**
Within 8" of Joint: **NO**
Remarks:

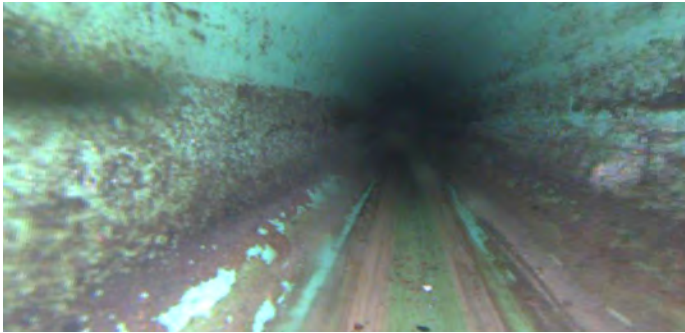
Code:	AMH
Description:	Manhole

Distance (ft):	.0
Structural Grade:	0
O&M Grade:	0
Clock Start/From:	
Clock To:	
1st Value:	
2nd Value:	
Value Percent:	
Continuous Index:	
Within 8" of Joint:	NO
Remarks:	M-902-064

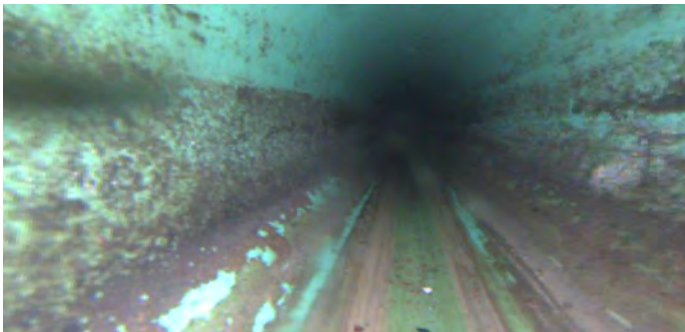
Code:	MWL
Description:	Water Level

Distance (ft):	.0
Structural Grade:	0
O&M Grade:	0
Clock Start/From:	
Clock To:	
1st Value:	
2nd Value:	
Value Percent:	5.000
Continuous Index:	
Within 8" of Joint:	NO
Remarks:

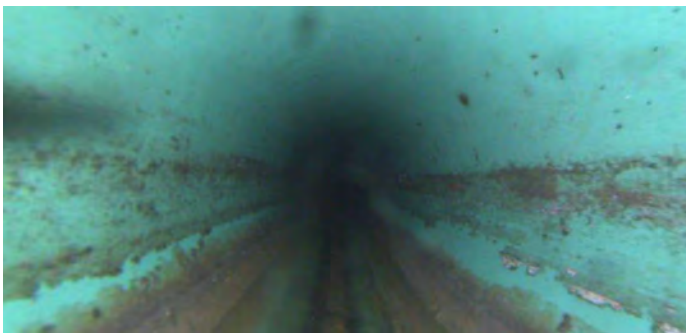
Code: **DAGS**
Description: **Deposits Attached Grease**

Distance (ft): **31.6**
Structural Grade: **0**
O&M Grade: **2**
Clock Start/From: **8**
Clock To: **4**
1st Value:
2nd Value:
Value Percent: **5.000**
Continuous Index: **F01**
Within 8" of Joint: **NO**
Remarks:

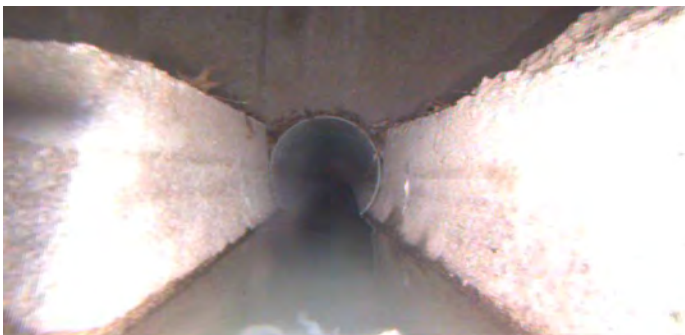
Code: **AMH**
Description: **Manhole**

Distance (ft): **243.3**
Structural Grade: **0**
O&M Grade: **0**
Clock Start/From:
Clock To:
1st Value:
2nd Value:
Value Percent:
Continuous Index:
Within 8" of Joint: **NO**
Remarks: **M-902-065**
