## Profile/Photo Observation Report

Street:	<b>e 37th ave</b>	Flow Control:	<b>Not Controlled</b>
City:	<b>Hobart, IN</b>	Year Renewed:	
Location:	<b>Other</b>	Tape/Media #:	
Purpose:	<b>Not Known</b>	Dia/Height:	<b>10"</b>
Use:	<b>Sanitary</b>	Material:	<b>PVC</b>
Drain Area:	<b>NA</b>	Lining:	
Category:	<b>NA</b>		
Comment:

Location Details:		Direction of Survey:	<b>Downstream</b>
US MH:	<b>M-902-064</b>	DS MH:	<b>M-902-065</b>
		Total Length Surveyed (ft):	<b>243.3</b>

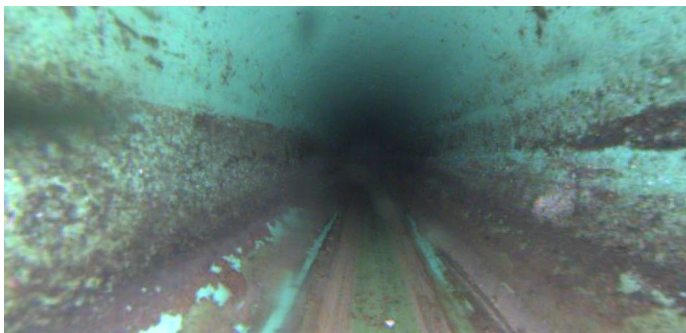
Code: **DAGS**  
Description: **Deposits Attached Grease**

Distance (ft): **.0**  
Structural Grade: **0**  
O&M Grade: **2**  
Clock Start/From: **8**  
Clock To: **4**  
1st Value:  
2nd Value:  
Value Percent: **5.000**  
Continuous Index: **S01**  
Within 8" of Joint: **NO**  
Remarks:

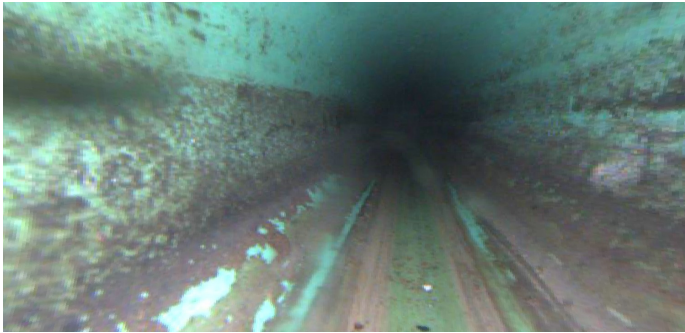
Code:	<b>AMH</b>
Description:	<b>Manhole</b>

Distance (ft):	<b>.0</b>
Structural Grade:	<b>0</b>
O&M Grade:	<b>0</b>
Clock Start/From:	
Clock To:	
1st Value:	
2nd Value:	
Value Percent:	
Continuous Index:	
Within 8" of Joint:	<b>NO</b>
Remarks:	<b>M-902-064</b>

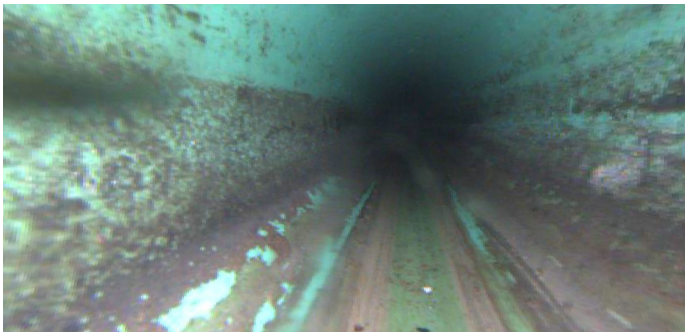
Code:	<b>MWL</b>
Description:	<b>Water Level</b>

Distance (ft):	<b>.0</b>
Structural Grade:	<b>0</b>
O&M Grade:	<b>0</b>
Clock Start/From:	
Clock To:	
1st Value:	
2nd Value:	
Value Percent:	<b>5.000</b>
Continuous Index:	
Within 8" of Joint:	<b>NO</b>
Remarks:

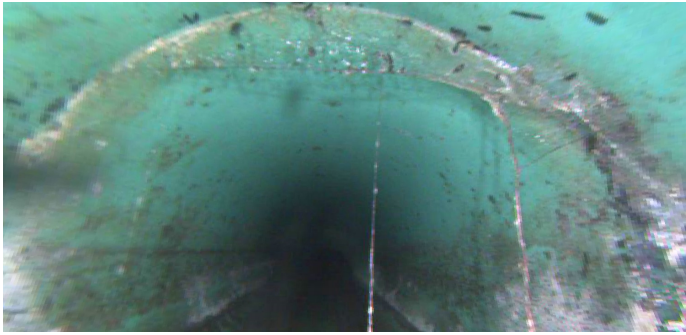
Code: **RFJ**  
Description: **Roots Fine Joint**

Distance (ft): **12.6**  
Structural Grade: **0**  
O&M Grade: **1**  
Clock Start/From: **12**  
Clock To: **1**  
1st Value:  
2nd Value:  
Value Percent:  
Continuous Index:  
Within 8" of Joint: **YES**  
Remarks:

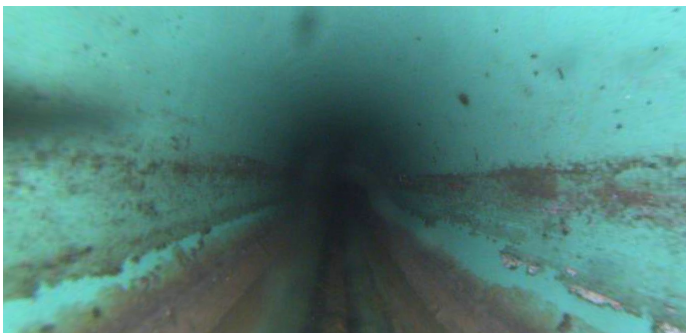
Code: **DAGS**  
Description: **Deposits Attached Grease**

Distance (ft): **31.6**  
Structural Grade: **0**  
O&M Grade: **2**  
Clock Start/From: **8**  
Clock To: **4**  
1st Value:  
2nd Value:  
Value Percent: **5.000**  
Continuous Index: **F01**  
Within 8" of Joint: **NO**  
Remarks:

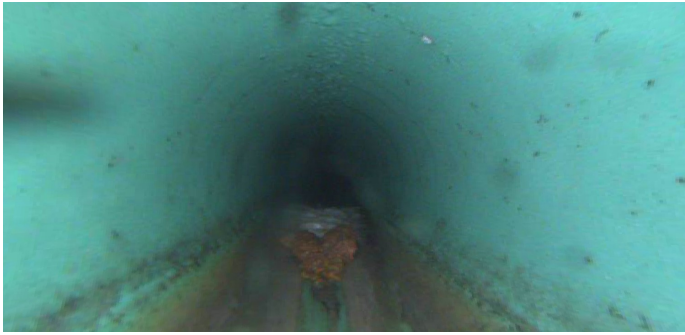
Code: **DSZ**  
Description: **Deposits Settled Other**

Distance (ft): **191.5**  
Structural Grade: **0**  
O&M Grade: **2**  
Clock Start/From: **6**  
Clock To:  
1st Value:  
2nd Value:  
Value Percent: **5.000**  
Continuous Index:  
Within 8" of Joint: **NO**  
Remarks: **mixed material**

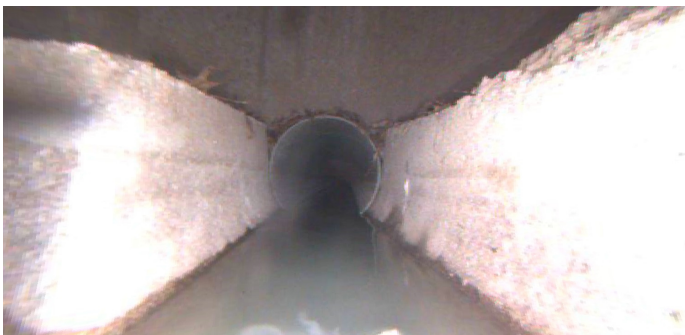
Code: **AMH**  
Description: **Manhole**

Distance (ft): **243.3**  
Structural Grade: **0**  
O&M Grade: **0**  
Clock Start/From:  
Clock To:  
1st Value:  
2nd Value:  
Value Percent:  
Continuous Index:  
Within 8" of Joint: **NO**  
Remarks: **M-902-065**
