## Profile/Photo Observation Report

Street:	<b>OFF E 34TH CT</b>	Flow Control:	<b>Not Controlled</b>
City:	<b>Hobart, IN</b>	Year Renewed:	
Location:	<b>Other</b>	Tape/Media #:	
Purpose:	<b>Not Known</b>	Dia/Height:	<b>10"</b>
Use:	<b>Sanitary</b>	Material:	<b>VCP</b>
Drain Area:	<b>NA</b>	Lining:	
Category:	<b>NA</b>		
Comment:

Location Details:		Direction of Survey:	<b>Upstream</b>
US MH:	<b>M-902-069</b>	DS MH:	<b>M-902-015</b>
		Total Length Surveyed (ft):	<b>4.6</b>

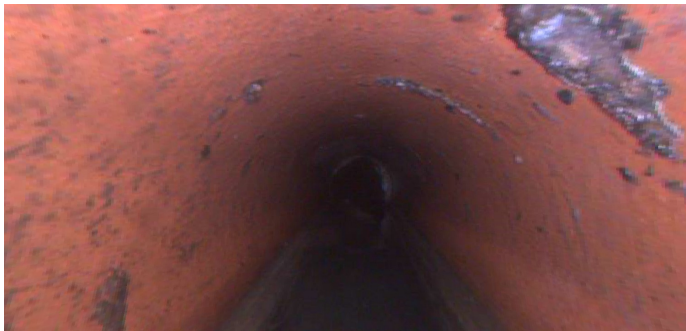
Code: **AMH**  
Description: **Manhole**

Distance (ft): **.0**  
Structural Grade: **0**  
O&M Grade: **0**  
Clock Start/From:  
Clock To:  
1st Value:  
2nd Value:  
Value Percent:  
Continuous Index:  
Within 8" of Joint: **NO**  
Remarks: **M-902-015**

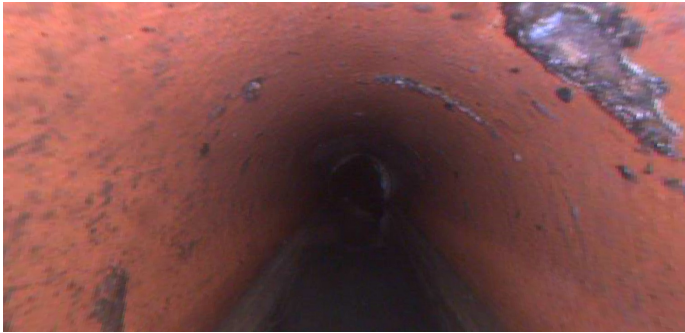
Code:	<b>MWL</b>
Description:	<b>Water Level</b>

Distance (ft):	<b>.0</b>
Structural Grade:	<b>0</b>
O&M Grade:	<b>0</b>
Clock Start/From:	
Clock To:	
1st Value:	
2nd Value:	
Value Percent:	<b>5.000</b>
Continuous Index:	
Within 8" of Joint:	<b>NO</b>
Remarks:

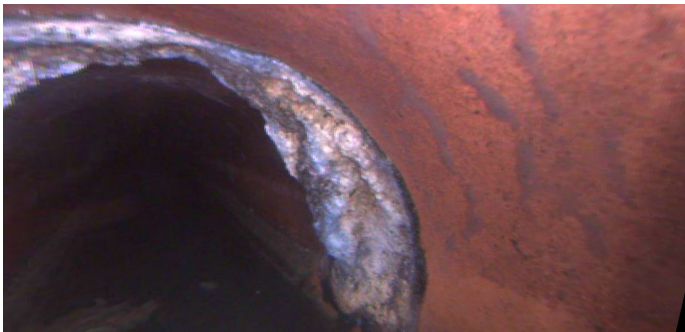
Code:	<b>DAGS</b>
Description:	<b>Deposits Attached Grease</b>

Distance (ft):	<b>4.0</b>
Structural Grade:	<b>0</b>
O&M Grade:	<b>2</b>
Clock Start/From:	<b>7</b>
Clock To:	<b>5</b>
1st Value:	
2nd Value:	
Value Percent:	<b>5.000</b>
Continuous Index:	
Within 8" of Joint:	<b>YES</b>
Remarks:

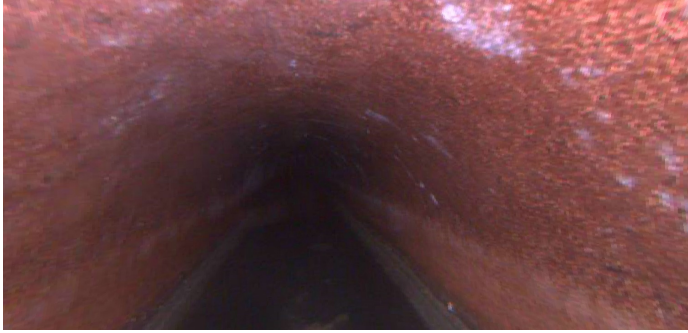
Code:	<b>MSA</b>
Description:	<b>Abandoned Survey</b>
Distance (ft):	<b>4.6</b>
Structural Grade:	<b>0</b>
O&M Grade:	<b>0</b>
Clock Start/From:	
Clock To:	
1st Value:	
2nd Value:	
Value Percent:	
Continuous Index:	
Within 8" of Joint:	<b>NO</b>
Remarks:	<b>stuck on dags???</b>
