## Profile/Photo Observation Report

Street:	<b>ALLEY BETWEEN SAINT JOSEPH PL &amp;</b>	Flow Control:	<b>Not Controlled</b>
City:	<b>Hobart, IN</b>	Year Renewed:	
Location:	<b>Other</b>	Tape/Media #:	
Purpose:	<b>Not Known</b>	Dia/Height:	<b>8"</b>
Use:	<b>Sanitary</b>	Material:	<b>VCP</b>
Drain Area:	<b>NA</b>	Lining:	<b>Cured in Place</b>
Category:	<b>NA</b>		
Comment:	<b>6 inch.</b>

Location Details:		Direction of Survey:	<b>Upstream</b>
US MH:	<b>M-902-070</b>	DS MH:	<b>M-902-071</b>
		Total Length Surveyed (ft):	<b>364.1</b>

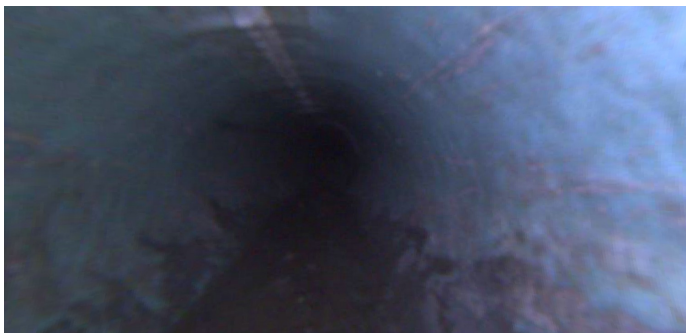
Code: **AMH**  
Description: **Manhole**

Distance (ft): **.0**  
Structural Grade: **0**  
O&M Grade: **0**  
Clock Start/From:  
Clock To:  
1st Value:  
2nd Value:  
Value Percent:  
Continuous Index:  
Within 8" of Joint: **NO**  
Remarks: **M-902-071**

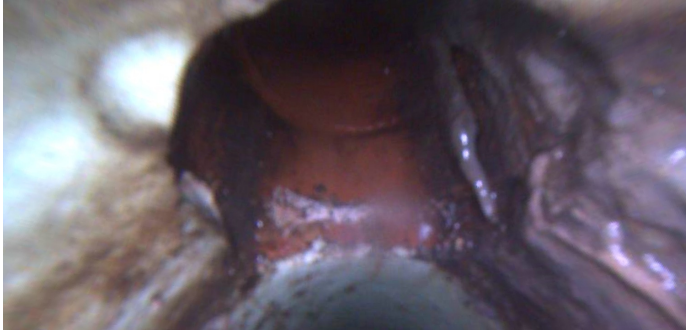
Code: **TBA**  
Description: **Tap Break-in Active**

Distance (ft): **57.5**  
Structural Grade: **0**  
O&M Grade: **0**  
Clock Start/From: **12**  
Clock To:  
1st Value: **4.000**  
2nd Value:  
Value Percent:  
Continuous Index:  
Within 8" of Joint:  
Remarks:

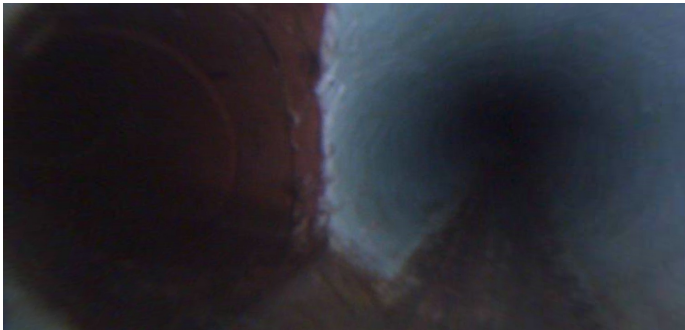
Code: **TFA**  
Description: **Tap Factory Active**

Distance (ft): **109.2**  
Structural Grade: **0**  
O&M Grade: **0**  
Clock Start/From: **9**  
Clock To:  
1st Value: **4.000**  
2nd Value:  
Value Percent:  
Continuous Index:  
Within 8" of Joint:  
Remarks:

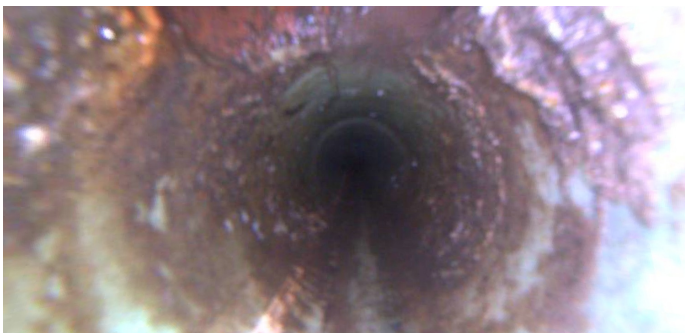
Code: **DAGS**  
Description: **Deposits Attached Grease**

Distance (ft): **119.3**  
Structural Grade: **0**  
O&M Grade: **2**  
Clock Start/From: **8**  
Clock To: **4**  
1st Value:  
2nd Value:  
Value Percent: **5.000**  
Continuous Index:  
Within 8" of Joint: **NO**  
Remarks:

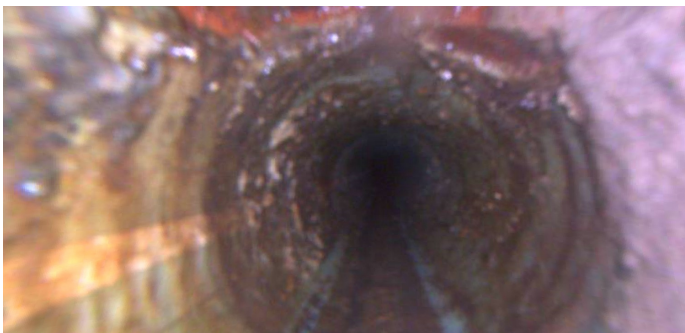
Code: **DAGS**  
Description: **Deposits Attached Grease**

Distance (ft): **176.0**  
Structural Grade: **0**  
O&M Grade: **2**  
Clock Start/From: **8**  
Clock To: **4**  
1st Value:  
2nd Value:  
Value Percent: **5.000**  
Continuous Index:  
Within 8" of Joint: **NO**  
Remarks:

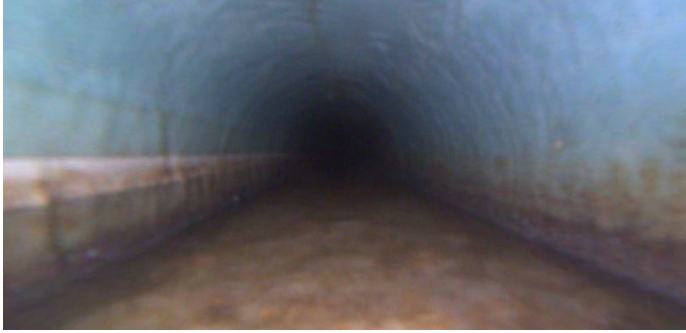
Code: **MWL**  
Description: **Water Level**

Distance (ft): **191.2**  
Structural Grade: **0**  
O&M Grade: **0**  
Clock Start/From:  
Clock To:  
1st Value:  
2nd Value:  
Value Percent: **30.000**  
Continuous Index:  
Within 8" of Joint: **NO**  
Remarks:

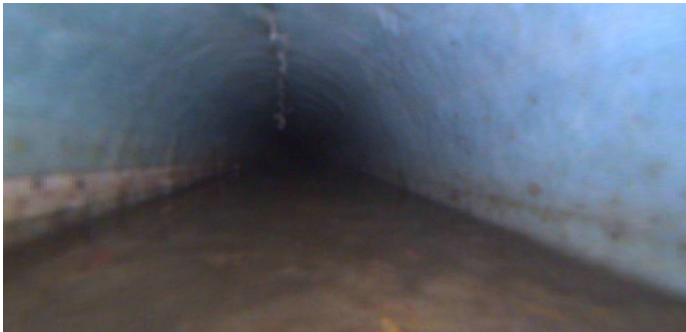
Code: **RFB**  
Description: **Roots Fine Barrel**

Distance (ft): **212.6**  
Structural Grade: **0**  
O&M Grade: **2**  
Clock Start/From: **12**  
Clock To:  
1st Value:  
2nd Value:  
Value Percent:  
Continuous Index:  
Within 8" of Joint: **NO**  
Remarks:

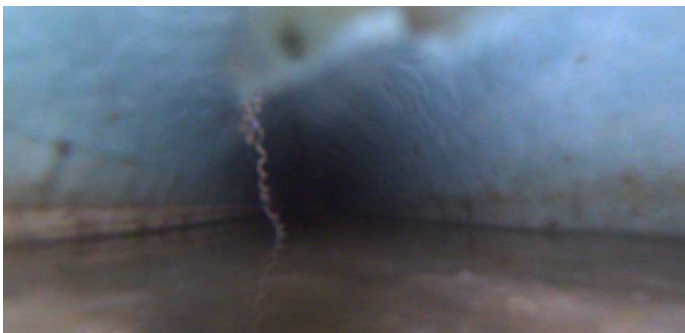
Code: **MWLS**  
Description: **Water Level Sag**

Distance (ft): **222.7**  
Structural Grade: **2**  
O&M Grade: **3**  
Clock Start/From:  
Clock To:  
1st Value:  
2nd Value:  
Value Percent: **10.000**  
Continuous Index: **F01**  
Within 8" of Joint: **NO**  
Remarks:

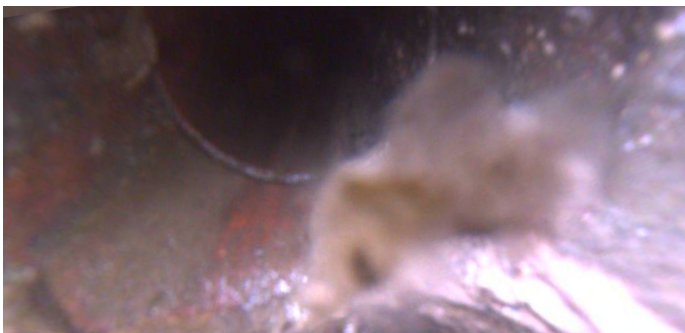
Code: **TFD**  
Description: **Tap Factory Defective**

Distance (ft): **241.9**  
Structural Grade: **0**  
O&M Grade: **2**  
Clock Start/From: **12**  
Clock To:  
1st Value: **4.000**  
2nd Value:  
Value Percent:  
Continuous Index:  
Within 8" of Joint:  
Remarks: **ROOTS**

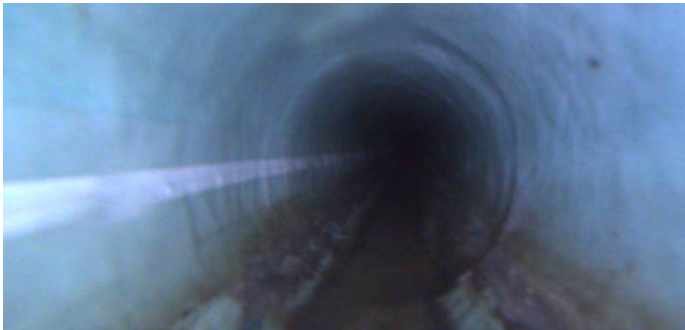
Code: **LR**  
Description: **Alignment Right**

Distance (ft): **289.8**  
Structural Grade: **0**  
O&M Grade: **1**  
Clock Start/From:  
Clock To:  
1st Value:  
2nd Value:  
Value Percent: **5.000**  
Continuous Index:  
Within 8" of Joint: **NO**  
Remarks:
