Profile/Photo Observation Report

Street:	38th pl	Flow Control:	Not Controlled
City:	Hobart, IN	Year Renewed:	
Location:	Other	Tape/Media #:	
Purpose:	Not Known	Dia/Height:	8"
Use:	Sanitary	Material:	VCP
Drain Area:	NA	Lining:	Cured in Place
Category:	NA		
Comment:	6 inch.

Location Details:		Direction of Survey:	Upstream
US MH:	M-902-070	DS MH:	M-902-071
		Total Length Surveyed (ft):	364.1

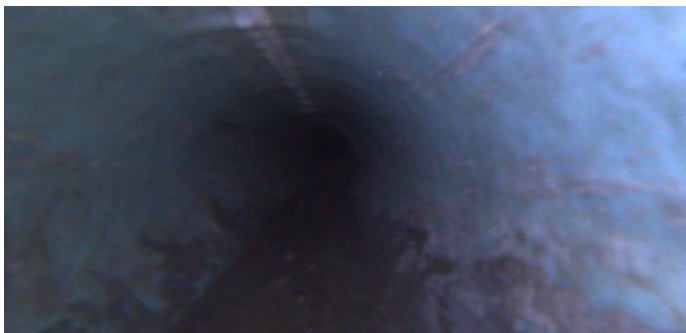
Code: **AMH**
Description: **Manhole**

Distance (ft): **.0**
Structural Grade: **0**
O&M Grade: **0**
Clock Start/From:
Clock To:
1st Value:
2nd Value:
Value Percent:
Continuous Index:
Within 8" of Joint: **NO**
Remarks: **M-902-071**

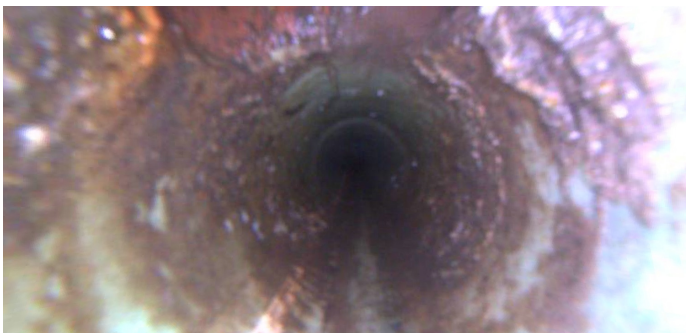
Code: **DAGS**
Description: **Deposits Attached Grease**

Distance (ft): **119.3**
Structural Grade: **0**
O&M Grade: **2**
Clock Start/From: **8**
Clock To: **4**
1st Value:
2nd Value:
Value Percent: **5.000**
Continuous Index:
Within 8" of Joint: **NO**
Remarks:

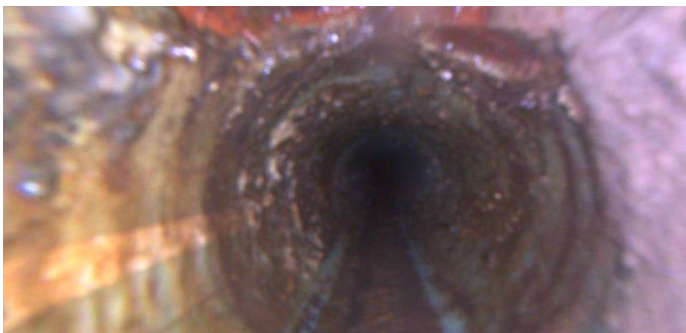
Code: **DAGS**
Description: **Deposits Attached Grease**

Distance (ft): **176.0**
Structural Grade: **0**
O&M Grade: **2**
Clock Start/From: **8**
Clock To: **4**
1st Value:
2nd Value:
Value Percent: **5.000**
Continuous Index:
Within 8" of Joint: **NO**
Remarks:

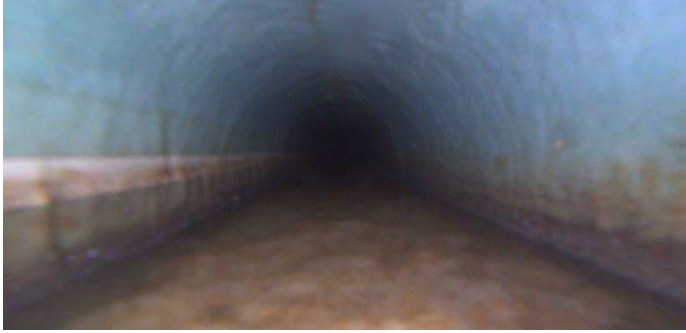
Code: **MWL**
Description: **Water Level**

Distance (ft): **191.2**
Structural Grade: **0**
O&M Grade: **0**
Clock Start/From:
Clock To:
1st Value:
2nd Value:
Value Percent: **30.000**
Continuous Index:
Within 8" of Joint: **NO**
Remarks:

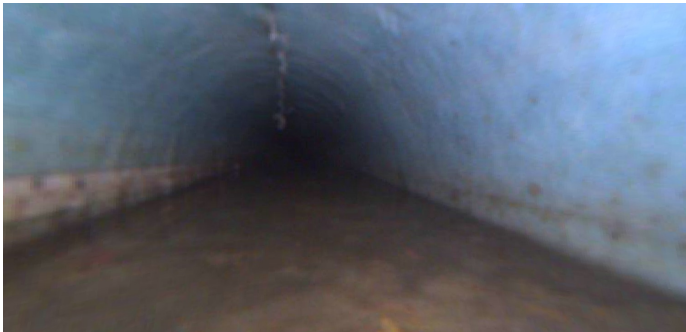
Code: **RFB**
Description: **Roots Fine Barrel**

Distance (ft): **212.6**
Structural Grade: **0**
O&M Grade: **2**
Clock Start/From: **12**
Clock To:
1st Value:
2nd Value:
Value Percent:
Continuous Index:
Within 8" of Joint: **NO**
Remarks:

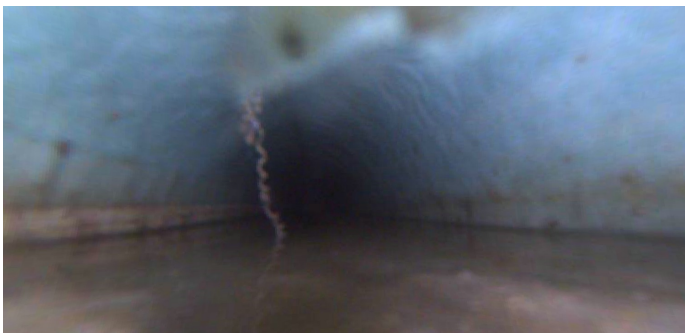
Code: **MWLS**
Description: **Water Level Sag**

Distance (ft): **222.7**
Structural Grade: **2**
O&M Grade: **3**
Clock Start/From:
Clock To:
1st Value:
2nd Value:
Value Percent: **10.000**
Continuous Index: **F01**
Within 8" of Joint: **NO**
Remarks:

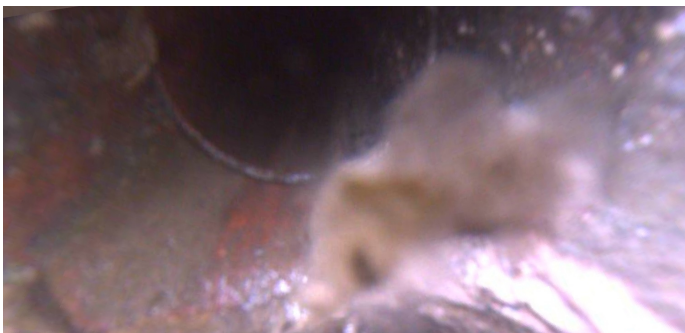
Code: **TFD**
Description: **Tap Factory Defective**

Distance (ft): **241.9**
Structural Grade: **0**
O&M Grade: **2**
Clock Start/From: **12**
Clock To:
1st Value: **4.000**
2nd Value:
Value Percent:
Continuous Index:
Within 8" of Joint:
Remarks: **ROOTS**

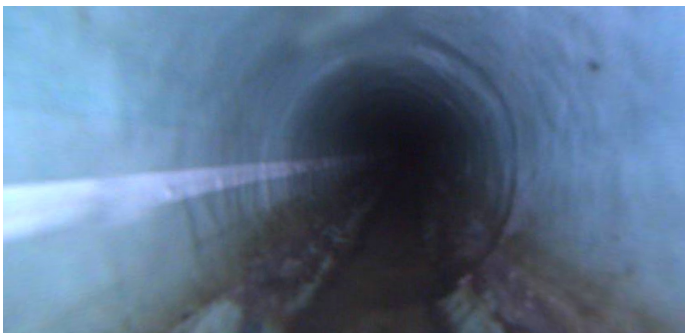
Code: **LR**
Description: **Alignment Right**

Distance (ft): **289.8**
Structural Grade: **0**
O&M Grade: **1**
Clock Start/From:
Clock To:
1st Value:
2nd Value:
Value Percent: **5.000**
Continuous Index:
Within 8" of Joint: **NO**
Remarks:
