Profile/Photo Observation Report

Date:	07/31/2023	Weather:		Coding:	PACP 7.0
Pipe Length (ft):	129.0	Owner:	City of Hobart	Pre Clean:	Heavy Cleaning
P.O.#:	YES502259	Surveyor:	S. Bucklin	PSR:	P-902-077-076
Customer:	City of Hobart	Clean Date:	05/07/2023	Shape:	C

Street:	East 34th Lane	Flow Control:	Not Controlled
City:	Hobart, IN	Year Renewed:	
Location:	Local rural streets with light traffic, t	Tape/Media #:	
Purpose:	Routine Assessment	Dia/Height:	15"
Use:	Sanitary Sewage Pipe	Material:	PVC
Drain Area:		Lining:	None
Category:	NA

Location Details:		Direction of Survey:	Downstream
US MH:	M-902-077	DS MH:	M-902-076
		Total Length Surveyed (ft):	121.0

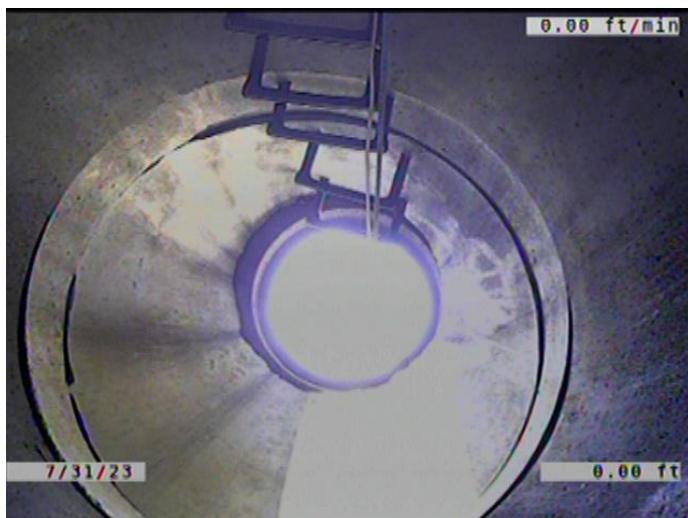
Code: **AMH**
Description: **Manhole**

Distance (ft): **.0**
Structural Grade: **0**
O&M Grade: **0**
Clock Start/From:
Clock To:
1st Value:
2nd Value:
Value Percent:
Continuous Index:
Within 8" of Joint: **NO**
Remarks: **M-902-077**

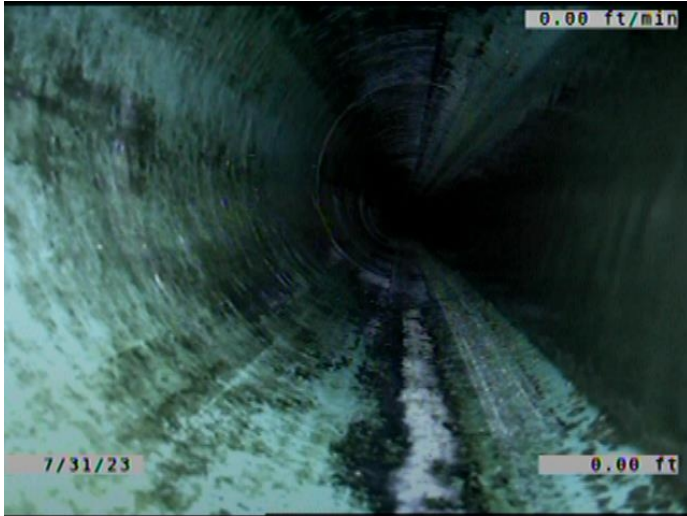
Code:	MWL
Description:	Miscellaneous Water Level
Distance (ft):	.0
Structural Grade:	0
O&M Grade:	0
Clock Start/From:	
Clock To:	
1st Value:	
2nd Value:	
Value Percent:	15.000
Continuous Index:	
Within 8" of Joint:	NO
Remarks:

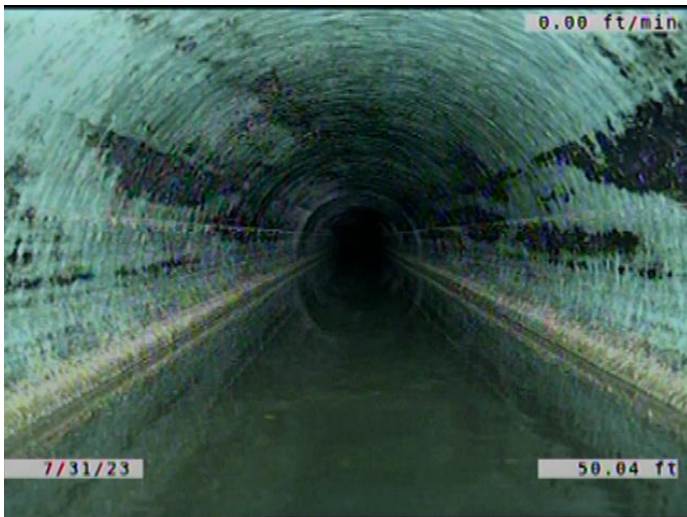
Code:	MWL
Description:	Miscellaneous Water Level
Distance (ft):	50.0
Structural Grade:	0
O&M Grade:	0
Clock Start/From:	
Clock To:	
1st Value:	
2nd Value:	
Value Percent:	25.000
Continuous Index:	
Within 8" of Joint:	NO
Remarks:

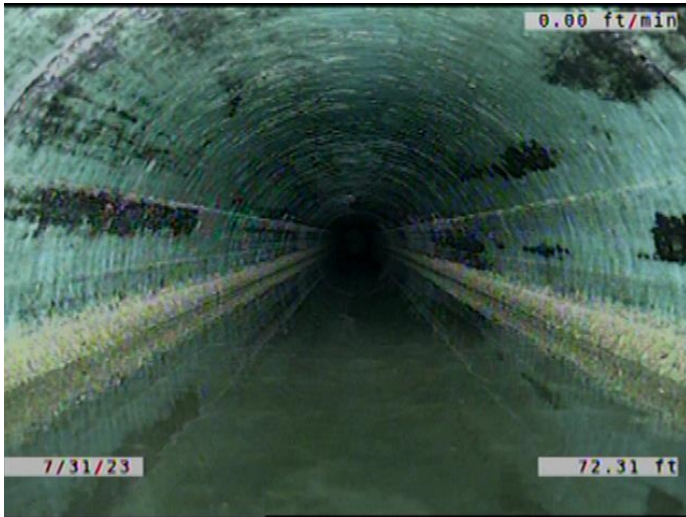
Code: **MWL**
Description: **Miscellaneous Water Level**

Distance (ft): **72.3**
Structural Grade: **0**
O&M Grade: **0**
Clock Start/From:
Clock To:
1st Value:
2nd Value:
Value Percent: **35.000**
Continuous Index:
Within 8" of Joint: **NO**
Remarks:

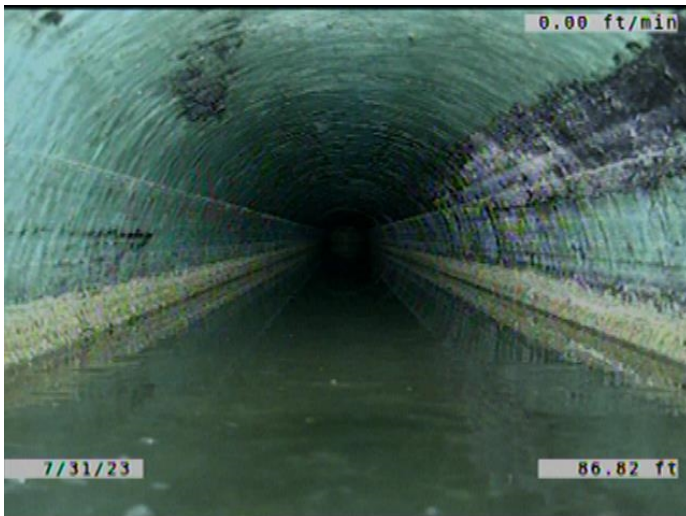
Code: **MWL**
Description: **Miscellaneous Water Level**

Distance (ft): **86.8**
Structural Grade: **0**
O&M Grade: **0**
Clock Start/From:
Clock To:
1st Value:
2nd Value:
Value Percent: **45.000**
Continuous Index:
Within 8" of Joint: **NO**
Remarks:

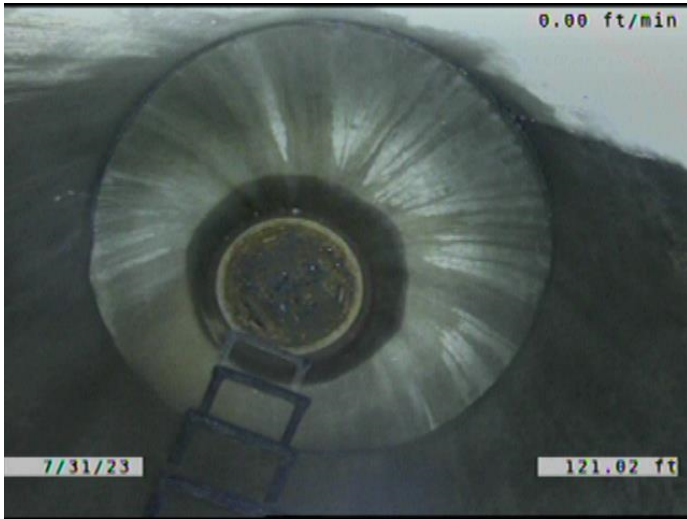
Code:	AMH
Description:	Manhole
Distance (ft):	121.0
Structural Grade:	0
O&M Grade:	0
Clock Start/From:	
Clock To:	
1st Value:	
2nd Value:	
Value Percent:	
Continuous Index:	
Within 8" of Joint:	NO
Remarks:	M-902-076
