## Profile/Photo Observation Report

Street:	<b>SAINT JOSEPH PL</b>	Flow Control:	<b>Not Controlled</b>
City:	<b>Hobart, IN</b>	Year Renewed:	
Location:	<b>Main Highway - Suburban/Rural</b>	Tape/Media #:	
Purpose:	<b>Resurvey</b>	Dia/Height:	<b>12"</b>
Use:	<b>Sanitary</b>	Material:	<b>VCP</b>
Drain Area:	<b>NA</b>	Lining:	
Category:	<b>NA</b>		
Comment:

Location Details:		Direction of Survey:	<b>Upstream</b>
US MH:	<b>M-902-078</b>	DS MH:	<b>M-902-046</b>
		Total Length Surveyed (ft):	<b>13.2</b>

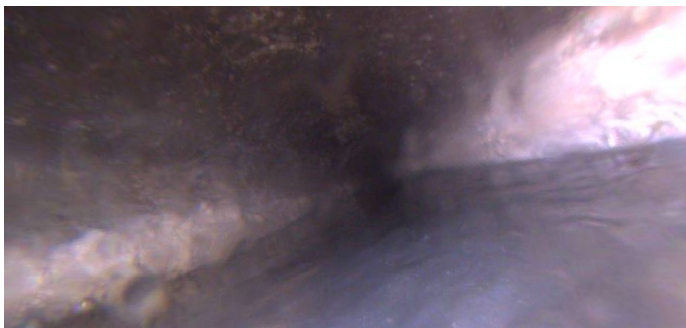
Code: **AMH**  
Description: **Manhole**

Distance (ft): **.0**  
Structural Grade: **0**  
O&M Grade: **0**  
Clock Start/From:  
Clock To:  
1st Value:  
2nd Value:  
Value Percent:  
Continuous Index:  
Within 8" of Joint: **NO**  
Remarks: **M-902-046**

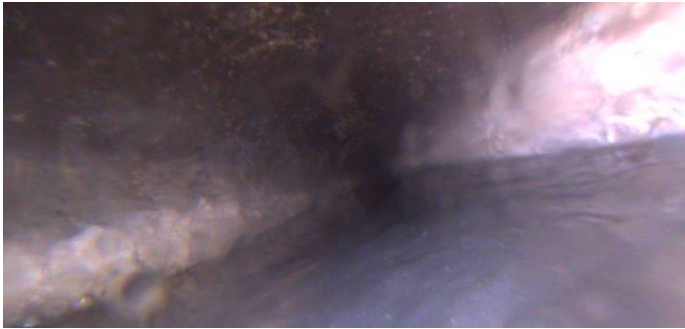
Code:	<b>MWL</b>
Description:	<b>Water Level</b>

Distance (ft):	<b>.0</b>
Structural Grade:	<b>0</b>
O&M Grade:	<b>0</b>
Clock Start/From:	
Clock To:	
1st Value:	
2nd Value:	
Value Percent:	<b>40.000</b>
Continuous Index:	
Within 8" of Joint:	<b>NO</b>
Remarks:

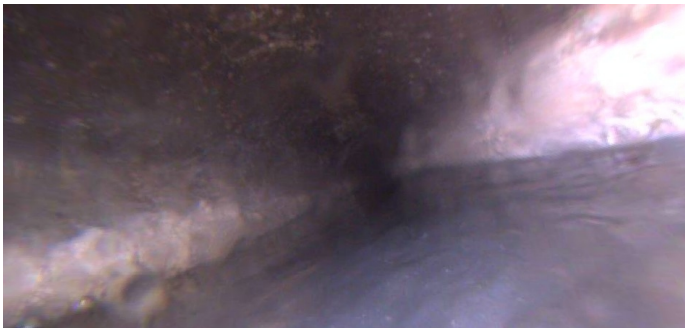
Code:	<b>DAGS</b>
Description:	<b>Deposits Attached Grease</b>

Distance (ft):	<b>.0</b>
Structural Grade:	<b>0</b>
O&M Grade:	<b>2</b>
Clock Start/From:	<b>3</b>
Clock To:	<b>9</b>
1st Value:	
2nd Value:	
Value Percent:	<b>10.000</b>
Continuous Index:	<b>S01</b>
Within 8" of Joint:	<b>NO</b>
Remarks:

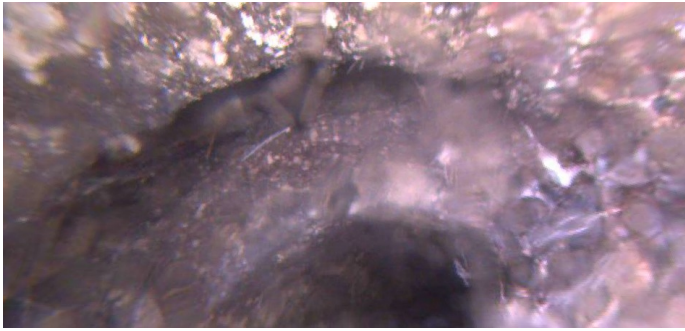
Code: **JOL**  
Description: **Joint Offset Large**

Distance (ft): **4.1**  
Structural Grade: **2**  
O&M Grade: **0**  
Clock Start/From:  
Clock To:  
1st Value:  
2nd Value:  
Value Percent:  
Continuous Index:  
Within 8" of Joint: **NO**  
Remarks:

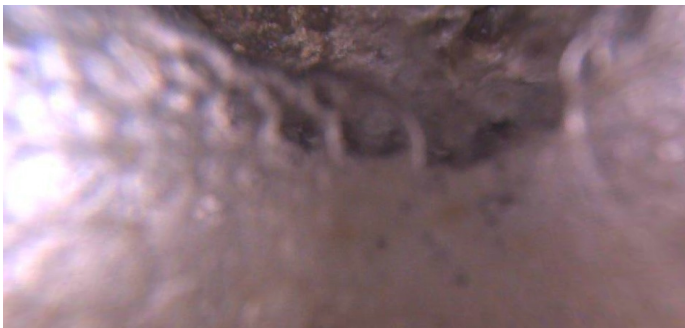
Code: **DAGS**  
Description: **Deposits Attached Grease**

Distance (ft): **9.8**  
Structural Grade: **0**  
O&M Grade: **2**  
Clock Start/From: **3**  
Clock To: **9**  
1st Value:  
2nd Value:  
Value Percent: **10.000**  
Continuous Index: **F01**  
Within 8" of Joint: **NO**  
Remarks: **Clock positions vary**

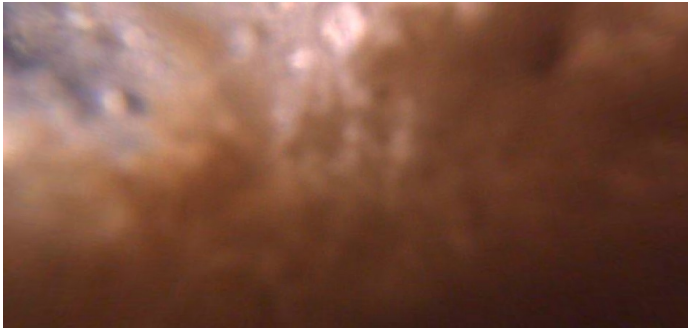
Code:	<b>MSA</b>
Description:	<b>Abandoned Survey</b>
Distance (ft):	<b>11.5</b>
Structural Grade:	<b>0</b>
O&M Grade:	<b>0</b>
Clock Start/From:	
Clock To:	
1st Value:	
2nd Value:	
Value Percent:	
Continuous Index:	
Within 8" of Joint:	<b>NO</b>
Remarks:	<b>mcu</b>
