Profile/Photo Observation Report

Street:	3775 St Joseph Pl	Flow Control:	Not Controlled
City:	Hobart In	Year Renewed:	
Location:	Light Highway	Tape/Media #:	Deliverable 1
Purpose:	Routine Assessment	Dia/Height:	15"
Use:	Sanitary	Material:	PVC
Drain Area:	Northeast	Lining:	
Category:	NA		
Comment:	402-1		
Location Details:	edge of street	Direction of Survey:	Upstream
US MH:	M-902-078	DS MH:	M-902-077
		Total Length Surveyed (ft):	163.8

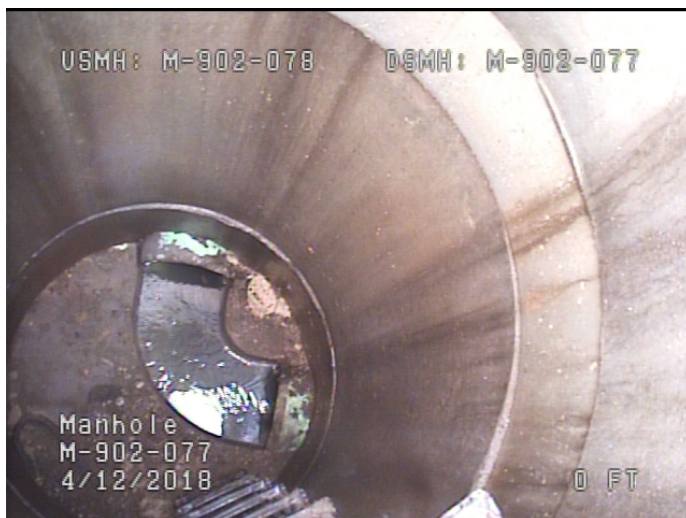
Code:	AMH
Description:	Manhole
Distance (ft):	.0
Structural Grade:	0
O&M Grade:	0
Clock Start/From:	
Clock To:	
1st Value:	
2nd Value:	
Value Percent:	
Continuous Index:	
Within 8" of Joint:	NO
Remarks:	M-902-077

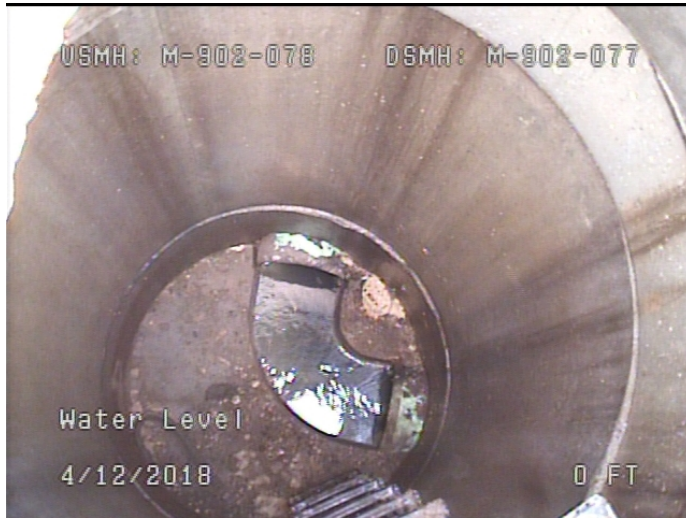
Code:	MWL
Description:	Water Level
Distance (ft):	.0
Structural Grade:	0
O&M Grade:	0
Clock Start/From:	
Clock To:	
1st Value:	
2nd Value:	
Value Percent:	20.000
Continuous Index:	
Within 8" of Joint:	NO
Remarks:

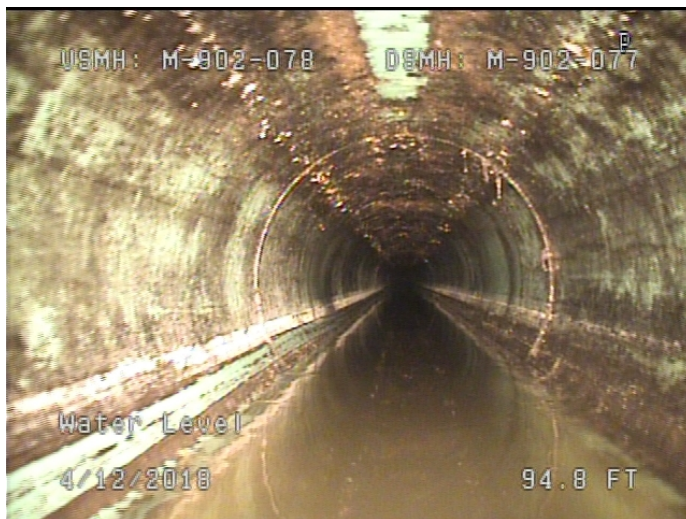
Code:	MWL
Description:	Water Level
Distance (ft):	94.8
Structural Grade:	0
O&M Grade:	0
Clock Start/From:	
Clock To:	
1st Value:	
2nd Value:	
Value Percent:	10.000
Continuous Index:	
Within 8" of Joint:	NO
Remarks:

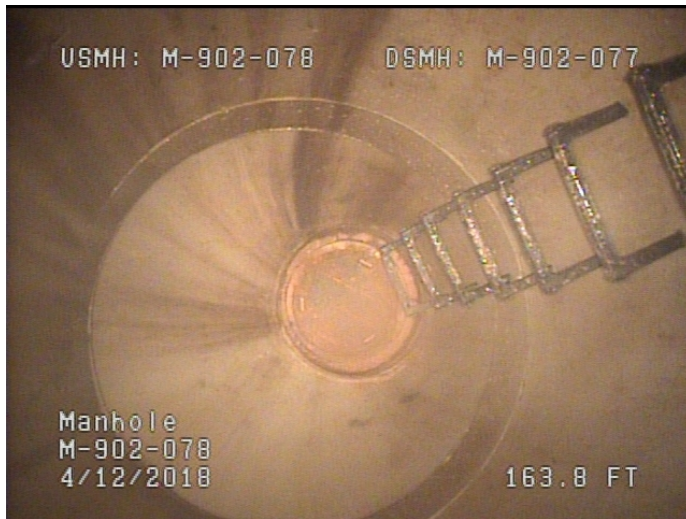
Code:	AMH
Description:	Manhole
Distance (ft):	163.8
Structural Grade:	0
O&M Grade:	0
Clock Start/From:	
Clock To:	
1st Value:	
2nd Value:	
Value Percent:	
Continuous Index:	
Within 8" of Joint:	NO
Remarks:	M-902-078
