## Profile/Photo Observation Report

Street:	<b>SAINT JOSEPH PL</b>	Flow Control:	<b>Not Controlled</b>
City:	<b>Hobart, IN</b>	Year Renewed:	
Location:	<b>Other</b>	Tape/Media #:	
Purpose:	<b>Not Known</b>	Dia/Height:	<b>8"</b>
Use:	<b>Sanitary</b>	Material:	<b>VCP</b>
Drain Area:	<b>NA</b>	Lining:	
Category:	<b>NA</b>		
Comment:

Location Details:		Direction of Survey:	<b>Downstream</b>
US MH:	<b>M-902-079</b>	DS MH:	<b>M-902-078</b>
		Total Length Surveyed (ft):	<b>341.7</b>

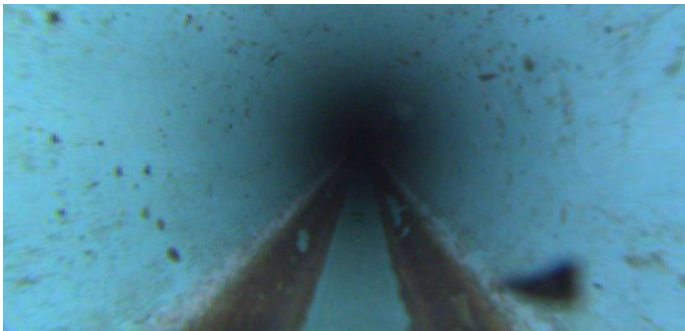
Code: **AMH**  
Description: **Manhole**

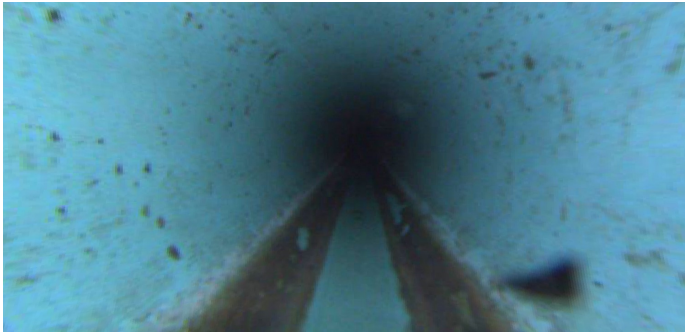
Code:	<b>MWL</b>
Description:	<b>Water Level</b>

Distance (ft):	<b>.0</b>
Structural Grade:	<b>0</b>
O&M Grade:	<b>0</b>
Clock Start/From:	
Clock To:	
1st Value:	
2nd Value:	
Value Percent:	<b>5.000</b>
Continuous Index:	
Within 8" of Joint:	<b>NO</b>
Remarks:

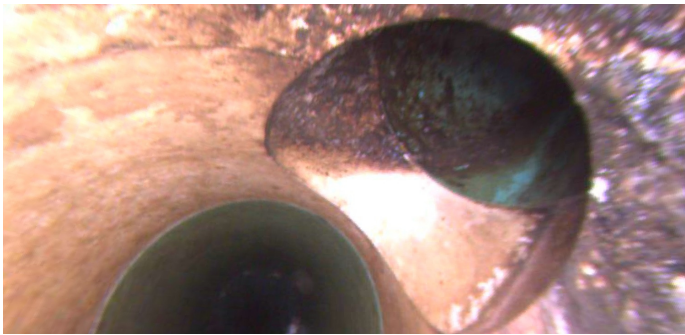
Code:	<b>TF</b>
Description:	<b>Tap Factory</b>

Distance (ft):	<b>16.2</b>
Structural Grade:	<b>0</b>
O&M Grade:	<b>0</b>
Clock Start/From:	<b>2</b>
Clock To:	
1st Value:	<b>4.000</b>
2nd Value:	
Value Percent:	
Continuous Index:	
Within 8" of Joint:	
Remarks:

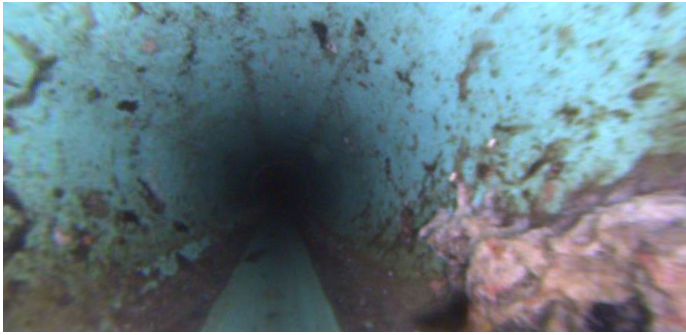
Code: **DAGS**  
Description: **Deposits Attached Grease**

Distance (ft): **18.5**  
Structural Grade: **0**  
O&M Grade: **2**  
Clock Start/From: **3**  
Clock To: **4**  
1st Value:  
2nd Value:  
Value Percent: **5.000**  
Continuous Index:  
Within 8" of Joint: **NO**  
Remarks:

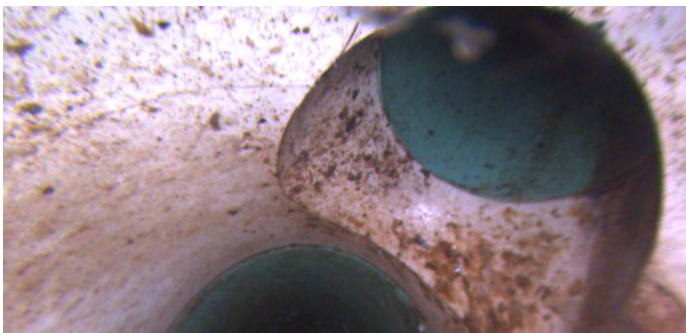
Code: **TF**  
Description: **Tap Factory**

Distance (ft): **77.1**  
Structural Grade: **0**  
O&M Grade: **0**  
Clock Start/From: **1**  
Clock To:  
1st Value: **4.000**  
2nd Value:  
Value Percent:  
Continuous Index:  
Within 8" of Joint:  
Remarks:

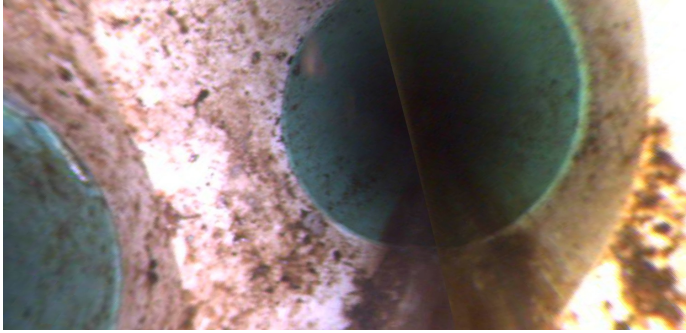
Code: **TF**  
Description: **Tap Factory**

Distance (ft): **83.4**  
Structural Grade: **0**  
O&M Grade: **0**  
Clock Start/From: **2**  
Clock To:  
1st Value: **4.000**  
2nd Value:  
Value Percent:  
Continuous Index:  
Within 8" of Joint:  
Remarks:

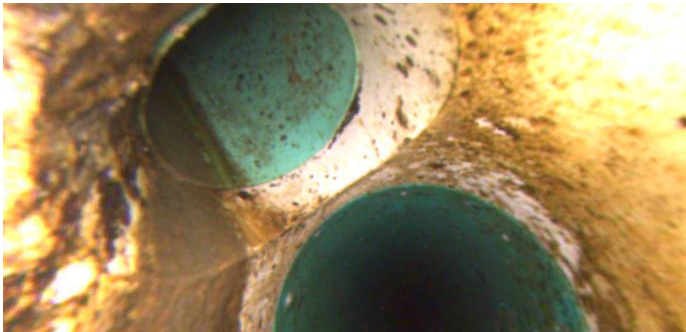
Code: **TF**  
Description: **Tap Factory**

Distance (ft): **191.8**  
Structural Grade: **0**  
O&M Grade: **0**  
Clock Start/From: **1**  
Clock To:  
1st Value: **4.000**  
2nd Value:  
Value Percent:  
Continuous Index:  
Within 8" of Joint:  
Remarks:

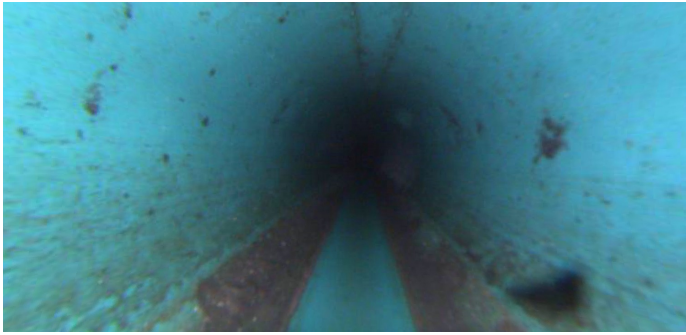
Code: **DAGS**  
Description: **Deposits Attached Grease**

Distance (ft): **221.5**  
Structural Grade: **0**  
O&M Grade: **2**  
Clock Start/From: **4**  
Clock To: **8**  
1st Value:  
2nd Value:  
Value Percent: **5.000**  
Continuous Index: **S01**  
Within 8" of Joint: **NO**  
Remarks:

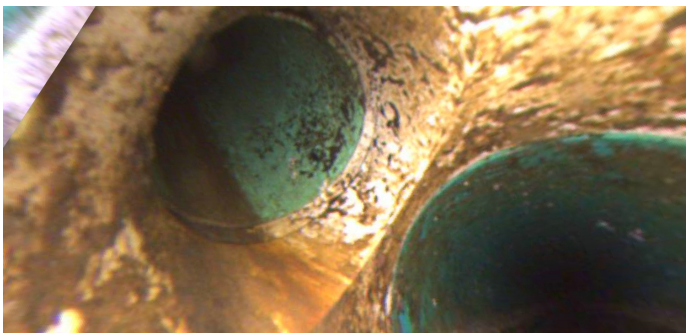
Code: **TF**  
Description: **Tap Factory**

Distance (ft): **255.9**  
Structural Grade: **0**  
O&M Grade: **0**  
Clock Start/From: **2**  
Clock To:  
1st Value: **4.000**  
2nd Value:  
Value Percent:  
Continuous Index:  
Within 8" of Joint:  
Remarks:

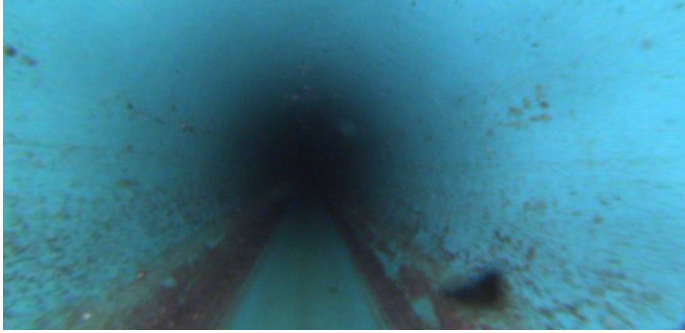
Code: **DAGS**  
Description: **Deposits Attached Grease**

Distance (ft): **262.6**  
Structural Grade: **0**  
O&M Grade: **2**  
Clock Start/From: **4**  
Clock To: **8**  
1st Value:  
2nd Value:  
Value Percent: **5.000**  
Continuous Index: **F01**  
Within 8" of Joint: **NO**  
Remarks:

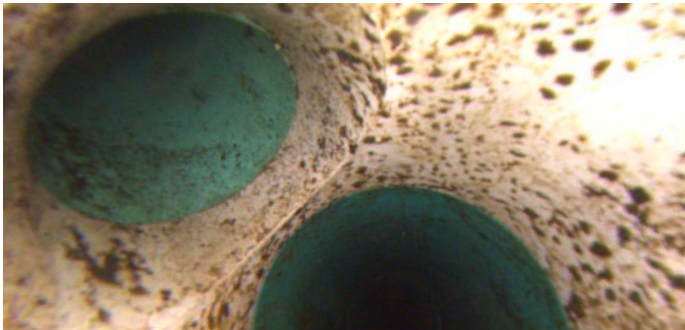
Code: **TF**  
Description: **Tap Factory**

Distance (ft): **301.6**  
Structural Grade: **0**  
O&M Grade: **0**  
Clock Start/From: **2**  
Clock To:  
1st Value: **4.000**  
2nd Value:  
Value Percent:  
Continuous Index:  
Within 8" of Joint:  
Remarks:

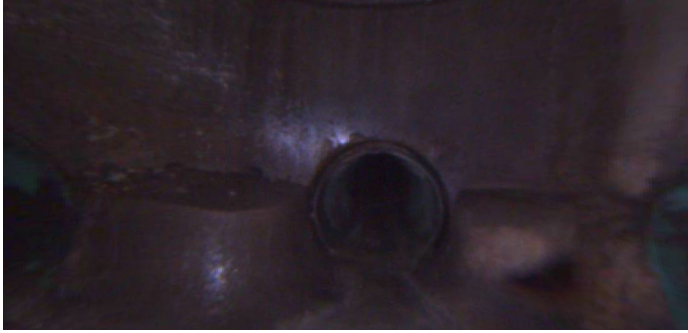
Code:	AMH
Description:	Manhole
Distance (ft):	341.7
Structural Grade:	0
O&M Grade:	0
Clock Start/From:	
Clock To:	
1st Value:	
2nd Value:	
Value Percent:	
Continuous Index:	
Within 8" of Joint:	NO
Remarks:	M-902-078
