## Profile/Photo Observation Report

Street:	<b>38th pl</b>	Flow Control:	<b>Not Controlled</b>
City:	<b>Hobart, IN</b>	Year Renewed:	
Location:	<b>Other</b>	Tape/Media #:	
Purpose:	<b>Not Known</b>	Dia/Height:	<b>8"</b>
Use:	<b>Sanitary</b>	Material:	<b>VCP</b>
Drain Area:	<b>NA</b>	Lining:	
Category:	<b>NA</b>		
Comment:

Location Details:		Direction of Survey:	<b>Downstream</b>
US MH:	<b>M-902-079</b>	DS MH:	<b>M-902-078</b>
		Total Length Surveyed (ft):	<b>341.7</b>

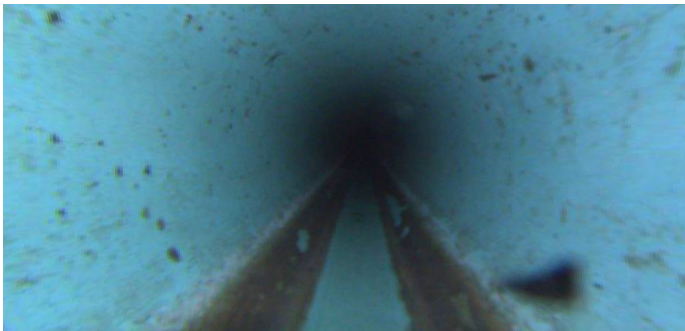
Code: **AMH**  
Description: **Manhole**

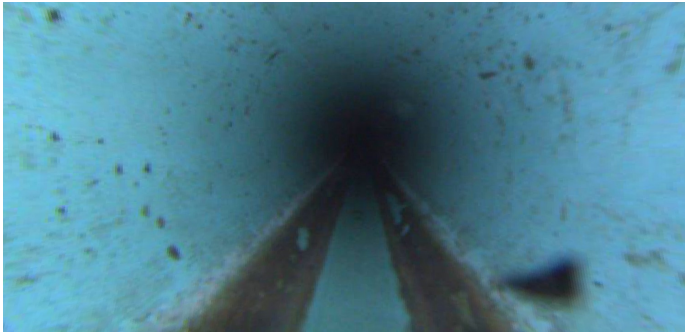
Code:	<b>MWL</b>
Description:	<b>Water Level</b>

Distance (ft):	<b>.0</b>
Structural Grade:	<b>0</b>
O&M Grade:	<b>0</b>
Clock Start/From:	
Clock To:	
1st Value:	
2nd Value:	
Value Percent:	<b>5.000</b>
Continuous Index:	
Within 8" of Joint:	<b>NO</b>
Remarks:

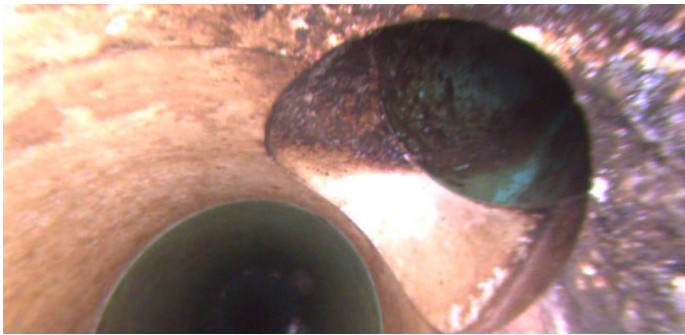
Code:	<b>TF</b>
Description:	<b>Tap Factory</b>

Distance (ft):	<b>16.2</b>
Structural Grade:	<b>0</b>
O&M Grade:	<b>0</b>
Clock Start/From:	<b>2</b>
Clock To:	
1st Value:	<b>4.000</b>
2nd Value:	
Value Percent:	
Continuous Index:	
Within 8" of Joint:	
Remarks:

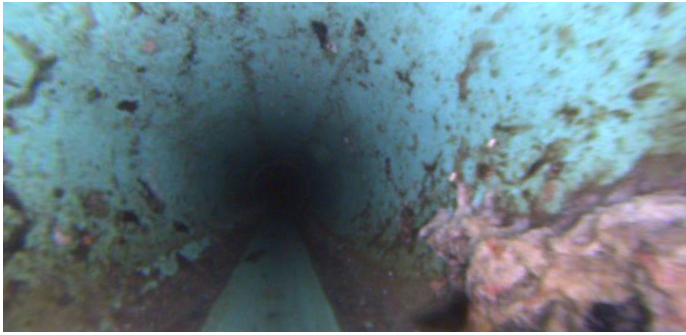
Code: **DAGS**  
Description: **Deposits Attached Grease**

Distance (ft): **18.5**  
Structural Grade: **0**  
O&M Grade: **2**  
Clock Start/From: **3**  
Clock To: **4**  
1st Value:  
2nd Value:  
Value Percent: **5.000**  
Continuous Index:  
Within 8" of Joint: **NO**  
Remarks:

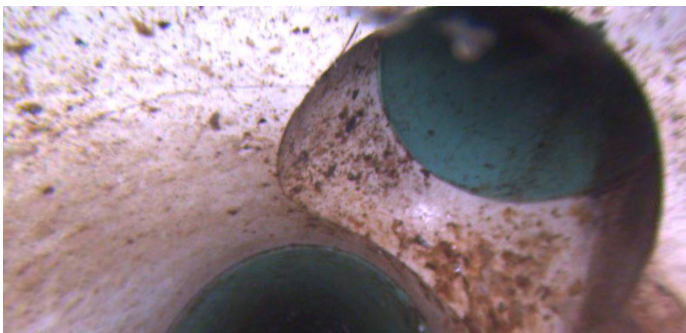
Code: **TF**  
Description: **Tap Factory**

Distance (ft): **77.1**  
Structural Grade: **0**  
O&M Grade: **0**  
Clock Start/From: **1**  
Clock To:  
1st Value: **4.000**  
2nd Value:  
Value Percent:  
Continuous Index:  
Within 8" of Joint:  
Remarks:

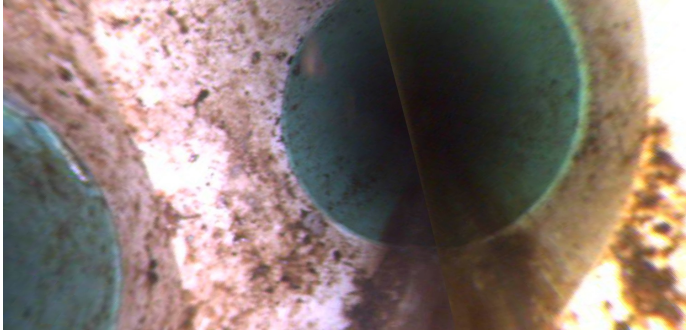
Code: **TF**  
Description: **Tap Factory**

Distance (ft): **83.4**  
Structural Grade: **0**  
O&M Grade: **0**  
Clock Start/From: **2**  
Clock To:  
1st Value: **4.000**  
2nd Value:  
Value Percent:  
Continuous Index:  
Within 8" of Joint:  
Remarks:

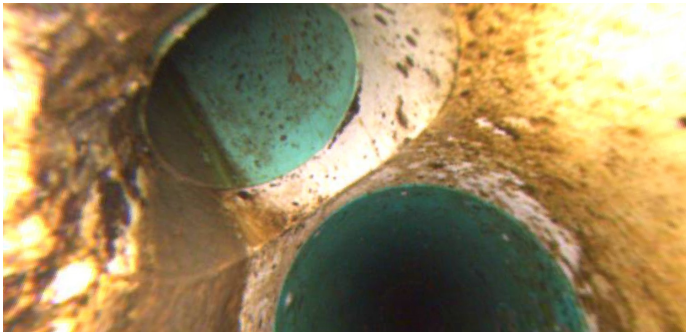
Code: **TF**  
Description: **Tap Factory**

Distance (ft): **191.8**  
Structural Grade: **0**  
O&M Grade: **0**  
Clock Start/From: **1**  
Clock To:  
1st Value: **4.000**  
2nd Value:  
Value Percent:  
Continuous Index:  
Within 8" of Joint:  
Remarks:

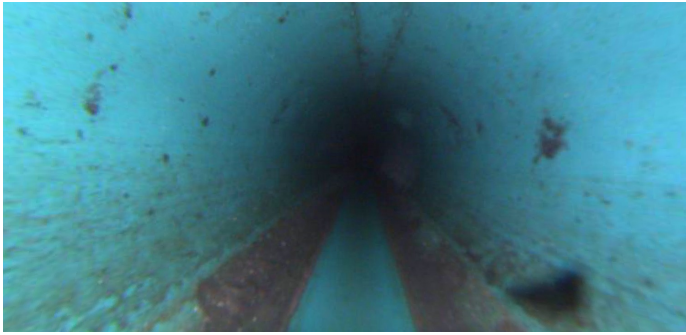
Code: **DAGS**  
Description: **Deposits Attached Grease**

Distance (ft): **221.5**  
Structural Grade: **0**  
O&M Grade: **2**  
Clock Start/From: **4**  
Clock To: **8**  
1st Value:  
2nd Value:  
Value Percent: **5.000**  
Continuous Index: **S01**  
Within 8" of Joint: **NO**  
Remarks:

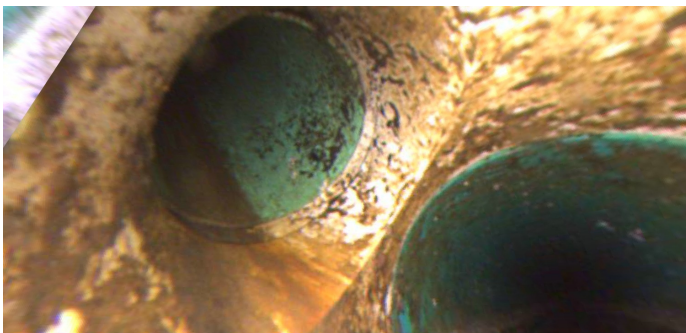
Code: **TF**  
Description: **Tap Factory**

Distance (ft): **255.9**  
Structural Grade: **0**  
O&M Grade: **0**  
Clock Start/From: **2**  
Clock To:  
1st Value: **4.000**  
2nd Value:  
Value Percent:  
Continuous Index:  
Within 8" of Joint:  
Remarks:

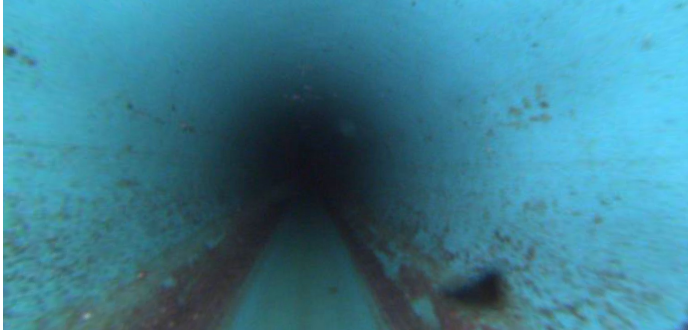
Code:	<b>DAGS</b>
Description:	<b>Deposits Attached Grease</b>
Distance (ft):	<b>262.6</b>
Structural Grade:	<b>0</b>
O&M Grade:	<b>2</b>
Clock Start/From:	<b>4</b>
Clock To:	<b>8</b>
1st Value:	
2nd Value:	
Value Percent:	<b>5.000</b>
Continuous Index:	<b>F01</b>
Within 8" of Joint:	<b>NO</b>
Remarks:

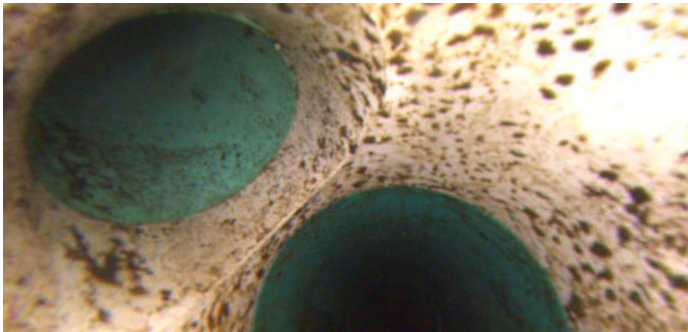
Code:	<b>TF</b>
Description:	<b>Tap Factory</b>
Distance (ft):	<b>301.6</b>
Structural Grade:	<b>0</b>
O&M Grade:	<b>0</b>
Clock Start/From:	<b>2</b>
Clock To:	
1st Value:	<b>4.000</b>
2nd Value:	
Value Percent:	
Continuous Index:	
Within 8" of Joint:	
Remarks:

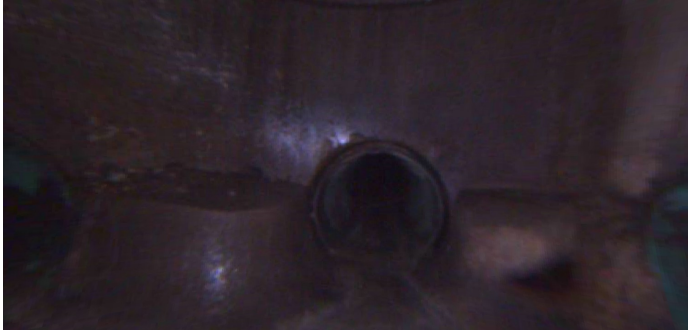
Code:	AMH
Description:	Manhole
Distance (ft):	341.7
Structural Grade:	0
O&M Grade:	0
Clock Start/From:	
Clock To:	
1st Value:	
2nd Value:	
Value Percent:	
Continuous Index:	
Within 8" of Joint:	NO
Remarks:	M-902-078
