Profile/Photo Observation Report

Street:	SAINT JOSEPH PL	Flow Control:	Not Controlled
City:	Hobart, IN	Year Renewed:	
Location:	Other	Tape/Media #:	
Purpose:	Not Known	Dia/Height:	8"
Use:	Sanitary	Material:	VCP
Drain Area:	NA	Lining:	
Category:	NA		
Comment:	cnl

Location Details:		Direction of Survey:	Upstream
US MH:	M-902-080	DS MH:	M-902-079
		Total Length Surveyed (ft):	265.3

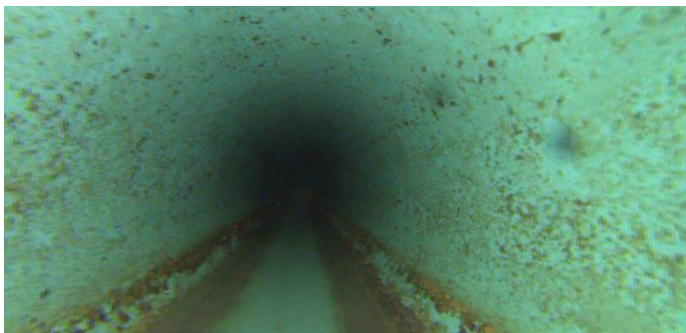
Code: **AMH**
Description: **Manhole**

Distance (ft): **.0**
Structural Grade: **0**
O&M Grade: **0**
Clock Start/From:
Clock To:
1st Value:
2nd Value:
Value Percent:
Continuous Index:
Within 8" of Joint: **NO**
Remarks: **M-902-079**

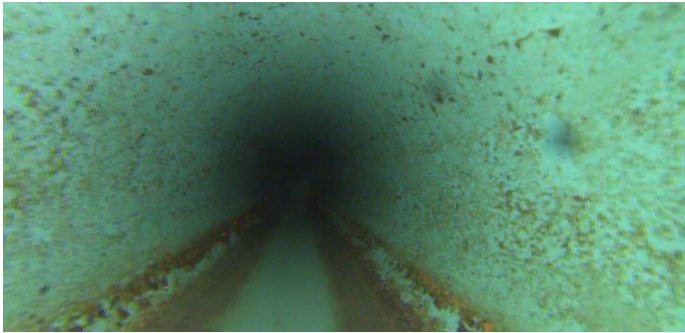
Code:	MWL
Description:	Water Level

Distance (ft):	.0
Structural Grade:	0
O&M Grade:	0
Clock Start/From:	
Clock To:	
1st Value:	
2nd Value:	
Value Percent:	5.000
Continuous Index:	
Within 8" of Joint:	NO
Remarks:

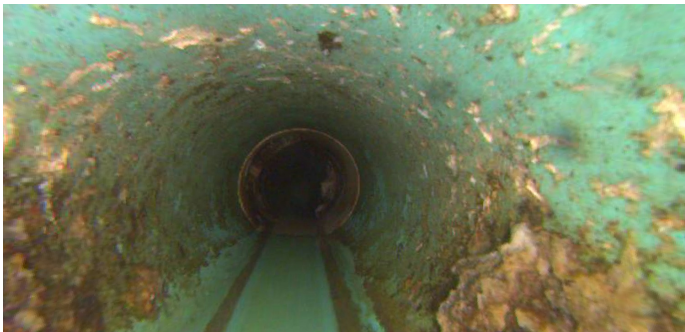
Code:	DAGS
Description:	Deposits Attached Grease

Distance (ft):	89.2
Structural Grade:	0
O&M Grade:	2
Clock Start/From:	8
Clock To:	4
1st Value:	
2nd Value:	
Value Percent:	5.000
Continuous Index:	
Within 8" of Joint:	NO
Remarks:

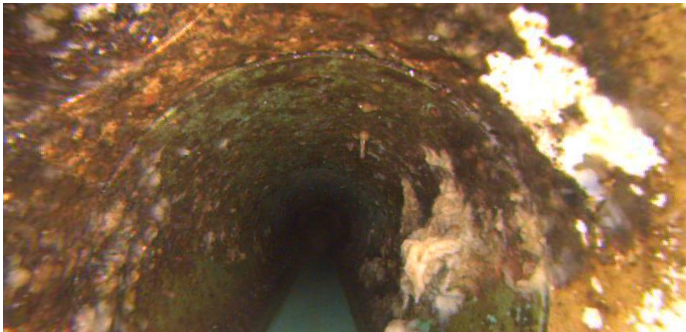
Code: **DAGS**
Description: **Deposits Attached Grease**

Distance (ft): **91.2**
Structural Grade: **0**
O&M Grade: **2**
Clock Start/From: **1**
Clock To: **4**
1st Value:
2nd Value:
Value Percent: **5.000**
Continuous Index:
Within 8" of Joint: **NO**
Remarks:

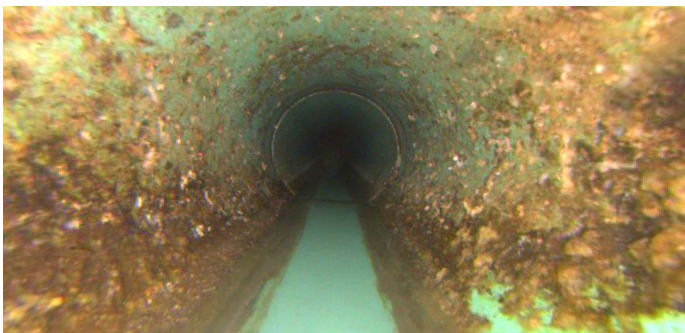
Code: **DAGS**
Description: **Deposits Attached Grease**

Distance (ft): **96.0**
Structural Grade: **0**
O&M Grade: **2**
Clock Start/From: **8**
Clock To: **4**
1st Value:
2nd Value:
Value Percent: **5.000**
Continuous Index:
Within 8" of Joint: **NO**
Remarks:

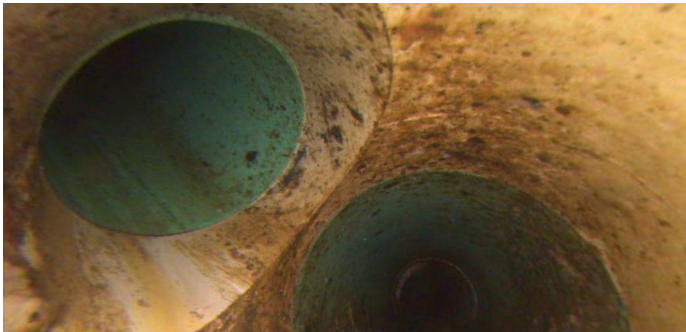
Code: **TF**
Description: **Tap Factory**

Distance (ft): **210.0**
Structural Grade: **0**
O&M Grade: **0**
Clock Start/From: **10**
Clock To:
1st Value: **4.000**
2nd Value:
Value Percent:
Continuous Index:
Within 8" of Joint:
Remarks:

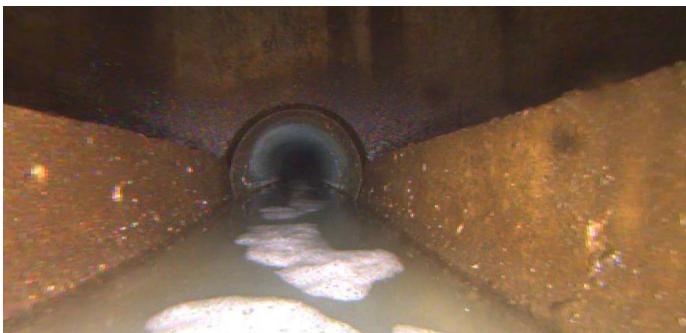
Code: **AMH**
Description: **Manhole**

Distance (ft): **265.3**
Structural Grade: **0**
O&M Grade: **0**
Clock Start/From:
Clock To:
1st Value:
2nd Value:
Value Percent:
Continuous Index:
Within 8" of Joint: **NO**
Remarks: **M-902-080**
