## Profile/Photo Observation Report

Street:	<b>SAINT JOSEPH PL</b>	Flow Control:	<b>Not Controlled</b>
City:	<b>Hobart, IN</b>	Year Renewed:	
Location:	<b>Other</b>	Tape/Media #:	
Purpose:	<b>Not Known</b>	Dia/Height:	<b>10"</b>
Use:	<b>Sanitary</b>	Material:	<b>PVC</b>
Drain Area:	<b>NA</b>	Lining:	
Category:	<b>NA</b>		
Comment:

Location Details:		Direction of Survey:	<b>Downstream</b>
US MH:	<b>M-902-081</b>	DS MH:	<b>M-902-080</b>
		Total Length Surveyed (ft):	<b>382.0</b>

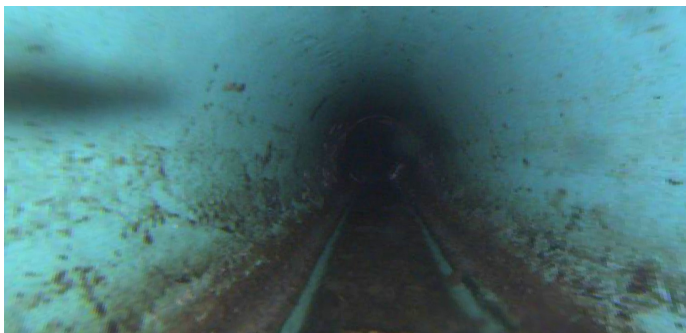
Code: **AMH**  
Description: **Manhole**

Distance (ft): **.0**  
Structural Grade: **0**  
O&M Grade: **0**  
Clock Start/From:  
Clock To:  
1st Value:  
2nd Value:  
Value Percent:  
Continuous Index:  
Within 8" of Joint: **NO**  
Remarks: **M-902-081**

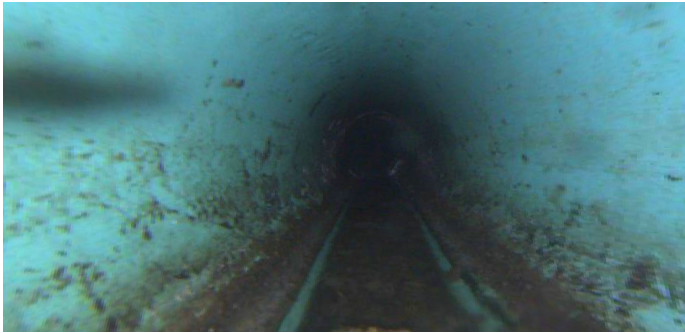
Code:	<b>MWL</b>
Description:	<b>Water Level</b>

Distance (ft):	<b>.0</b>
Structural Grade:	<b>0</b>
O&M Grade:	<b>0</b>
Clock Start/From:	
Clock To:	
1st Value:	
2nd Value:	
Value Percent:	<b>5.000</b>
Continuous Index:	
Within 8" of Joint:	<b>NO</b>
Remarks:

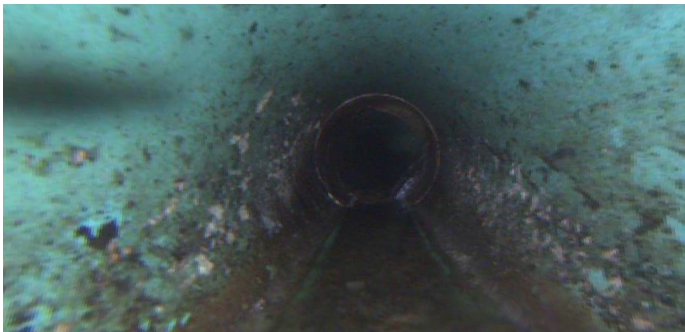
Code:	<b>DAZ</b>
Description:	<b>Deposits Attached Other</b>

Distance (ft):	<b>2.3</b>
Structural Grade:	<b>0</b>
O&M Grade:	<b>2</b>
Clock Start/From:	<b>7</b>
Clock To:	<b>5</b>
1st Value:	
2nd Value:	
Value Percent:	<b>5.000</b>
Continuous Index:	
Within 8" of Joint:	<b>NO</b>
Remarks:

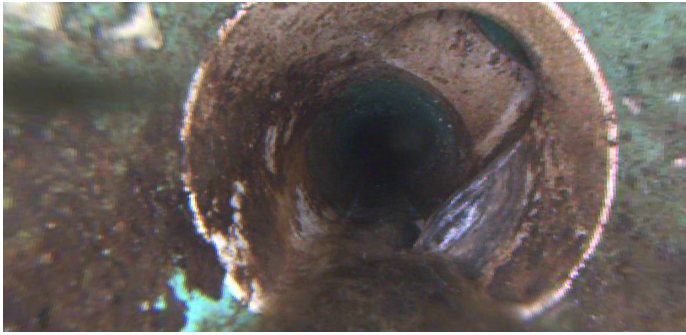
Code: **TFA**  
Description: **Tap Factory Active**

Distance (ft): **3.2**  
Structural Grade: **0**  
O&M Grade: **0**  
Clock Start/From: **2**  
Clock To:  
1st Value: **4.000**  
2nd Value:  
Value Percent:  
Continuous Index:  
Within 8" of Joint:  
Remarks:

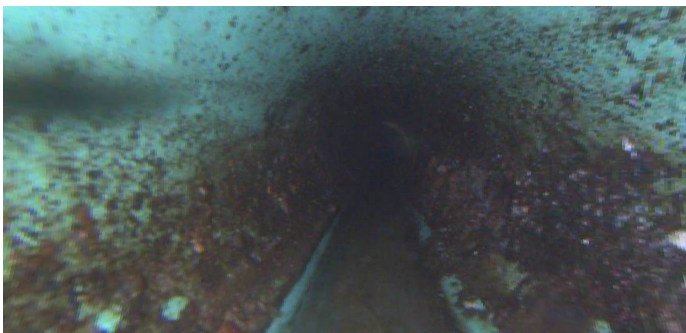
Code: **DAZ**  
Description: **Deposits Attached Other**

Distance (ft): **57.9**  
Structural Grade: **0**  
O&M Grade: **2**  
Clock Start/From: **7**  
Clock To: **5**  
1st Value:  
2nd Value:  
Value Percent: **5.000**  
Continuous Index:  
Within 8" of Joint: **YES**  
Remarks:

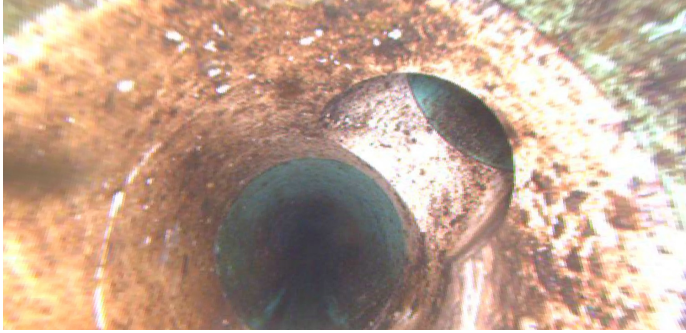
Code: **TF**  
Description: **Tap Factory**

Distance (ft): **60.3**  
Structural Grade: **0**  
O&M Grade: **0**  
Clock Start/From: **2**  
Clock To:  
1st Value: **4.000**  
2nd Value:  
Value Percent:  
Continuous Index:  
Within 8" of Joint:  
Remarks:

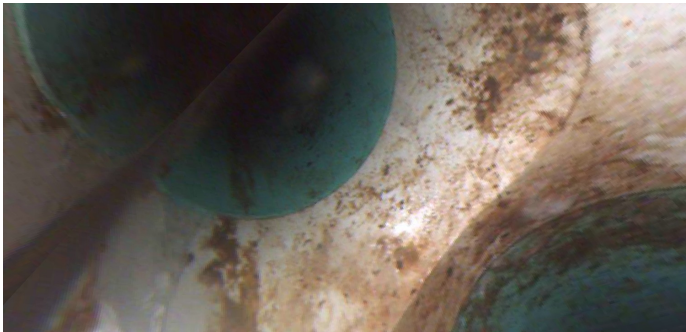
Code: **TFA**  
Description: **Tap Factory Active**

Distance (ft): **124.6**  
Structural Grade: **0**  
O&M Grade: **0**  
Clock Start/From: **11**  
Clock To:  
1st Value: **4.000**  
2nd Value:  
Value Percent:  
Continuous Index:  
Within 8" of Joint:  
Remarks:

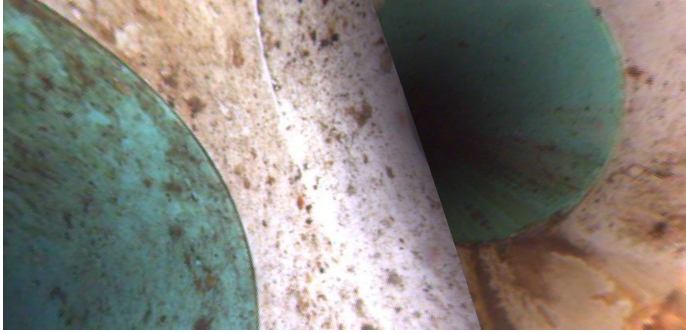
Code: **TF**  
Description: **Tap Factory**

Distance (ft): **127.2**  
Structural Grade: **0**  
O&M Grade: **0**  
Clock Start/From: **1**  
Clock To:  
1st Value: **4.000**  
2nd Value:  
Value Percent:  
Continuous Index:  
Within 8" of Joint:  
Remarks:

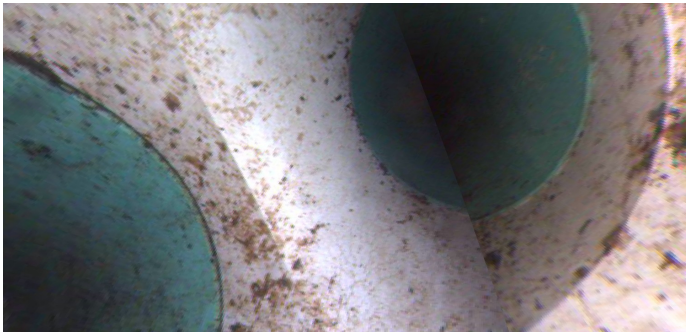
Code: **TF**  
Description: **Tap Factory**

Distance (ft): **186.6**  
Structural Grade: **0**  
O&M Grade: **0**  
Clock Start/From: **2**  
Clock To:  
1st Value: **4.000**  
2nd Value:  
Value Percent:  
Continuous Index:  
Within 8" of Joint:  
Remarks:

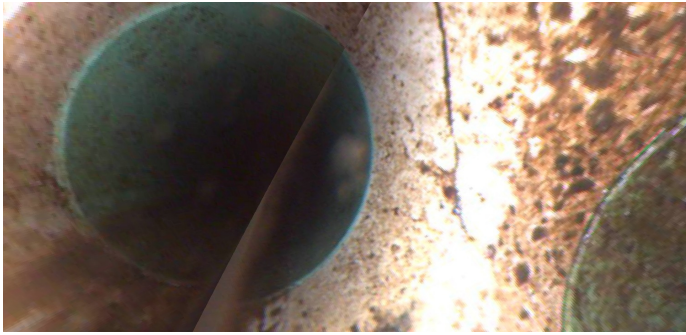
Code: **TF**  
Description: **Tap Factory**

Distance (ft): **189.0**  
Structural Grade: **0**  
O&M Grade: **0**  
Clock Start/From: **11**  
Clock To:  
1st Value: **4.000**  
2nd Value:  
Value Percent:  
Continuous Index:  
Within 8" of Joint:  
Remarks:

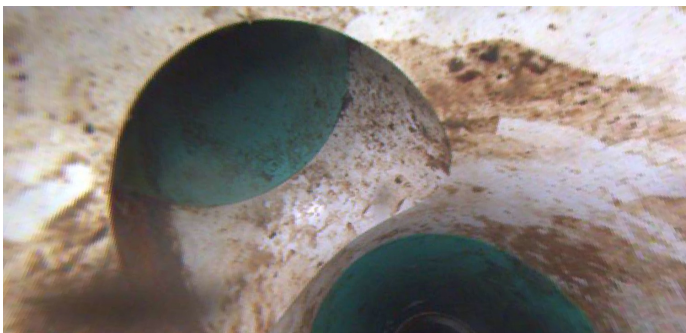
Code: **TF**  
Description: **Tap Factory**

Distance (ft): **243.3**  
Structural Grade: **0**  
O&M Grade: **0**  
Clock Start/From: **10**  
Clock To:  
1st Value: **4.000**  
2nd Value:  
Value Percent:  
Continuous Index:  
Within 8" of Joint:  
Remarks:

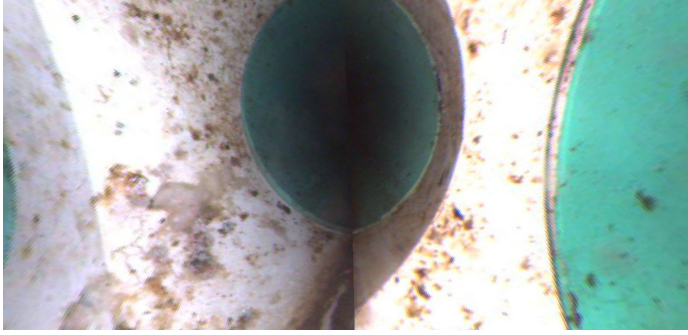
Code: **TF**  
Description: **Tap Factory**

Distance (ft): **246.0**  
Structural Grade: **0**  
O&M Grade: **0**  
Clock Start/From: **2**  
Clock To:  
1st Value: **4.000**  
2nd Value:  
Value Percent:  
Continuous Index:  
Within 8" of Joint:  
Remarks:

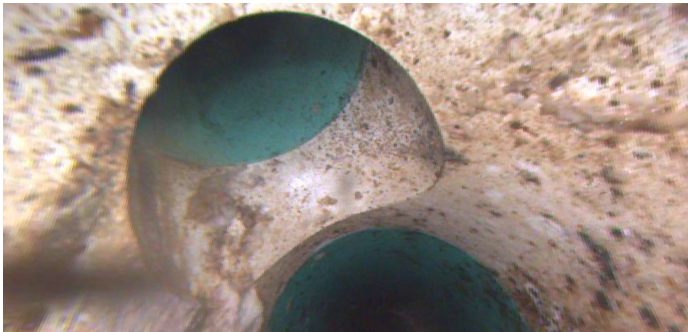
Code: **TF**  
Description: **Tap Factory**

Distance (ft): **303.5**  
Structural Grade: **0**  
O&M Grade: **0**  
Clock Start/From: **10**  
Clock To:  
1st Value: **4.000**  
2nd Value:  
Value Percent:  
Continuous Index:  
Within 8" of Joint:  
Remarks:

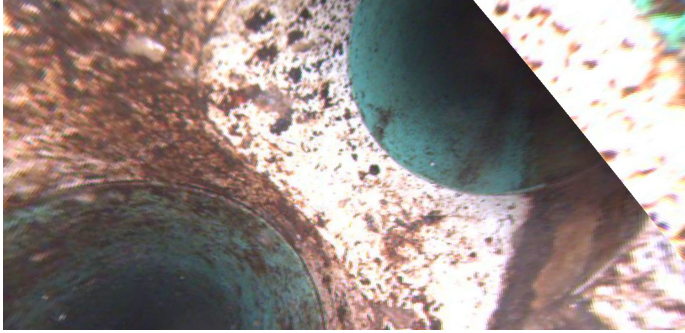
Code: **TF**  
Description: **Tap Factory**

Distance (ft): **306.6**  
Structural Grade: **0**  
O&M Grade: **0**  
Clock Start/From: **2**  
Clock To:  
1st Value: **4.000**  
2nd Value:  
Value Percent:  
Continuous Index:  
Within 8" of Joint:  
Remarks:

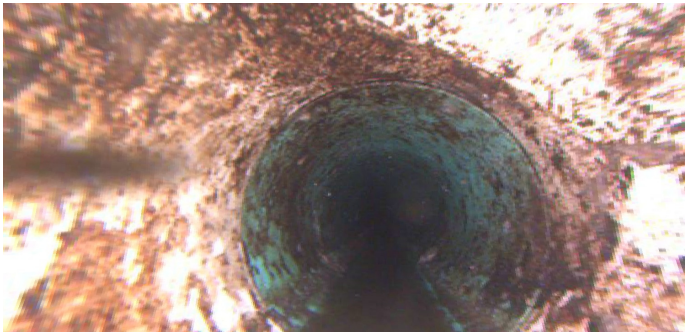
Code: **DAZ**  
Description: **Deposits Attached Other**

Distance (ft): **306.6**  
Structural Grade: **0**  
O&M Grade: **2**  
Clock Start/From: **7**  
Clock To: **5**  
1st Value:  
2nd Value:  
Value Percent: **5.000**  
Continuous Index:  
Within 8" of Joint: **YES**  
Remarks:

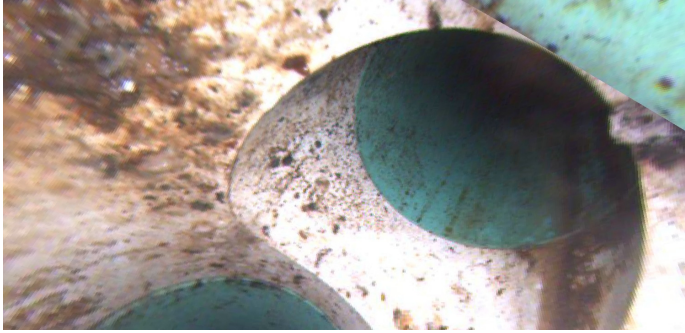
Code: **TF**  
Description: **Tap Factory**

Distance (ft): **314.6**  
Structural Grade: **0**  
O&M Grade: **0**  
Clock Start/From: **2**  
Clock To:  
1st Value: **4.000**  
2nd Value:  
Value Percent:  
Continuous Index:  
Within 8" of Joint:  
Remarks:

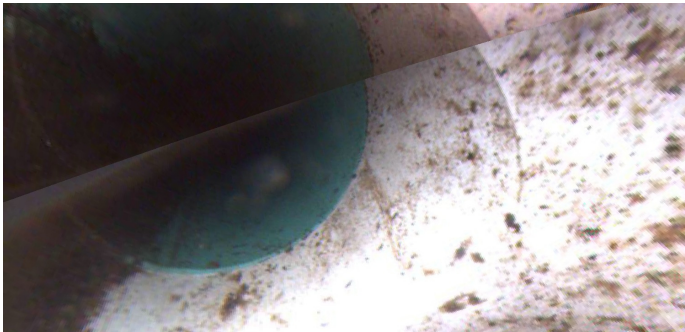
Code: **TF**  
Description: **Tap Factory**

Distance (ft): **327.5**  
Structural Grade: **0**  
O&M Grade: **0**  
Clock Start/From: **11**  
Clock To:  
1st Value: **4.000**  
2nd Value:  
Value Percent:  
Continuous Index:  
Within 8" of Joint:  
Remarks:

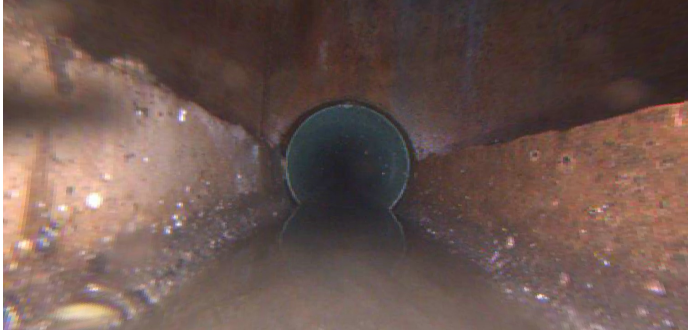
Code:	<b>AMH</b>
Description:	<b>Manhole</b>
Distance (ft):	<b>382.0</b>
Structural Grade:	<b>0</b>
O&M Grade:	<b>0</b>
Clock Start/From:	
Clock To:	
1st Value:	
2nd Value:	
Value Percent:	
Continuous Index:	
Within 8" of Joint:	<b>NO</b>
Remarks:	<b>M-902-080</b>
