Profile/Photo Observation Report

Street:	saint joesph pl	Flow Control:	Not Controlled
City:	Hobart, IN	Year Renewed:	
Location:	Other	Tape/Media #:	
Purpose:	Not Known	Dia/Height:	10"
Use:	Sanitary	Material:	PVC
Drain Area:	NA	Lining:	
Category:	NA		
Comment:

Location Details:		Direction of Survey:	Upstream
US MH:	M-902-082	DS MH:	M-902-081
		Total Length Surveyed (ft):	234.1

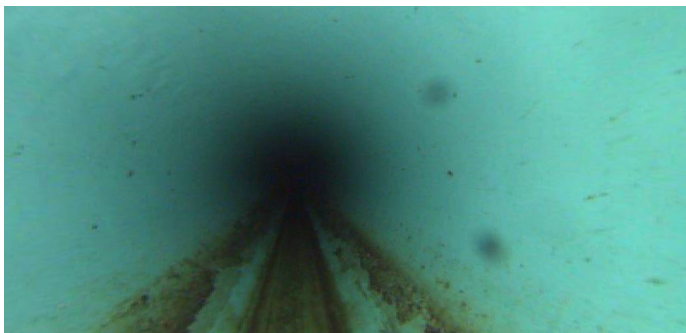
Code: **AMH**
Description: **Manhole**

Distance (ft): **.0**
Structural Grade: **0**
O&M Grade: **0**
Clock Start/From:
Clock To:
1st Value:
2nd Value:
Value Percent:
Continuous Index:
Within 8" of Joint: **NO**
Remarks: **M-902-081**

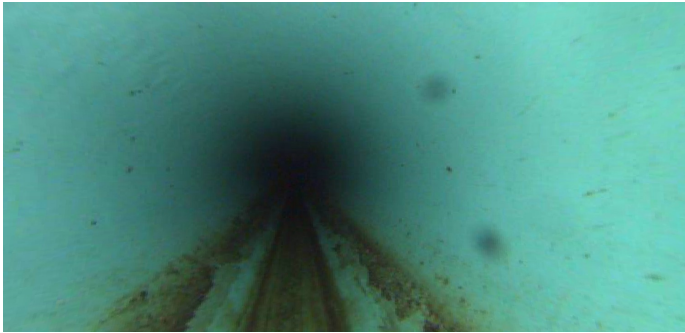
Code:	MWL
Description:	Water Level

Distance (ft):	.0
Structural Grade:	0
O&M Grade:	0
Clock Start/From:	
Clock To:	
1st Value:	
2nd Value:	
Value Percent:	5.000
Continuous Index:	
Within 8" of Joint:	NO
Remarks:

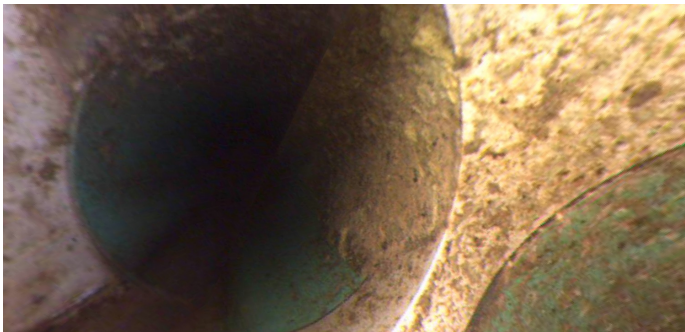
Code:	TF
Description:	Tap Factory

Distance (ft):	48.1
Structural Grade:	0
O&M Grade:	0
Clock Start/From:	10
Clock To:	
1st Value:	4.000
2nd Value:	
Value Percent:	
Continuous Index:	
Within 8" of Joint:	
Remarks:

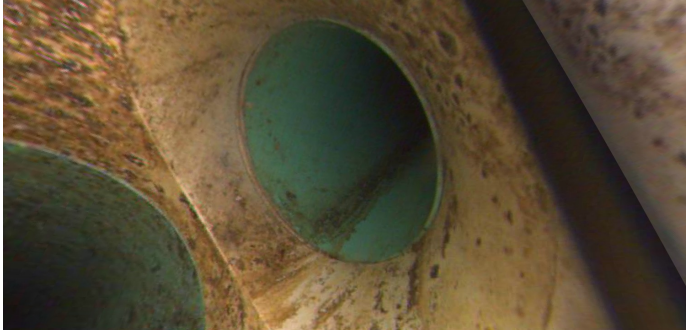
Code: **TF**
Description: **Tap Factory**

Distance (ft): **108.9**
Structural Grade: **0**
O&M Grade: **0**
Clock Start/From: **2**
Clock To:
1st Value: **4.000**
2nd Value:
Value Percent:
Continuous Index:
Within 8" of Joint:
Remarks:

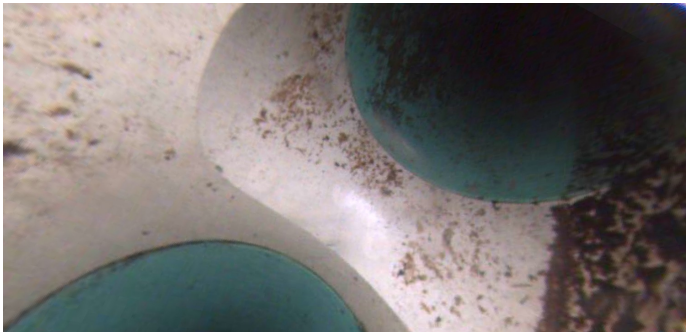
Code: **TF**
Description: **Tap Factory**

Distance (ft): **230.7**
Structural Grade: **0**
O&M Grade: **0**
Clock Start/From: **11**
Clock To:
1st Value: **4.000**
2nd Value:
Value Percent:
Continuous Index:
Within 8" of Joint:
Remarks:

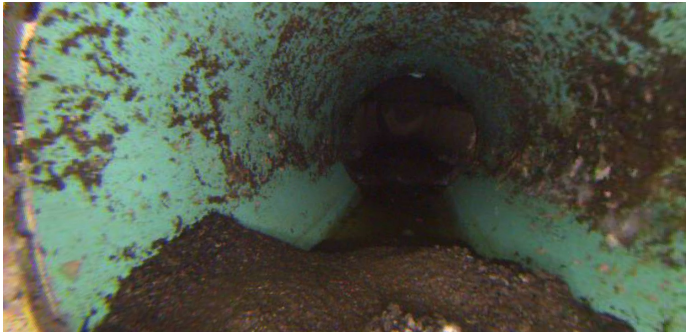
Code: **DSF**
Description: **Deposits Settled Fine**

Distance (ft): **230.7**
Structural Grade: **0**
O&M Grade: **3**
Clock Start/From: **4**
Clock To: **8**
1st Value:
2nd Value:
Value Percent: **20.000**
Continuous Index:
Within 8" of Joint: **NO**
Remarks:

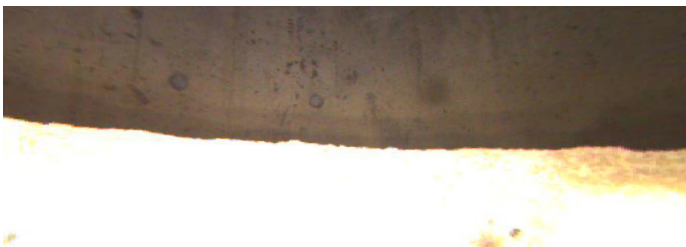
Code: **AMH**
Description: **Manhole**

Distance (ft): **234.1**
Structural Grade: **0**
O&M Grade: **0**
Clock Start/From:
Clock To:
1st Value:
2nd Value:
Value Percent:
Continuous Index:
Within 8" of Joint: **NO**
Remarks: **M-902-082**
