Profile/Photo Observation Report

Street:	East 38th Avenue	Flow Control:	
City:	Hobart, IN	Year Renewed:	
Location:	Sidewalk	Tape/Media #:	816
Purpose:	Routine Assessment	Dia/Height:	10"
Use:	Sanitary	Material:	PVC
Drain Area:		Lining:	
Category:	NA		
Comment:

Location Details:		Direction of Survey:	Upstream
US MH:	M-903-4	DS MH:	M-903-5
		Total Length Surveyed (ft):	199.3

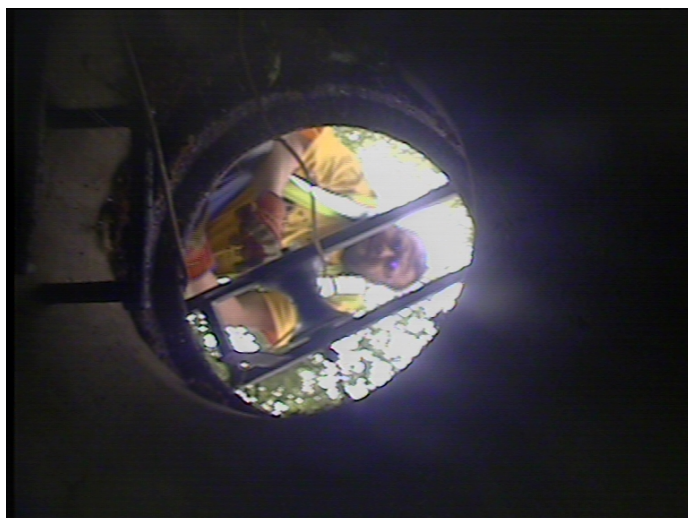
Code: **AMH**
Description: **Manhole**

Distance (ft): **.0**
Structural Grade: **0**
O&M Grade: **0**
Clock Start/From:
Clock To:
1st Value:
2nd Value:
Value Percent:
Continuous Index:
Within 8" of Joint: **NO**
Remarks: **M-903-5**

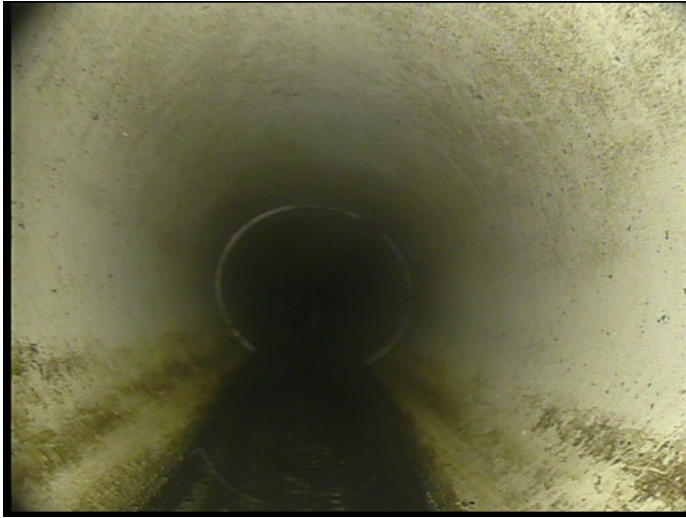
Code: **MWL**
Description: **Water Level**

Distance (ft): **.0**
Structural Grade: **0**
O&M Grade: **0**
Clock Start/From:
Clock To:
1st Value:
2nd Value:
Value Percent: **5.000**
Continuous Index:
Within 8" of Joint: **NO**
Remarks:

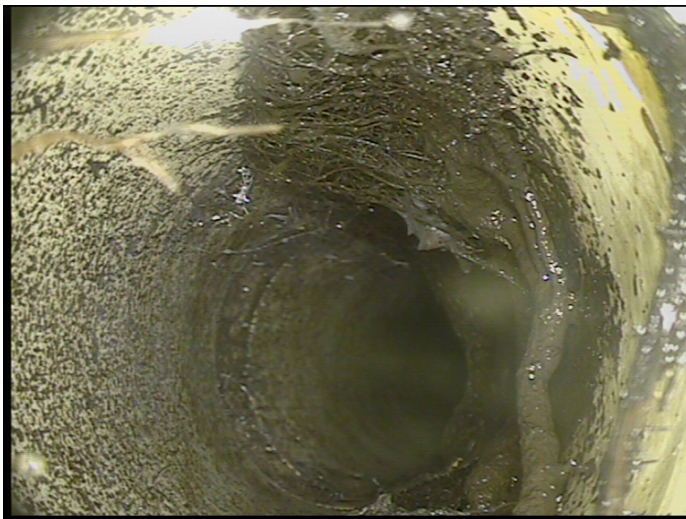
Code: **TFD**
Description: **Tap Factory Defective**

Distance (ft): **24.6**
Structural Grade: **0**
O&M Grade: **2**
Clock Start/From: **3**
Clock To:
1st Value: **4.000**
2nd Value:
Value Percent:
Continuous Index:
Within 8" of Joint: **NO**
Remarks: **roots**

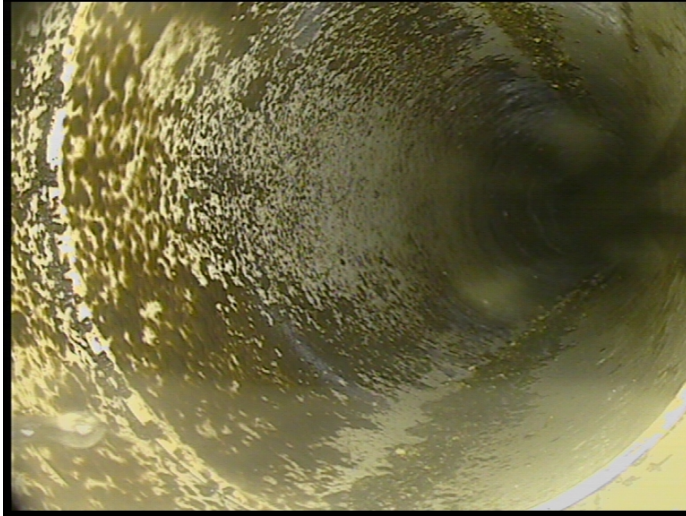
Code: **TF**
Description: **Tap Factory**

Distance (ft): **103.4**
Structural Grade: **0**
O&M Grade: **0**
Clock Start/From: **3**
Clock To:
1st Value: **4.000**
2nd Value:
Value Percent:
Continuous Index:
Within 8" of Joint: **NO**
Remarks:

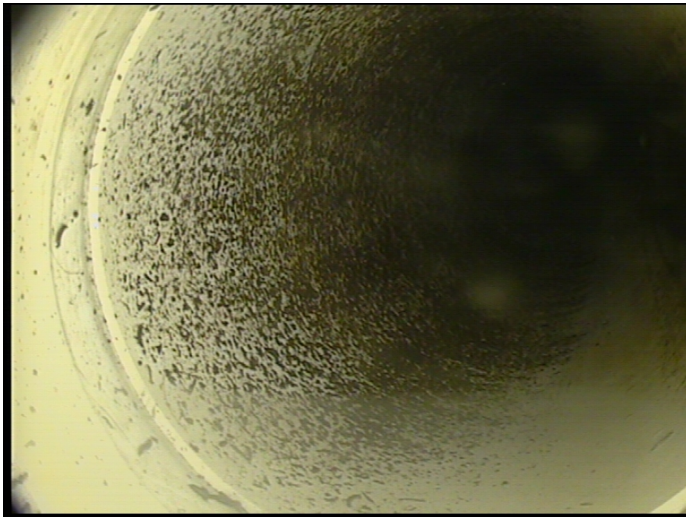
Code: **TF**
Description: **Tap Factory**

Distance (ft): **118.8**
Structural Grade: **0**
O&M Grade: **0**
Clock Start/From: **3**
Clock To:
1st Value: **4.000**
2nd Value:
Value Percent:
Continuous Index:
Within 8" of Joint: **NO**
Remarks:

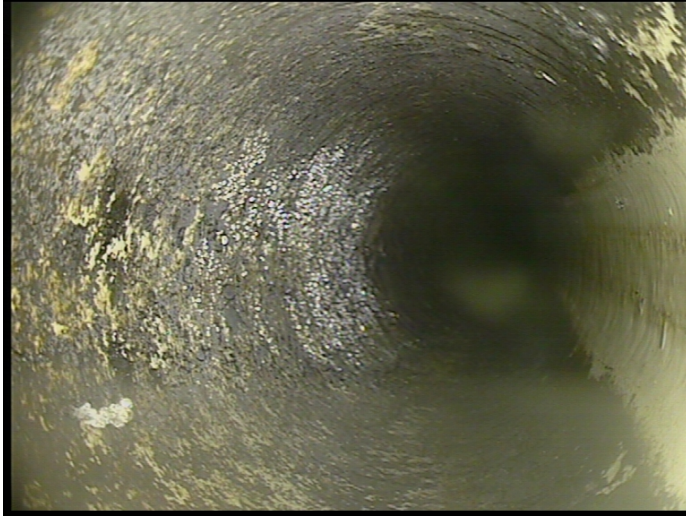
Code: **TF**
Description: **Tap Factory**

Distance (ft): **196.1**
Structural Grade: **0**
O&M Grade: **0**
Clock Start/From: **3**
Clock To:
1st Value: **4.000**
2nd Value:
Value Percent:
Continuous Index:
Within 8" of Joint: **NO**
Remarks:

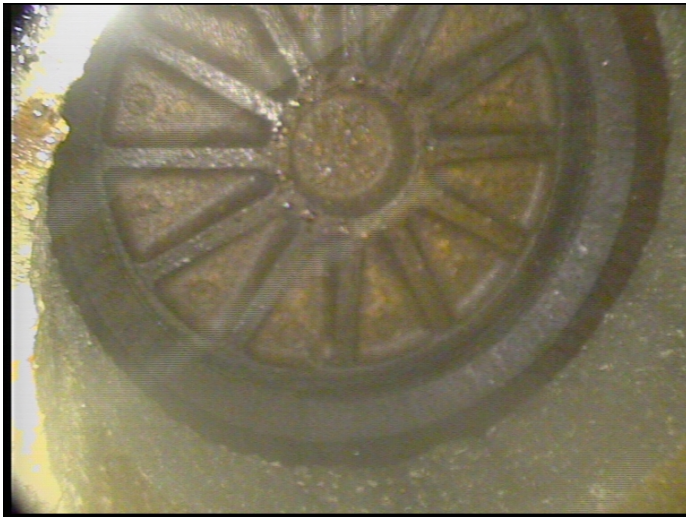
Code: **AMH**
Description: **Manhole**

Distance (ft): **199.3**
Structural Grade: **0**
O&M Grade: **0**
Clock Start/From:
Clock To:
1st Value:
2nd Value:
Value Percent:
Continuous Index:
Within 8" of Joint: **NO**
Remarks: **M-903-4**
