## Profile/Photo Observation Report

Street:	<b>E 38TH AVE &amp; SPENCER PL</b>	Flow Control:	<b>Not Controlled</b>
City:	<b>Hobart, IN</b>	Year Renewed:	
Location:	<b>Other</b>	Tape/Media #:	
Purpose:	<b>Not Known</b>	Dia/Height:	<b>10"</b>
Use:	<b>Sanitary</b>	Material:	<b>PVC</b>
Drain Area:	<b>NA</b>	Lining:	
Category:	<b>NA</b>		
Comment:

Location Details:		Direction of Survey:	<b>Downstream</b>
US MH:	<b>M-903-006</b>	DS MH:	<b>M-903-007</b>
		Total Length Surveyed (ft):	<b>1.1</b>

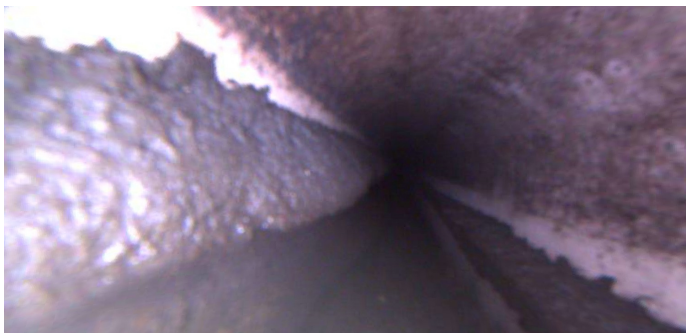
Code: **AMH**  
Description: **Manhole**

Distance (ft): **.0**  
Structural Grade: **0**  
O&M Grade: **0**  
Clock Start/From:  
Clock To:  
1st Value:  
2nd Value:  
Value Percent:  
Continuous Index:  
Within 8" of Joint: **NO**  
Remarks: **M-903-006**

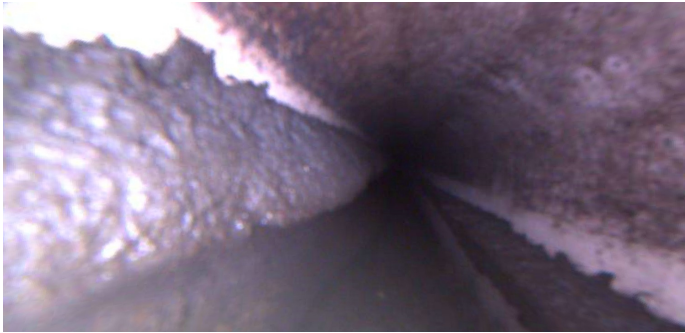
Code:	<b>MWL</b>
Description:	<b>Water Level</b>

Distance (ft):	<b>.0</b>
Structural Grade:	<b>0</b>
O&M Grade:	<b>0</b>
Clock Start/From:	
Clock To:	
1st Value:	
2nd Value:	
Value Percent:	<b>10.000</b>
Continuous Index:	
Within 8" of Joint:	<b>NO</b>
Remarks:

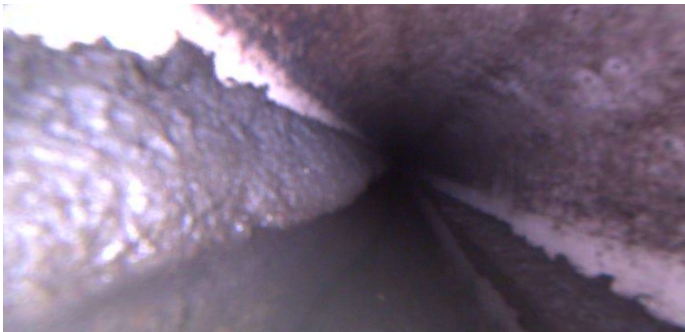
Code:	<b>DAGS</b>
Description:	<b>Deposits Attached Grease</b>

Distance (ft):	<b>.0</b>
Structural Grade:	<b>0</b>
O&M Grade:	<b>3</b>
Clock Start/From:	<b>8</b>
Clock To:	<b>4</b>
1st Value:	
2nd Value:	
Value Percent:	<b>20.000</b>
Continuous Index:	
Within 8" of Joint:	<b>NO</b>
Remarks:

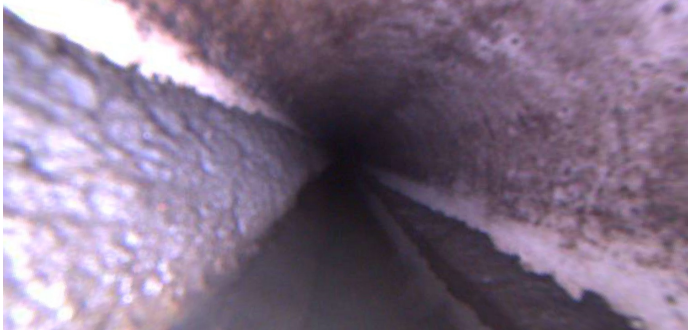
Code:	<b>MSA</b>
Description:	<b>Abandoned Survey</b>
Distance (ft):	<b>1.1</b>
Structural Grade:	<b>0</b>
O&M Grade:	<b>0</b>
Clock Start/From:	
Clock To:	
1st Value:	
2nd Value:	
Value Percent:	
Continuous Index:	
Within 8" of Joint:	<b>NO</b>
Remarks:	<b>DAGS</b>
