Profile/Photo Observation Report

Date:	06/12/2023	Weather:		Coding:	PACP 7.0
Pipe Length (ft):	47.1	Owner:	City of Hobart	Pre Clean:	Heavy Cleaning
P.O.#:	YES502259	Surveyor:	S. Bucklin	PSR:	P-903-007-006
Customer:	City of Hobart	Clean Date:	06/11/2023	Shape:	C

Street:	East 38th Avenue	Flow Control:	Not Controlled
City:	Hobart, IN	Year Renewed:	
Location:	Easement/Right of Way	Tape/Media #:	
Purpose:	Routine Assessment	Dia/Height:	12"
Use:	Sanitary Sewage Pipe	Material:	PVC
Drain Area:		Lining:	None
Category:	NA		
Comment:			
Location Details:		Direction of Survey:	Upstream
US MH:	M-903-006	DS MH:	M-903-007
		Total Length Surveyed (ft):	47.1

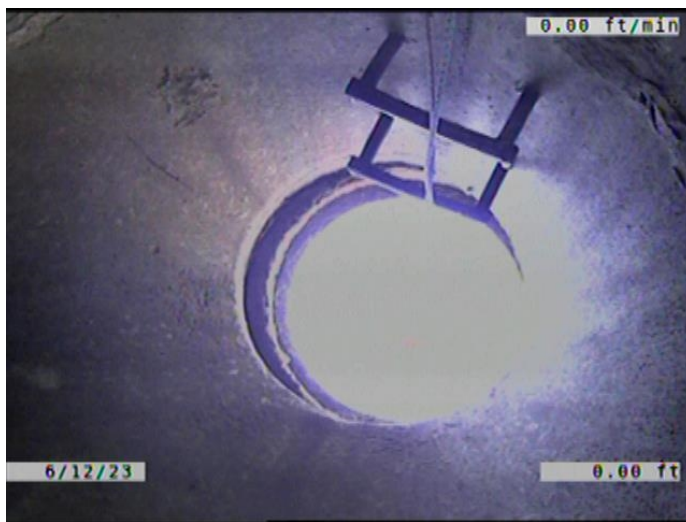
Code: **AMH**
Description: **Manhole**

Distance (ft): **.0**
Structural Grade: **0**
O&M Grade: **0**
Clock Start/From:
Clock To:
1st Value:
2nd Value:
Value Percent:
Continuous Index:
Within 8" of Joint: **NO**
Remarks: **M-903-007**

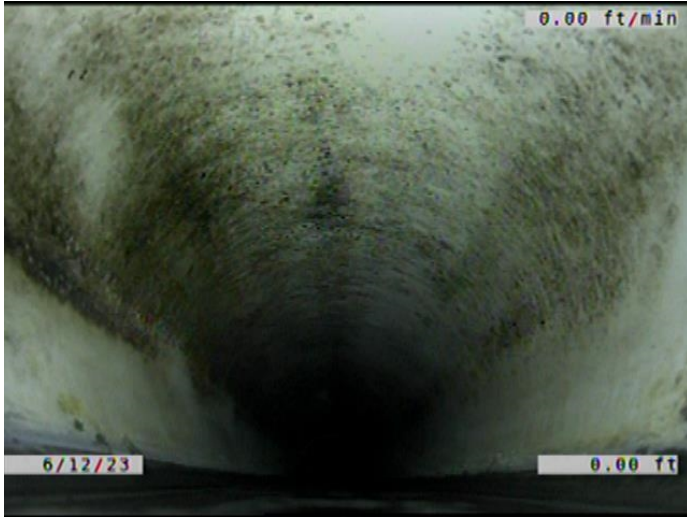
Code: **MWL**
Description: **Miscellaneous Water Level**

Distance (ft): **.0**
Structural Grade: **0**
O&M Grade: **0**
Clock Start/From:
Clock To:
1st Value:
2nd Value:
Value Percent: **20.000**
Continuous Index:
Within 8" of Joint: **NO**
Remarks:

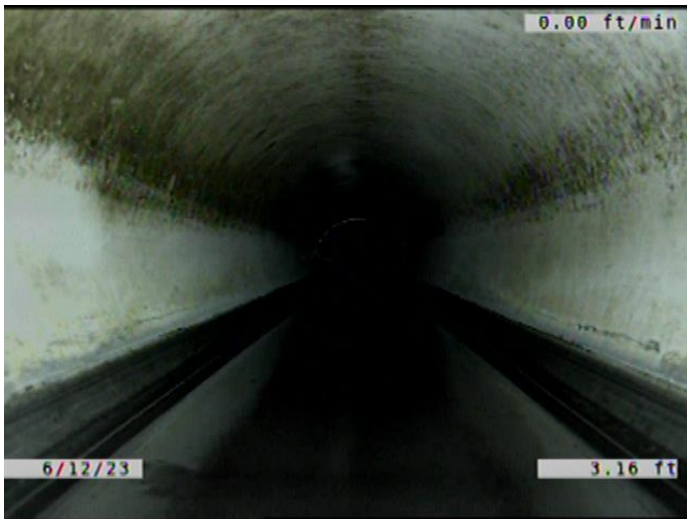
Code: **MWLS**
Description: **Miscellaneous Water Level Sag**

Distance (ft): **3.2**
Structural Grade: **2**
O&M Grade: **0**
Clock Start/From:
Clock To:
1st Value:
2nd Value:
Value Percent: **20.000**
Continuous Index: **S01**
Within 8" of Joint: **NO**
Remarks:

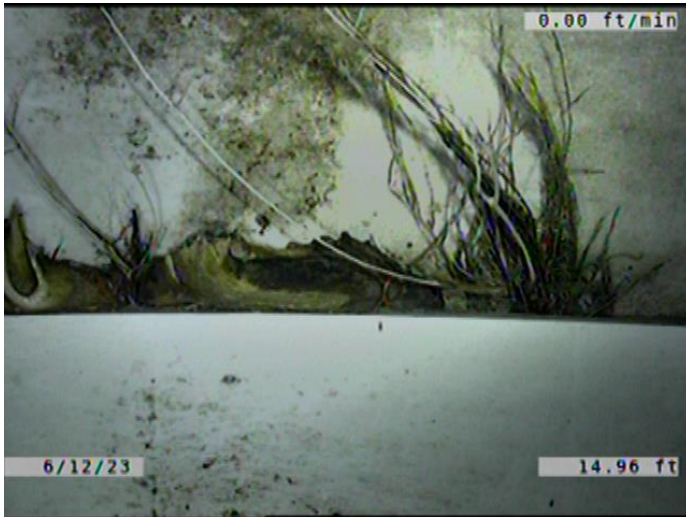
Code: **RFJ**
Description: **Roots Fine Joint**

Distance (ft): **15.0**
Structural Grade: **0**
O&M Grade: **1**
Clock Start/From: **8**
Clock To: **4**
1st Value:
2nd Value:
Value Percent:
Continuous Index:
Within 8" of Joint: **YES**
Remarks:

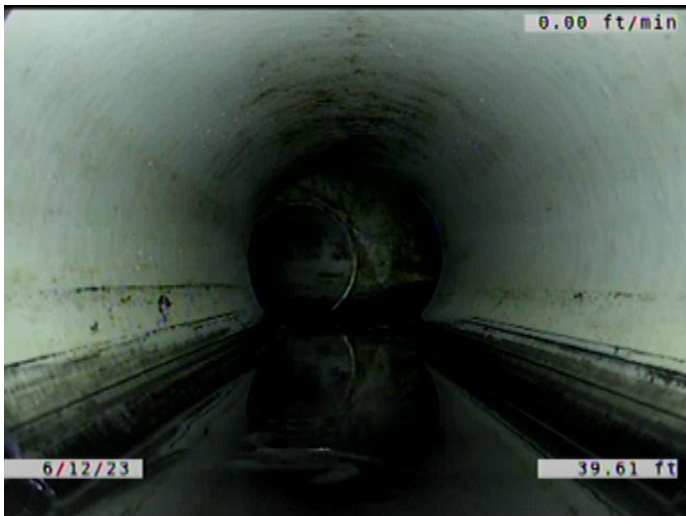
Code: **MWLS**
Description: **Miscellaneous Water Level Sag**

Distance (ft): **39.6**
Structural Grade: **2**
O&M Grade: **0**
Clock Start/From:
Clock To:
1st Value:
2nd Value:
Value Percent: **20.000**
Continuous Index: **F01**
Within 8" of Joint: **NO**
Remarks:

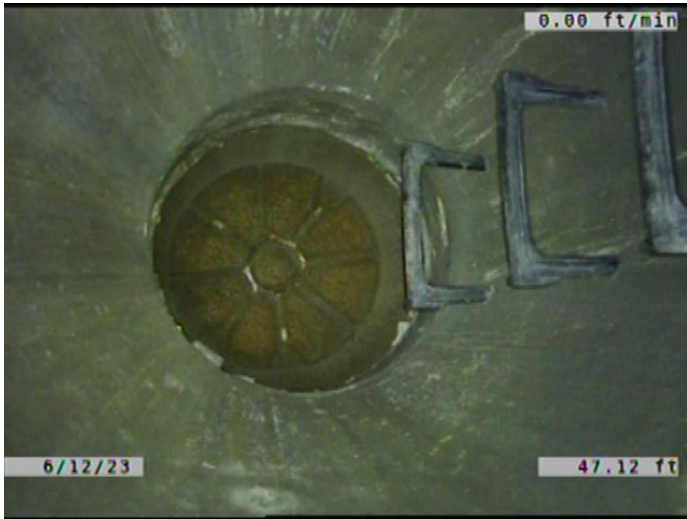
Code:	AMH
Description:	Manhole
Distance (ft):	47.1
Structural Grade:	0
O&M Grade:	0
Clock Start/From:	
Clock To:	
1st Value:	
2nd Value:	
Value Percent:	
Continuous Index:	
Within 8" of Joint:	NO
Remarks:	M-903-006
