## Profile/Photo Observation Report

Street:	<b>e 38th ave</b>	Flow Control:	<b>Not Controlled</b>
City:	<b>Hobart, IN</b>	Year Renewed:	
Location:	<b>Other</b>	Tape/Media #:	
Purpose:	<b>Not Known</b>	Dia/Height:	<b>10"</b>
Use:	<b>Sanitary</b>	Material:	<b>VCP</b>
Drain Area:	<b>NA</b>	Lining:	
Category:	<b>NA</b>		
Comment:

Location Details:		Direction of Survey:	<b>Downstream</b>
US MH:	<b>M-903-006</b>	DS MH:	<b>M-903-011</b>
		Total Length Surveyed (ft):	<b>4.7</b>

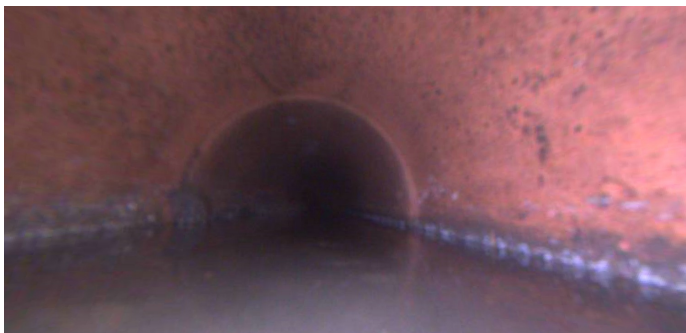
Code: **AMH**  
Description: **Manhole**

Distance (ft): **.0**  
Structural Grade: **0**  
O&M Grade: **0**  
Clock Start/From:  
Clock To:  
1st Value:  
2nd Value:  
Value Percent:  
Continuous Index:  
Within 8" of Joint: **NO**  
Remarks: **M-903-006**

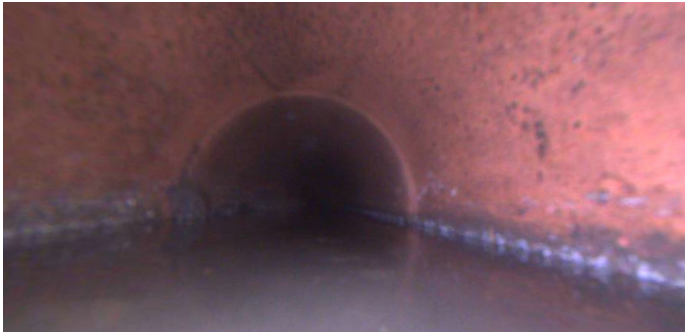
Code:	<b>MWL</b>
Description:	<b>Water Level</b>

Distance (ft):	<b>.0</b>
Structural Grade:	<b>0</b>
O&M Grade:	<b>0</b>
Clock Start/From:	
Clock To:	
1st Value:	
2nd Value:	
Value Percent:	<b>40.000</b>
Continuous Index:	
Within 8" of Joint:	<b>NO</b>
Remarks:

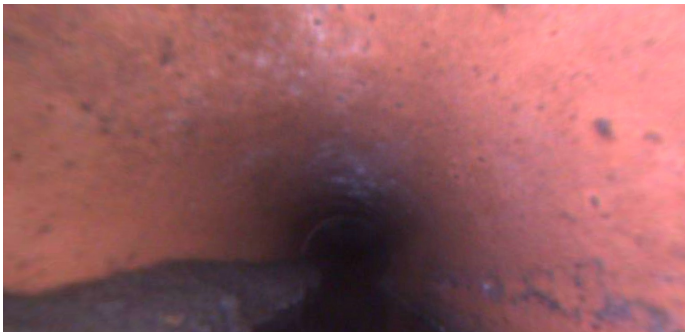
Code:	<b>DAZ</b>
Description:	<b>Deposits Attached Other</b>

Distance (ft):	<b>4.7</b>
Structural Grade:	<b>0</b>
O&M Grade:	<b>2</b>
Clock Start/From:	<b>7</b>
Clock To:	<b>9</b>
1st Value:	
2nd Value:	
Value Percent:	<b>10.000</b>
Continuous Index:	
Within 8" of Joint:	<b>NO</b>
Remarks:

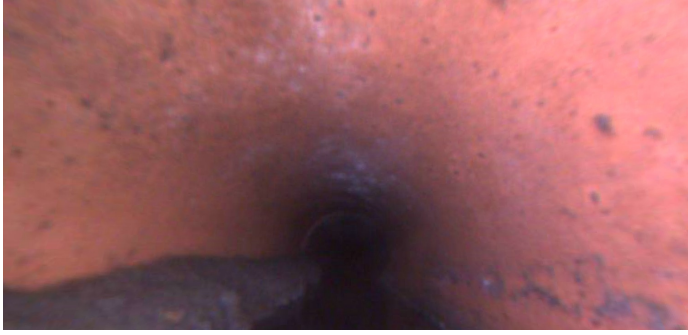
Code:	<b>MSA</b>
Description:	<b>Abandoned Survey</b>
Distance (ft):	<b>4.7</b>
Structural Grade:	<b>0</b>
O&M Grade:	<b>0</b>
Clock Start/From:	
Clock To:	
1st Value:	
2nd Value:	
Value Percent:	
Continuous Index:	
Within 8" of Joint:	<b>NO</b>
Remarks:	<b>daz</b>
