Profile/Photo Observation Report

Date:	03/23/2018	Weather:		Coding:	PACP 6.0
Pipe Length (ft):	320.2	Owner:	NA	Pre Clean:	Not Known
P.O.#:		Surveyor:	Jen Costello	PSR:	P-903-006-011
Customer:		Clean Date:	01/01/1900	Shape:	C

Street:	e 38th pl	Flow Control:	Not Controlled
City:	Hobart, IN	Year Renewed:	
Location:	Other	Tape/Media #:	
Purpose:	Not Known	Dia/Height:	10"
Use:	Sanitary	Material:	VCP
Drain Area:	NA	Lining:	
Category:	NA		
Comment:			
Location Details:		Direction of Survey:	Upstream
US MH:	M-903-006	DS MH:	M-903-011
		Total Length Surveyed (ft):	312.0

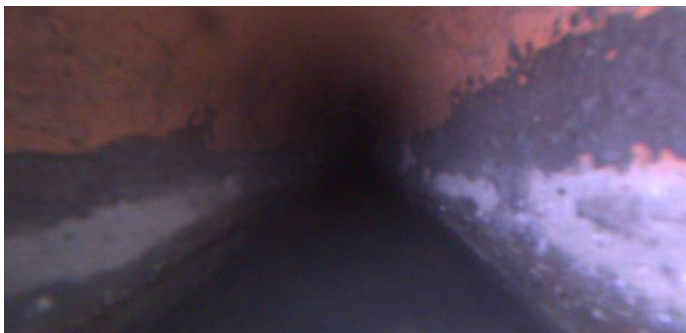
Code: **AMH**
Description: **Manhole**

Distance (ft): **.0**
Structural Grade: **0**
O&M Grade: **0**
Clock Start/From:
Clock To:
1st Value:
2nd Value:
Value Percent:
Continuous Index:
Within 8" of Joint: **NO**
Remarks: **M-903-011**

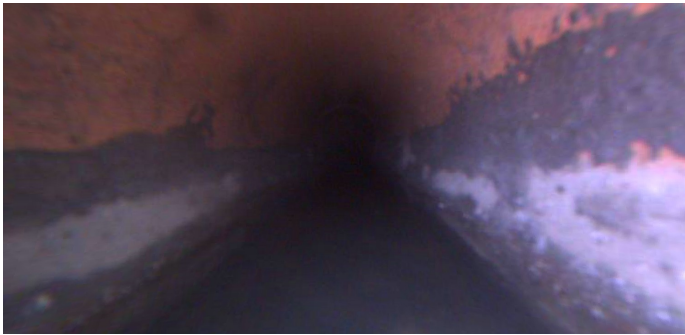
Code:	MWL
Description:	Water Level

Distance (ft):	.0
Structural Grade:	0
O&M Grade:	0
Clock Start/From:	
Clock To:	
1st Value:	
2nd Value:	
Value Percent:	30.000
Continuous Index:	
Within 8" of Joint:	NO
Remarks:

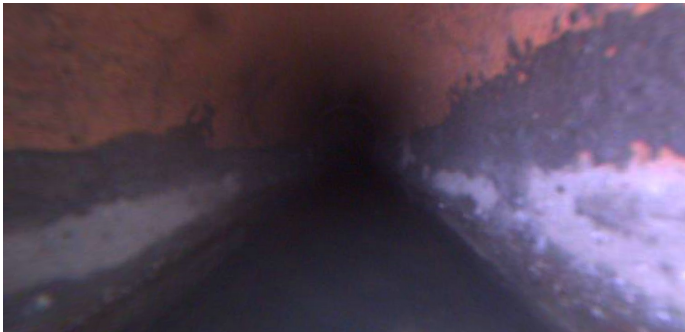
Code:	DAGS
Description:	Deposits Attached Grease

Distance (ft):	.0
Structural Grade:	0
O&M Grade:	2
Clock Start/From:	8
Clock To:	4
1st Value:	
2nd Value:	
Value Percent:	5.000
Continuous Index:	S01
Within 8" of Joint:	NO
Remarks:

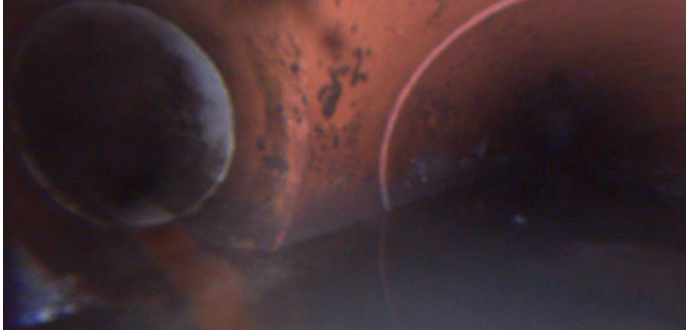
Code: **TFA**
Description: **Tap Factory Active**

Distance (ft): **36.5**
Structural Grade: **0**
O&M Grade: **0**
Clock Start/From: **9**
Clock To:
1st Value: **4.000**
2nd Value:
Value Percent:
Continuous Index:
Within 8" of Joint:
Remarks:

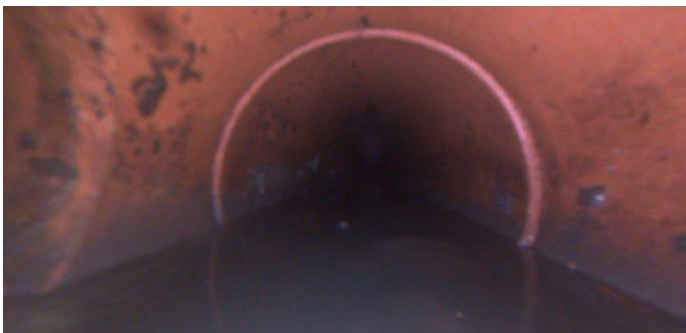
Code: **DAGS**
Description: **Deposits Attached Grease**

Distance (ft): **36.5**
Structural Grade: **0**
O&M Grade: **2**
Clock Start/From: **8**
Clock To: **4**
1st Value:
2nd Value:
Value Percent: **5.000**
Continuous Index: **F01**
Within 8" of Joint: **NO**
Remarks:

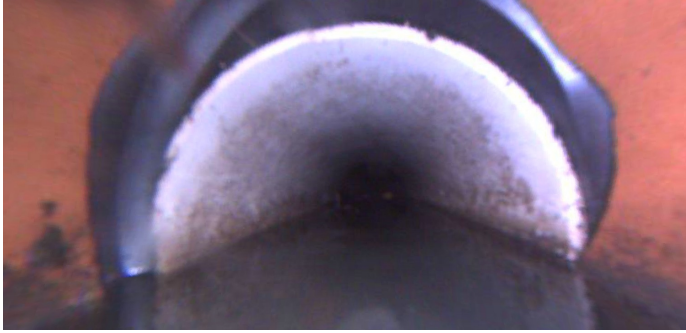
Code: **JOL**
Description: **Joint Offset Large**

Distance (ft): **57.6**
Structural Grade: **2**
O&M Grade: **0**
Clock Start/From:
Clock To:
1st Value:
2nd Value:
Value Percent:
Continuous Index:
Within 8" of Joint: **NO**
Remarks:

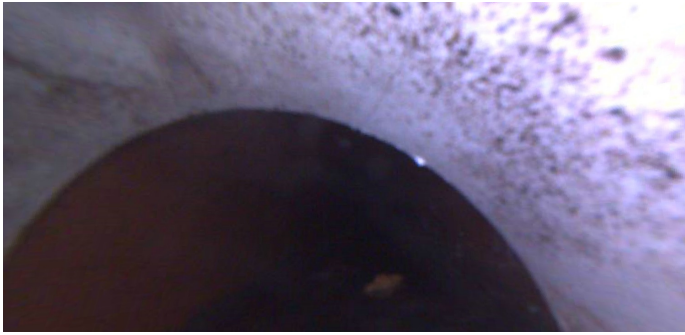
Code: **MMC**
Description: **Material Change**

Distance (ft): **61.0**
Structural Grade: **0**
O&M Grade: **0**
Clock Start/From:
Clock To:
1st Value:
2nd Value:
Value Percent:
Continuous Index:
Within 8" of Joint: **NO**
Remarks: **VCP**

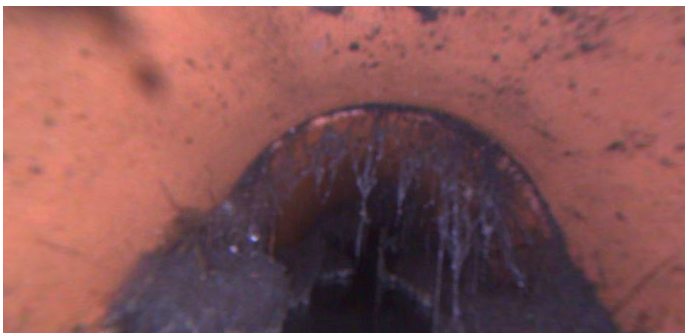
Code: **RMJ**
Description: **Roots Medium Joint**

Distance (ft): **72.1**
Structural Grade: **0**
O&M Grade: **3**
Clock Start/From: **8**
Clock To: **4**
1st Value:
2nd Value:
Value Percent: **20.000**
Continuous Index:
Within 8" of Joint: **YES**
Remarks:

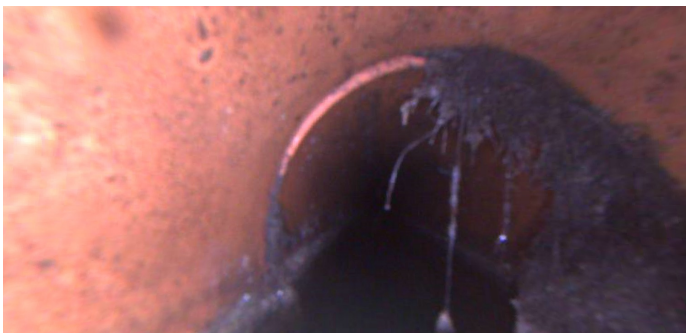
Code: **RMJ**
Description: **Roots Medium Joint**

Distance (ft): **79.9**
Structural Grade: **0**
O&M Grade: **3**
Clock Start/From: **8**
Clock To: **4**
1st Value:
2nd Value:
Value Percent: **20.000**
Continuous Index:
Within 8" of Joint: **YES**
Remarks:

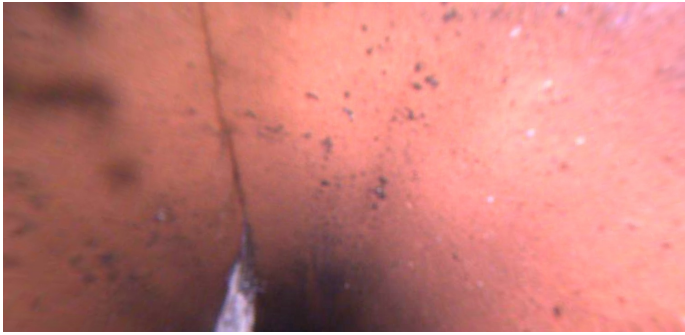
Code: **FL**
Description: **Fracture Longitudinal**

Distance (ft): **89.0**
Structural Grade: **3**
O&M Grade: **0**
Clock Start/From: **12**
Clock To:
1st Value:
2nd Value:
Value Percent:
Continuous Index:
Within 8" of Joint: **YES**
Remarks:

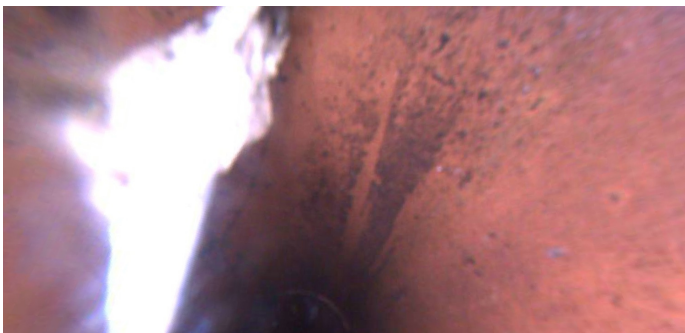
Code: **DAR**
Description: **Deposits Attached Ragging**

Distance (ft): **89.7**
Structural Grade: **0**
O&M Grade: **2**
Clock Start/From: **12**
Clock To:
1st Value:
2nd Value:
Value Percent: **10.000**
Continuous Index:
Within 8" of Joint: **NO**
Remarks:

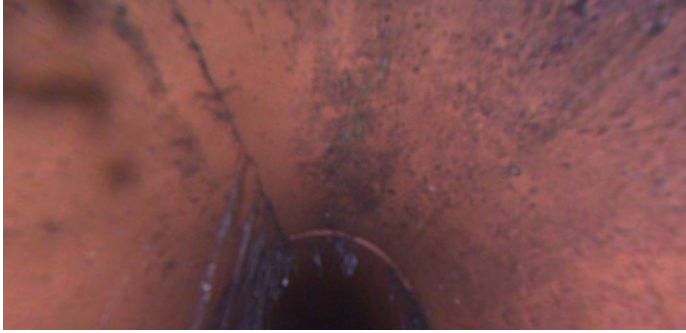
Code: **RFB**
Description: **Roots Fine Barrel**

Distance (ft): **91.0**
Structural Grade: **0**
O&M Grade: **2**
Clock Start/From: **12**
Clock To:
1st Value:
2nd Value:
Value Percent:
Continuous Index:
Within 8" of Joint: **NO**
Remarks:

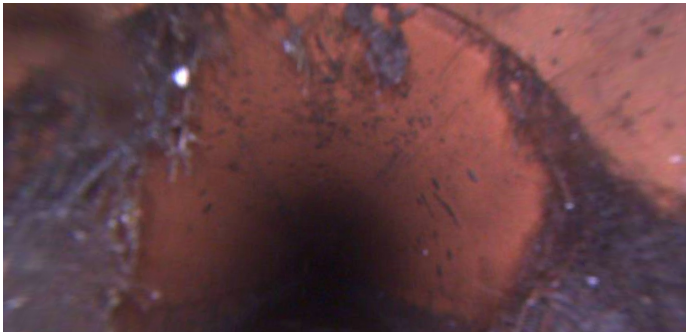
Code: **RMJ**
Description: **Roots Medium Joint**

Distance (ft): **92.0**
Structural Grade: **0**
O&M Grade: **3**
Clock Start/From: **8**
Clock To: **4**
1st Value:
2nd Value:
Value Percent: **20.000**
Continuous Index:
Within 8" of Joint: **YES**
Remarks:

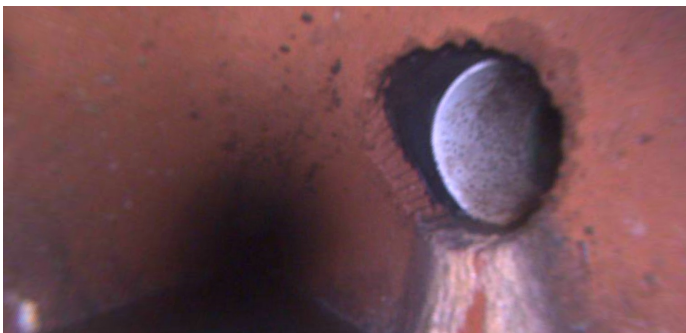
Code: **TBA**
Description: **Tap Break-in Active**

Distance (ft): **125.8**
Structural Grade: **0**
O&M Grade: **0**
Clock Start/From: **2**
Clock To:
1st Value: **4.000**
2nd Value:
Value Percent:
Continuous Index:
Within 8" of Joint:
Remarks:

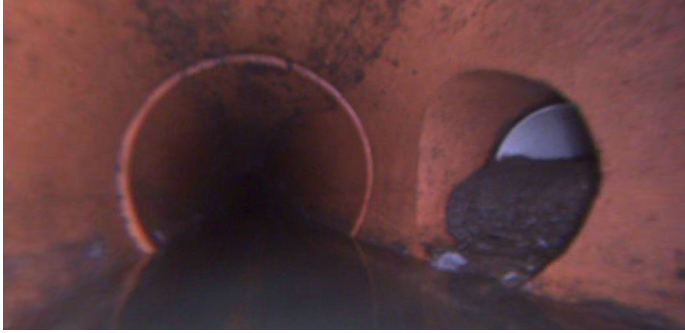
Code: **TF**
Description: **Tap Factory**

Distance (ft): **136.8**
Structural Grade: **0**
O&M Grade: **0**
Clock Start/From: **3**
Clock To:
1st Value: **4.000**
2nd Value:
Value Percent:
Continuous Index:
Within 8" of Joint:
Remarks:

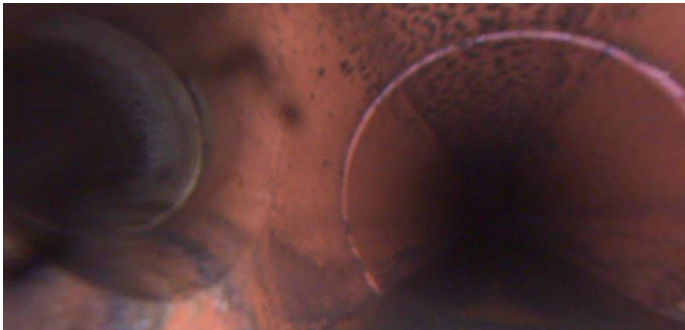
Code: **TFA**
Description: **Tap Factory Active**

Distance (ft): **156.8**
Structural Grade: **0**
O&M Grade: **0**
Clock Start/From: **9**
Clock To:
1st Value: **4.000**
2nd Value:
Value Percent:
Continuous Index:
Within 8" of Joint:
Remarks:

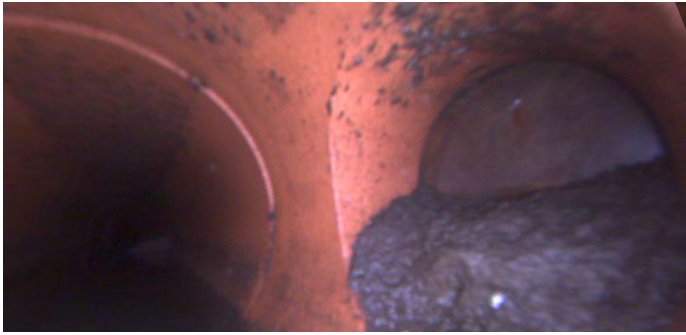
Code: **TFC**
Description: **Tap Factory Capped**

Distance (ft): **200.4**
Structural Grade: **0**
O&M Grade: **0**
Clock Start/From: **3**
Clock To:
1st Value: **4.000**
2nd Value:
Value Percent:
Continuous Index:
Within 8" of Joint:
Remarks:

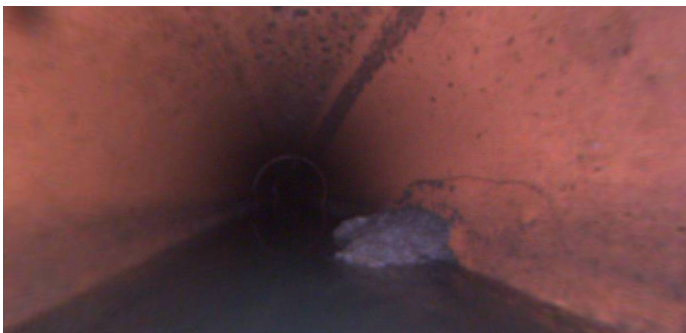
Code: **FL**
Description: **Fracture Longitudinal**

Distance (ft): **203.2**
Structural Grade: **3**
O&M Grade: **0**
Clock Start/From: **3**
Clock To:
1st Value:
2nd Value:
Value Percent:
Continuous Index:
Within 8" of Joint:
Remarks:

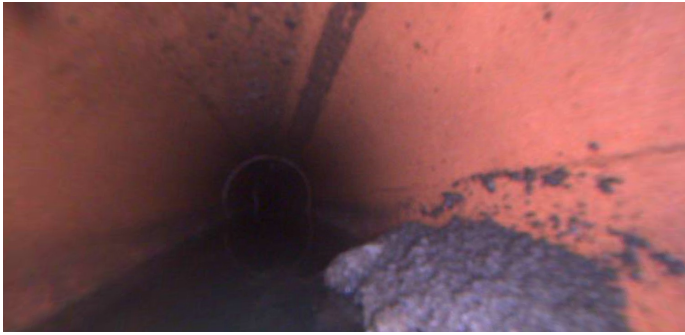
Code: **DAZ**
Description: **Deposits Attached Other**

Distance (ft): **203.8**
Structural Grade: **0**
O&M Grade: **2**
Clock Start/From: **3**
Clock To: **4**
1st Value:
2nd Value:
Value Percent: **10.000**
Continuous Index:
Within 8" of Joint: **NO**
Remarks:

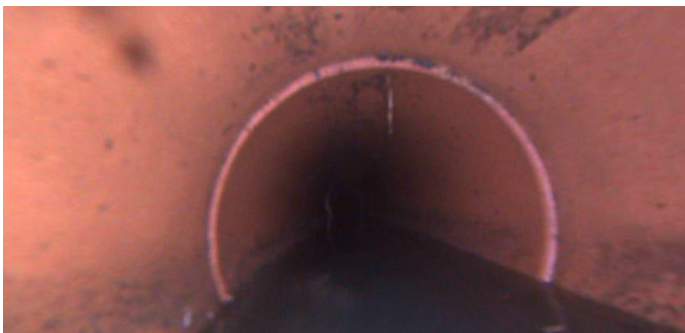
Code: **RFJ**
Description: **Roots Fine Joint**

Distance (ft): **206.5**
Structural Grade: **0**
O&M Grade: **1**
Clock Start/From: **12**
Clock To:
1st Value:
2nd Value:
Value Percent:
Continuous Index:
Within 8" of Joint: **YES**
Remarks:

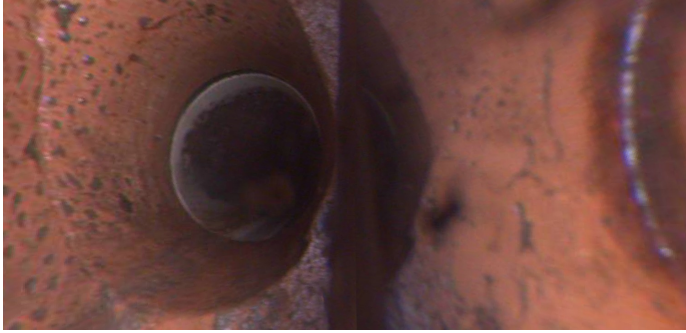
Code: **TF**
Description: **Tap Factory**

Distance (ft): **214.7**
Structural Grade: **0**
O&M Grade: **0**
Clock Start/From: **9**
Clock To:
1st Value: **4.000**
2nd Value:
Value Percent:
Continuous Index:
Within 8" of Joint:
Remarks:

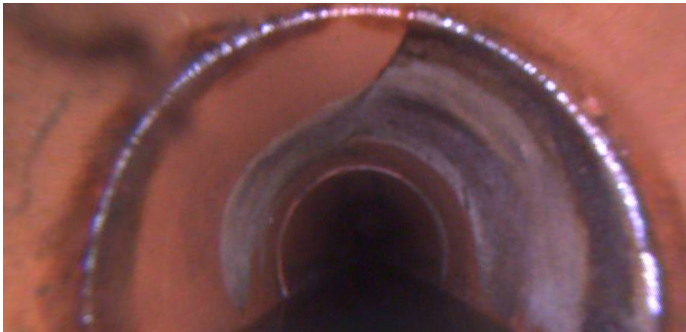
Code: **IW**
Description: **Infil Weeper**

Distance (ft): **214.7**
Structural Grade: **0**
O&M Grade: **2**
Clock Start/From: **8**
Clock To: **4**
1st Value:
2nd Value:
Value Percent:
Continuous Index:
Within 8" of Joint: **YES**
Remarks:

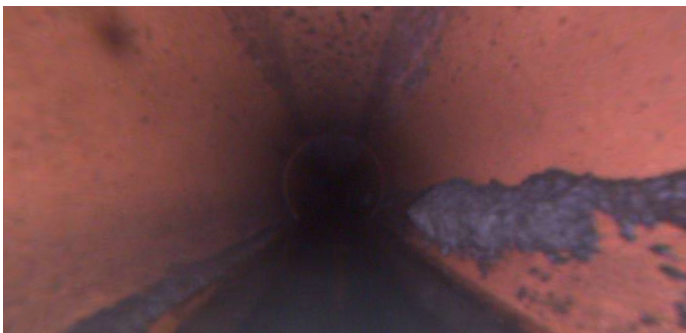
Code: **DAGS**
Description: **Deposits Attached Grease**

Distance (ft): **248.0**
Structural Grade: **0**
O&M Grade: **2**
Clock Start/From: **3**
Clock To: **4**
1st Value:
2nd Value:
Value Percent: **5.000**
Continuous Index: **S02**
Within 8" of Joint: **NO**
Remarks:

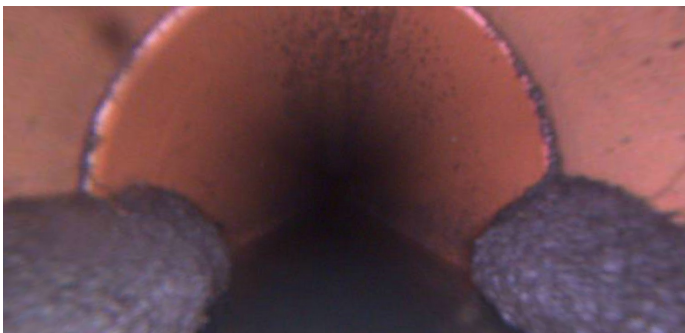
Code: **DAGS**
Description: **Deposits Attached Grease**

Distance (ft): **256.1**
Structural Grade: **0**
O&M Grade: **2**
Clock Start/From: **3**
Clock To: **4**
1st Value:
2nd Value:
Value Percent: **5.000**
Continuous Index: **F02**
Within 8" of Joint: **NO**
Remarks:

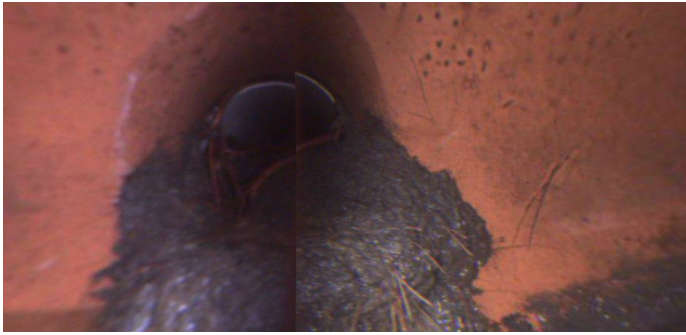
Code: **TFD**
Description: **Tap Factory Defective**

Distance (ft): **264.0**
Structural Grade: **0**
O&M Grade: **2**
Clock Start/From: **3**
Clock To:
1st Value: **4.000**
2nd Value:
Value Percent:
Continuous Index:
Within 8" of Joint:
Remarks: **RML**

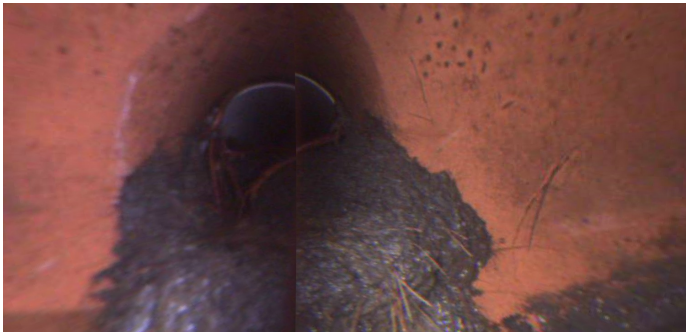
Code: **RML**
Description: **Roots Medium Lateral**

Distance (ft): **264.0**
Structural Grade: **0**
O&M Grade: **3**
Clock Start/From: **3**
Clock To: **4**
1st Value:
2nd Value:
Value Percent: **10.000**
Continuous Index:
Within 8" of Joint: **NO**
Remarks:

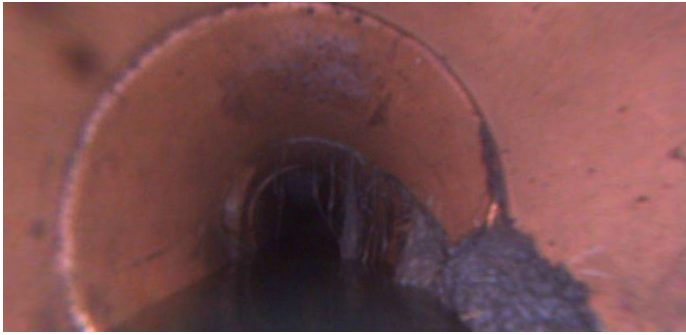
Code: **FM**
Description: **Fracture Multiple**

Distance (ft): **270.0**
Structural Grade: **4**
O&M Grade: **0**
Clock Start/From: **8**
Clock To: **2**
1st Value:
2nd Value:
Value Percent:
Continuous Index:
Within 8" of Joint: **YES**
Remarks:

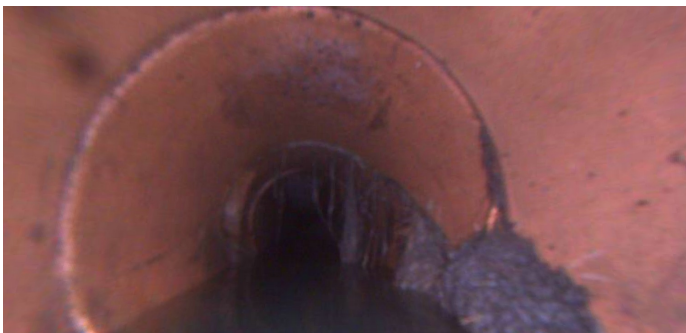
Code: **RMJ**
Description: **Roots Medium Joint**

Distance (ft): **270.0**
Structural Grade: **0**
O&M Grade: **3**
Clock Start/From: **3**
Clock To: **4**
1st Value:
2nd Value:
Value Percent: **5.000**
Continuous Index:
Within 8" of Joint: **YES**
Remarks:

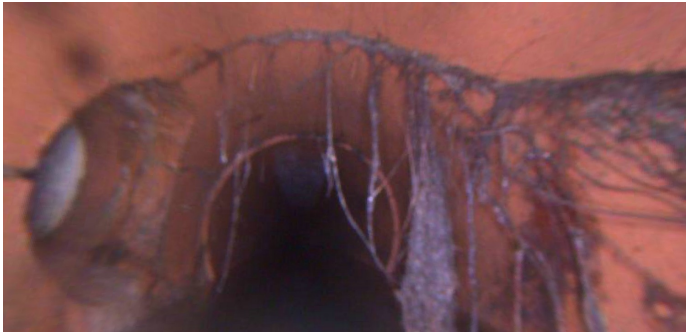
Code: **FS**
Description: **Fracture Spiral**

Distance (ft): **271.2**
Structural Grade: **3**
O&M Grade: **0**
Clock Start/From: **11**
Clock To: **4**
1st Value:
2nd Value:
Value Percent:
Continuous Index:
Within 8" of Joint:
Remarks:

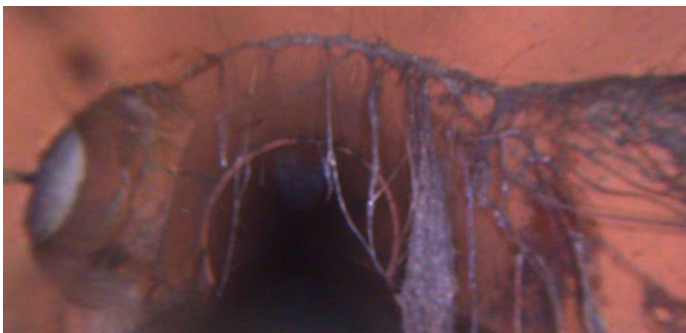
Code: **RMB**
Description: **Roots Medium Barrel**

Distance (ft): **271.2**
Structural Grade: **0**
O&M Grade: **4**
Clock Start/From: **11**
Clock To: **4**
1st Value:
2nd Value:
Value Percent: **10.000**
Continuous Index:
Within 8" of Joint: **NO**
Remarks:

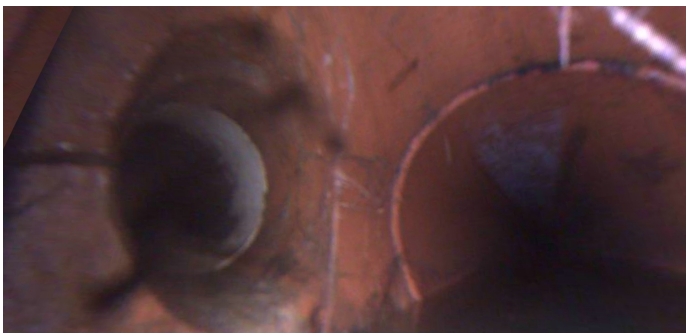
Code: **RFL**
Description: **Roots Fine Lateral**

Distance (ft): **271.6**
Structural Grade: **0**
O&M Grade: **1**
Clock Start/From: **8**
Clock To: **10**
1st Value:
2nd Value:
Value Percent:
Continuous Index:
Within 8" of Joint: **NO**
Remarks:

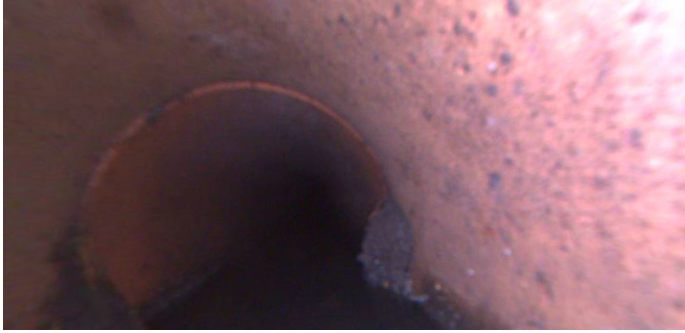
Code: **DAZ**
Description: **Deposits Attached Other**

Distance (ft): **295.6**
Structural Grade: **0**
O&M Grade: **2**
Clock Start/From: **8**
Clock To: **4**
1st Value:
2nd Value:
Value Percent: **5.000**
Continuous Index:
Within 8" of Joint: **YES**
Remarks:

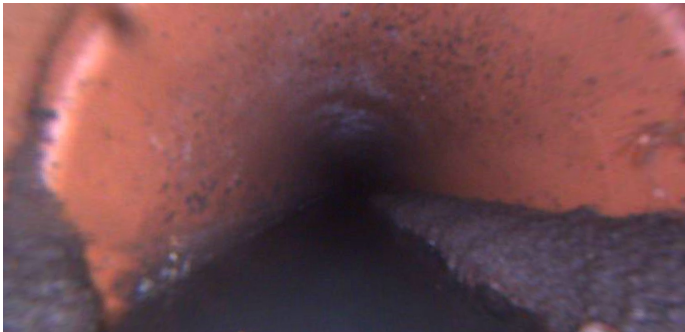
Code: **DAZ**
Description: **Deposits Attached Other**

Distance (ft): **302.0**
Structural Grade: **0**
O&M Grade: **2**
Clock Start/From: **7**
Clock To: **5**
1st Value:
2nd Value:
Value Percent: **10.000**
Continuous Index: **S03**
Within 8" of Joint: **NO**
Remarks:

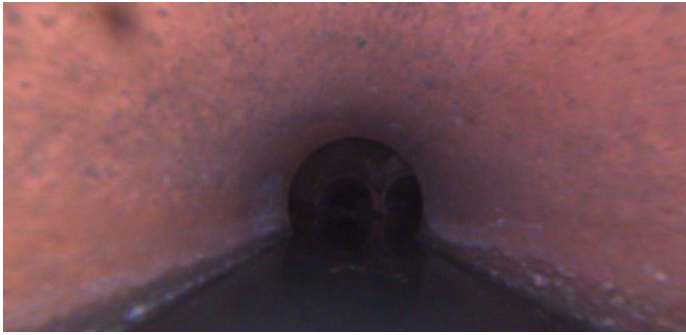
Code: **DAZ**
Description: **Deposits Attached Other**

Distance (ft): **309.3**
Structural Grade: **0**
O&M Grade: **2**
Clock Start/From: **7**
Clock To: **5**
1st Value:
2nd Value:
Value Percent: **10.000**
Continuous Index: **F03**
Within 8" of Joint: **NO**
Remarks:

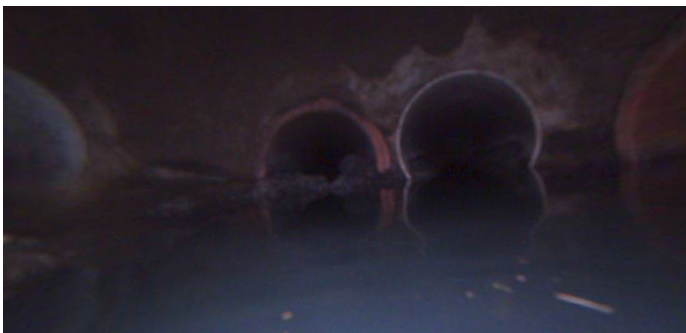
Code: **AMH**
Description: **Manhole**

Distance (ft): **312.0**
Structural Grade: **0**
O&M Grade: **0**
Clock Start/From:
Clock To:
1st Value:
2nd Value:
Value Percent:
Continuous Index:
Within 8" of Joint: **NO**
Remarks: **M-903-006**
