Profile/Photo Observation Report

Date:	03/23/2018	Weather:		Coding:	PACP 6.0
Pipe Length (ft):	145.1	Owner:	NA	Pre Clean:	Not Known
P.O.#:		Surveyor:	Jen Costello	PSR:	P-903-008-007
Customer:		Clean Date:	01/01/1900	Shape:	C

Street:	e 38th ave	Flow Control:	Not Controlled
City:	Hobart, IN	Year Renewed:	
Location:	Other	Tape/Media #:	
Purpose:	Not Known	Dia/Height:	10"
Use:	Sanitary	Material:	PVC
Drain Area:	NA	Lining:	
Category:	NA		
Comment:

Location Details:		Direction of Survey:	Downstream
US MH:	M-903-007	DS MH:	M-903-008
		Total Length Surveyed (ft):	5.4

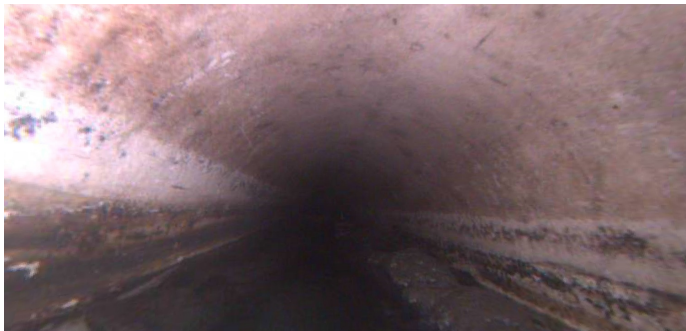
Code: **AMH**
Description: **Manhole**

Distance (ft): **.0**
Structural Grade: **0**
O&M Grade: **0**
Clock Start/From:
Clock To:
1st Value:
2nd Value:
Value Percent:
Continuous Index:
Within 8" of Joint: **NO**
Remarks: **M-903-007**

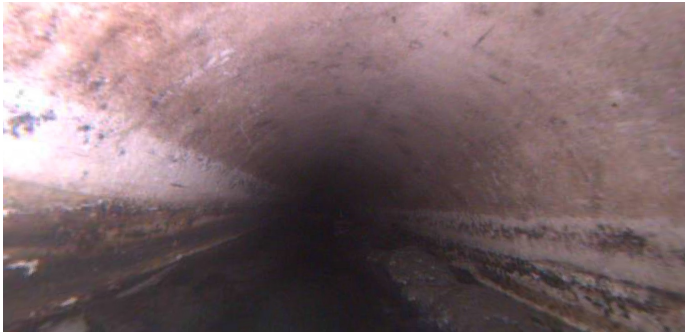
Code:	MWL
Description:	Water Level

Distance (ft):	.0
Structural Grade:	0
O&M Grade:	0
Clock Start/From:	
Clock To:	
1st Value:	
2nd Value:	
Value Percent:	30.000
Continuous Index:	
Within 8" of Joint:	NO
Remarks:

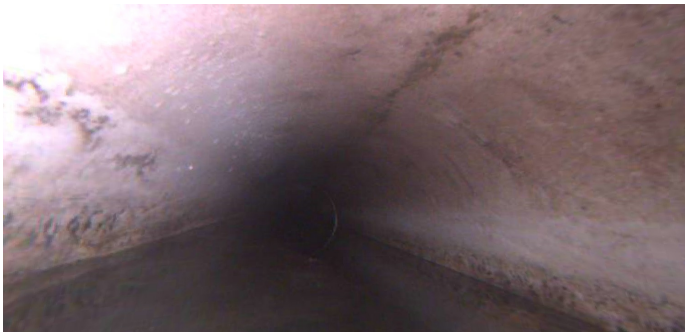
Code:	MSA
Description:	Abandoned Survey

Distance (ft):	5.4
Structural Grade:	0
O&M Grade:	0
Clock Start/From:	
Clock To:	
1st Value:	
2nd Value:	
Value Percent:	
Continuous Index:	
Within 8" of Joint:	NO
Remarks:	OVERTURNED
