Profile/Photo Observation Report

Street:	N UNION ST	Flow Control:	Not Controlled
City:	Hobart, IN	Year Renewed:	
Location:	Other	Tape/Media #:	
Purpose:	Not Known	Dia/Height:	10"
Use:	Sanitary	Material:	VCP
Drain Area:	NA	Lining:	
Category:	NA		
Comment:	NULL-REV-CNL M-902-062

Location Details:		Direction of Survey:	Upstream
US MH:	M-903-009	DS MH:	M-903-010
		Total Length Surveyed (ft):	122.0

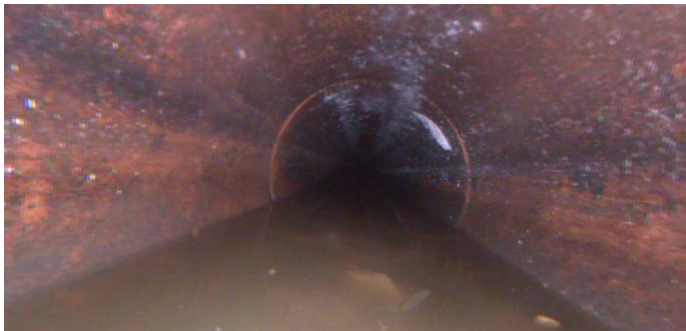
Code: **AMH**
Description: **Manhole**

Distance (ft): **.0**
Structural Grade: **0**
O&M Grade: **0**
Clock Start/From:
Clock To:
1st Value:
2nd Value:
Value Percent:
Continuous Index:
Within 8" of Joint: **NO**
Remarks: **M-903-009**

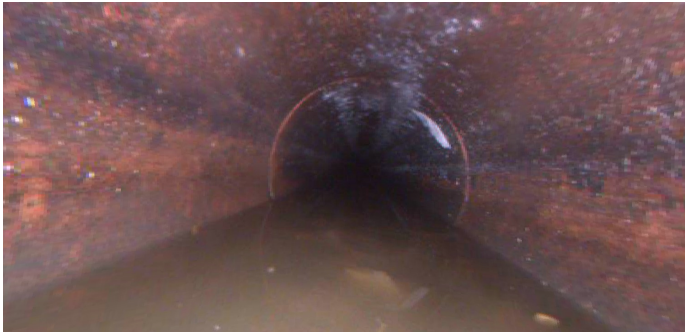
Code:	MWL
Description:	Water Level

Distance (ft):	.0
Structural Grade:	0
O&M Grade:	0
Clock Start/From:	
Clock To:	
1st Value:	
2nd Value:	
Value Percent:	5.000
Continuous Index:	
Within 8" of Joint:	NO
Remarks:

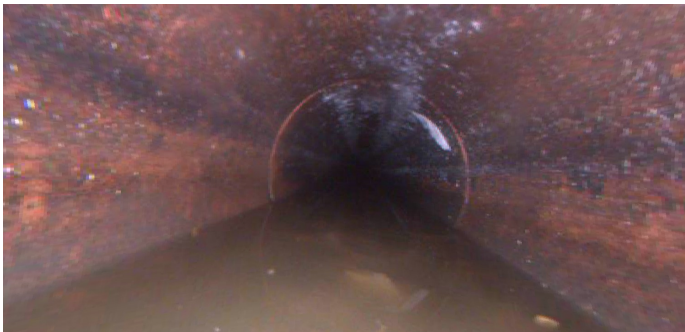
Code:	DAGS
Description:	Deposits Attached Grease

Distance (ft):	.0
Structural Grade:	0
O&M Grade:	2
Clock Start/From:	7
Clock To:	5
1st Value:	
2nd Value:	
Value Percent:	5.000
Continuous Index:	S01
Within 8" of Joint:	YES
Remarks:	WANDER

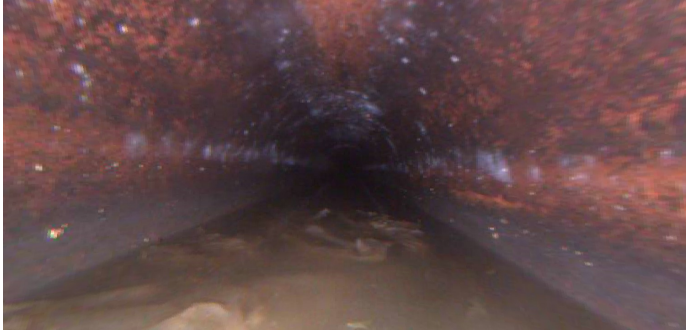
Code: **MGO**
Description: **General Observation**

Distance (ft): **8.3**
Structural Grade: **0**
O&M Grade: **0**
Clock Start/From:
Clock To:
1st Value:
2nd Value:
Value Percent:
Continuous Index:
Within 8" of Joint: **NO**
Remarks: **TOILET TISSUE**

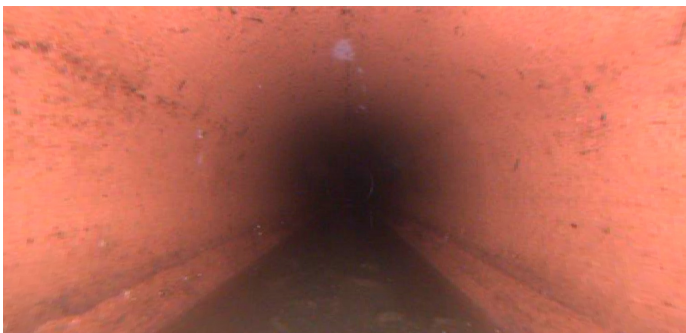
Code: **MSA**
Description: **Abandoned Survey**

Distance (ft): **122.0**
Structural Grade: **0**
O&M Grade: **0**
Clock Start/From:
Clock To:
1st Value:
2nd Value:
Value Percent:
Continuous Index:
Within 8" of Joint: **NO**
Remarks: **ROBOT HAS STOPPED**

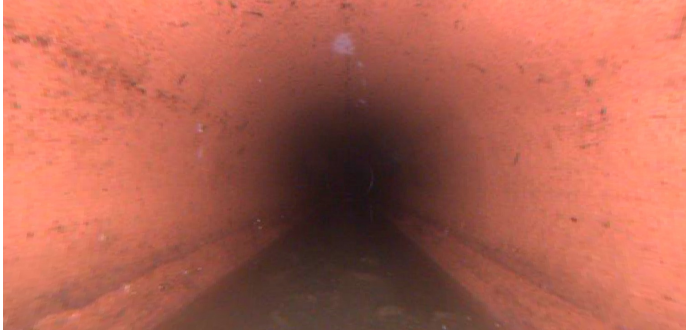
Code:	DAGS
Description:	Deposits Attached Grease
Distance (ft):	122.0
Structural Grade:	0
O&M Grade:	2
Clock Start/From:	7
Clock To:	5
1st Value:	
2nd Value:	
Value Percent:	5.000
Continuous Index:	F01
Within 8" of Joint:	YES
Remarks:	WANDER
