Profile/Photo Observation Report

Street:	SPENCER PL	Flow Control:	Not Controlled
City:	Hobart, IN	Year Renewed:	
Location:	Other	Tape/Media #:	
Purpose:	Not Known	Dia/Height:	12"
Use:	Sanitary	Material:	VCP
Drain Area:	NA	Lining:	
Category:	NA		
Comment:

Location Details:		Direction of Survey:	Upstream
US MH:	M-903-011	DS MH:	M-903-012
		Total Length Surveyed (ft):	13.9

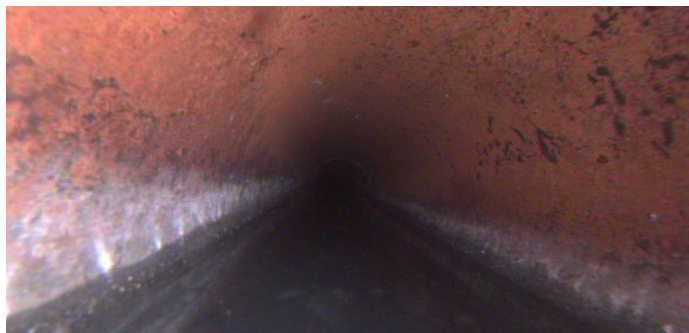
Code: **AMH**
 Description: **Manhole**
 Distance (ft): **.0**
 Structural Grade: **0**
 O&M Grade: **0**
 Clock Start/From:
 Clock To:
 1st Value:
 2nd Value:
 Value Percent:
 Continuous Index:
 Within 8" of Joint: **NO**
 Remarks: **M-903-012**

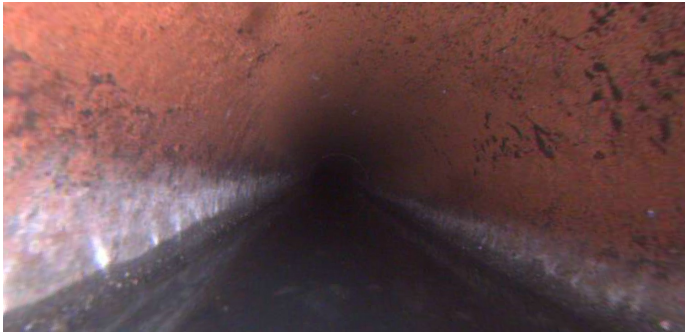
Code:	MWL
Description:	Water Level

Distance (ft):	.0
Structural Grade:	0
O&M Grade:	0
Clock Start/From:	
Clock To:	
1st Value:	
2nd Value:	
Value Percent:	20.000
Continuous Index:	
Within 8" of Joint:	NO
Remarks:

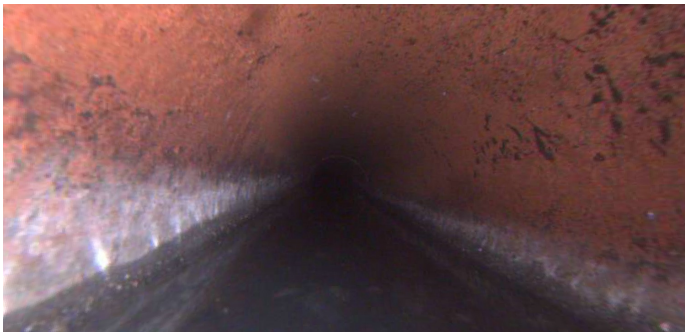
Code:	DAGS
Description:	Deposits Attached Grease

Distance (ft):	.0
Structural Grade:	0
O&M Grade:	2
Clock Start/From:	8
Clock To:	4
1st Value:	
2nd Value:	
Value Percent:	5.000
Continuous Index:	S01
Within 8" of Joint:	NO
Remarks:

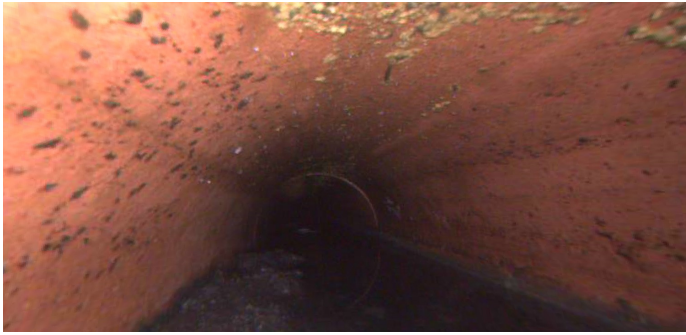
Code: **MSA**
Description: **Abandoned Survey**

Distance (ft): **13.9**
Structural Grade: **0**
O&M Grade: **0**
Clock Start/From:
Clock To:
1st Value:
2nd Value:
Value Percent:
Continuous Index:
Within 8" of Joint: **NO**
Remarks: **debris under water**

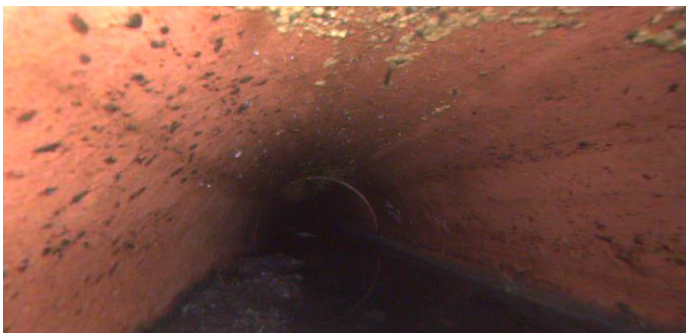
Code: **DAGS**
Description: **Deposits Attached Grease**

Distance (ft): **13.9**
Structural Grade: **0**
O&M Grade: **2**
Clock Start/From: **8**
Clock To: **4**
1st Value:
2nd Value:
Value Percent: **5.000**
Continuous Index: **F01**
Within 8" of Joint: **NO**
Remarks:
