Profile/Photo Observation Report

Street:	Rand St.	Flow Control:	Not Controlled
City:	Hobart, IN	Year Renewed:	
Location:	Other	Tape/Media #:	
Purpose:	Not Known	Dia/Height:	12"
Use:	Sanitary	Material:	VCP
Drain Area:	NA	Lining:	
Category:	NA		
Comment:

Location Details:		Direction of Survey:	Downstream
US MH:	M-903-012	DS MH:	M-903-015
		Total Length Surveyed (ft):	9.1

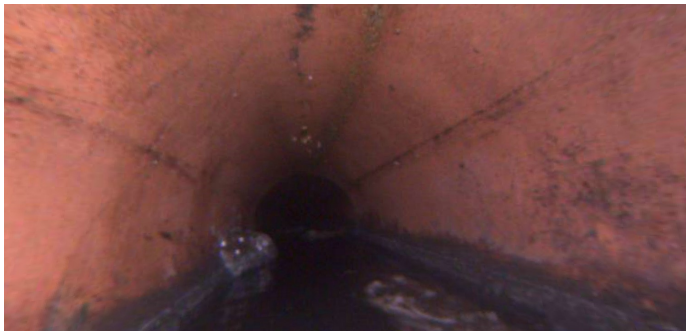
Code: **AMH**
Description: **Manhole**

Distance (ft): **.0**
Structural Grade: **0**
O&M Grade: **0**
Clock Start/From:
Clock To:
1st Value:
2nd Value:
Value Percent:
Continuous Index:
Within 8" of Joint: **NO**
Remarks: **M-903-012**

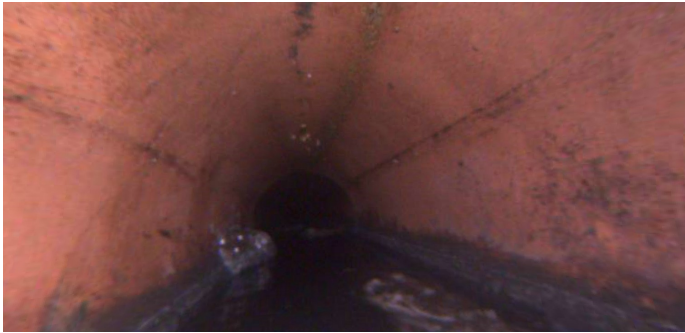
Code:	MWL
Description:	Water Level

Distance (ft):	.0
Structural Grade:	0
O&M Grade:	0
Clock Start/From:	
Clock To:	
1st Value:	
2nd Value:	
Value Percent:	20.000
Continuous Index:	
Within 8" of Joint:	NO
Remarks:

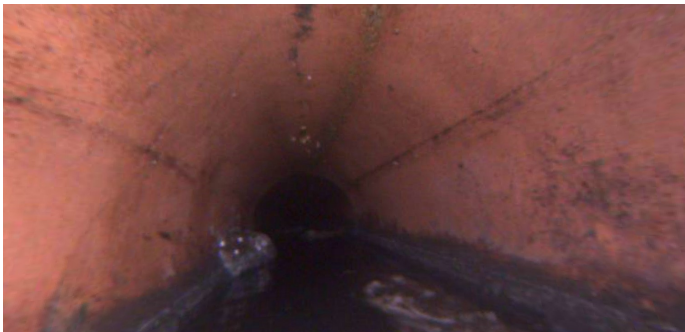
Code:	FC
Description:	Fracture Circumferential

Distance (ft):	.0
Structural Grade:	2
O&M Grade:	0
Clock Start/From:	8
Clock To:	9
1st Value:	
2nd Value:	
Value Percent:	
Continuous Index:	
Within 8" of Joint:	
Remarks:

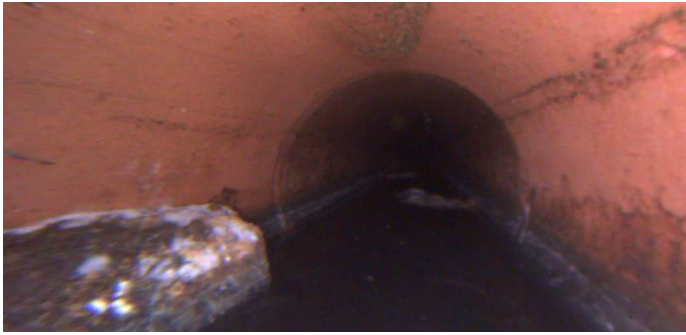
Code: **DAE**
Description: **Deposits Attached Encrustation**

Distance (ft): **2.8**
Structural Grade: **0**
O&M Grade: **2**
Clock Start/From: **7**
Clock To: **9**
1st Value:
2nd Value:
Value Percent: **10.000**
Continuous Index:
Within 8" of Joint: **NO**
Remarks:

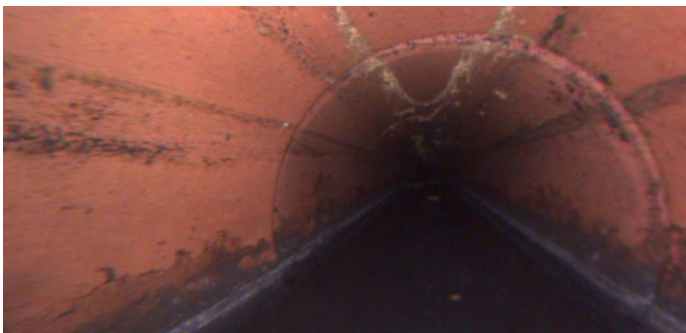
Code: **MSA**
Description: **Abandoned Survey**

Distance (ft): **9.1**
Structural Grade: **0**
O&M Grade: **0**
Clock Start/From:
Clock To:
1st Value:
2nd Value:
Value Percent:
Continuous Index:
Within 8" of Joint: **NO**
Remarks: **dae**
