Profile/Photo Observation Report

Street:	N SHELBY PL	Flow Control:	Not Controlled
City:	Hobart, IN	Year Renewed:	
Location:	Other	Tape/Media #:	
Purpose:	Not Known	Dia/Height:	8"
Use:	Sanitary	Material:	VCP
Drain Area:	NA	Lining:	
Category:	NA		
Comment:

Location Details:		Direction of Survey:	Downstream
US MH:	M-903-014	DS MH:	M-903-013
		Total Length Surveyed (ft):	190.1

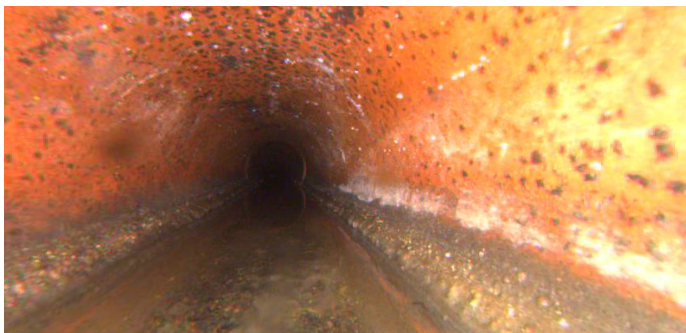
Code: **AMH**
Description: **Manhole**

Distance (ft): **.0**
Structural Grade: **0**
O&M Grade: **0**
Clock Start/From:
Clock To:
1st Value:
2nd Value:
Value Percent:
Continuous Index:
Within 8" of Joint: **NO**
Remarks: **M-903-014**

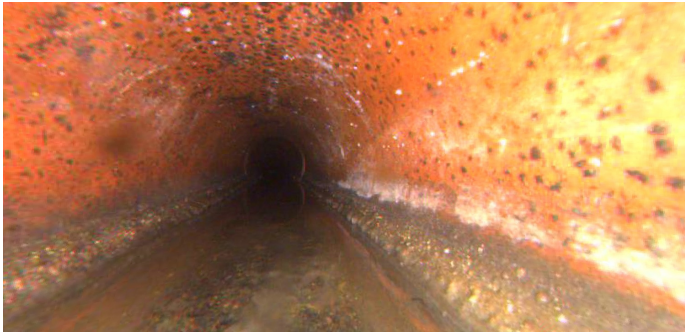
Code:	MWL
Description:	Water Level

Distance (ft):	.0
Structural Grade:	0
O&M Grade:	0
Clock Start/From:	
Clock To:	
1st Value:	
2nd Value:	
Value Percent:	5.000
Continuous Index:	
Within 8" of Joint:	NO
Remarks:

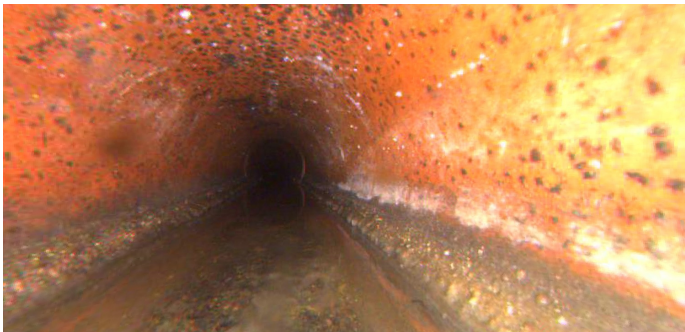
Code:	DAGS
Description:	Deposits Attached Grease

Distance (ft):	.0
Structural Grade:	0
O&M Grade:	2
Clock Start/From:	8
Clock To:	4
1st Value:	
2nd Value:	
Value Percent:	5.000
Continuous Index:	S01
Within 8" of Joint:	NO
Remarks:

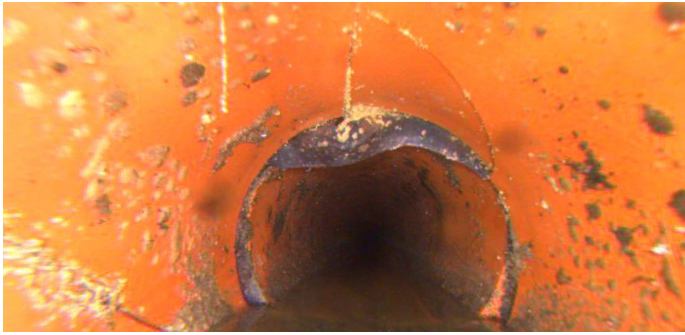
Code: **FM**
Description: **Fracture Multiple**

Distance (ft): **20.1**
Structural Grade: **4**
O&M Grade: **0**
Clock Start/From: **8**
Clock To: **2**
1st Value:
2nd Value:
Value Percent:
Continuous Index:
Within 8" of Joint: **YES**
Remarks:

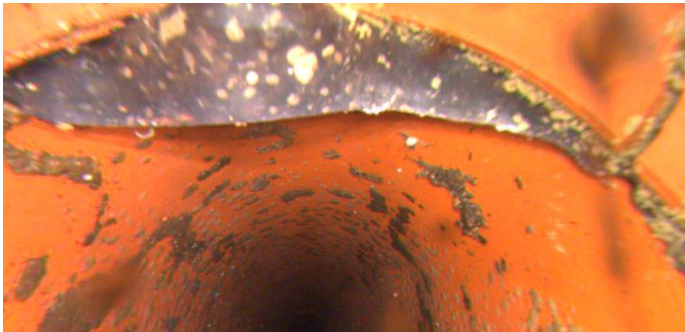
Code: **ISSR**
Description: **Intruding Sealing Ring**

Distance (ft): **20.6**
Structural Grade: **0**
O&M Grade: **2**
Clock Start/From: **10**
Clock To: **2**
1st Value:
2nd Value:
Value Percent: **10.000**
Continuous Index:
Within 8" of Joint: **NO**
Remarks:

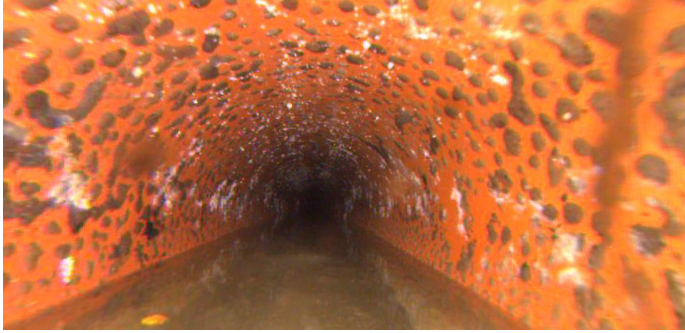
Code: **MWL**
Description: **Water Level**

Distance (ft): **59.3**
Structural Grade: **0**
O&M Grade: **0**
Clock Start/From:
Clock To:
1st Value:
2nd Value:
Value Percent: **30.000**
Continuous Index:
Within 8" of Joint: **NO**
Remarks:

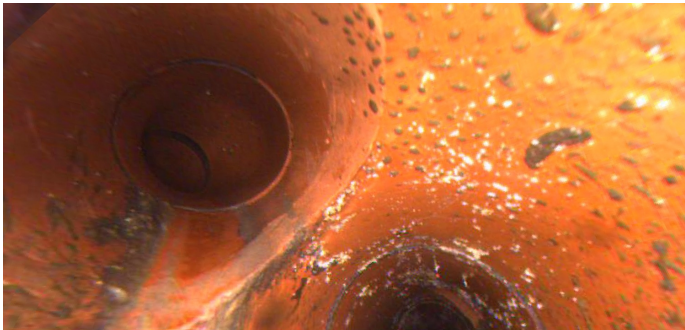
Code: **TF**
Description: **Tap Factory**

Distance (ft): **65.4**
Structural Grade: **0**
O&M Grade: **0**
Clock Start/From: **10**
Clock To:
1st Value: **4.000**
2nd Value:
Value Percent:
Continuous Index:
Within 8" of Joint:
Remarks:

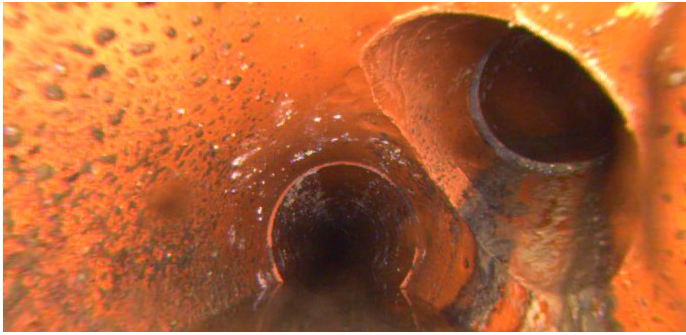
Code: **TF**
Description: **Tap Factory**

Distance (ft): **67.2**
Structural Grade: **0**
O&M Grade: **0**
Clock Start/From: **2**
Clock To:
1st Value: **4.000**
2nd Value:
Value Percent:
Continuous Index:
Within 8" of Joint:
Remarks:

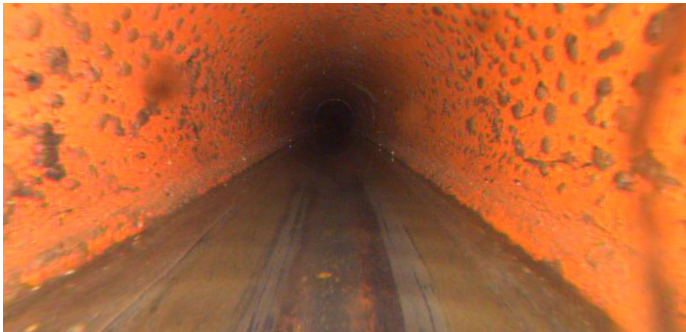
Code: **MWL**
Description: **Water Level**

Distance (ft): **91.1**
Structural Grade: **0**
O&M Grade: **0**
Clock Start/From:
Clock To:
1st Value:
2nd Value:
Value Percent: **20.000**
Continuous Index:
Within 8" of Joint: **NO**
Remarks:

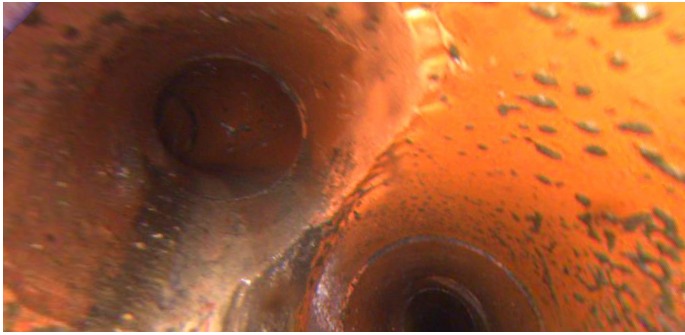
Code: **TF**
Description: **Tap Factory**

Distance (ft): **135.2**
Structural Grade: **0**
O&M Grade: **0**
Clock Start/From: **10**
Clock To:
1st Value: **4.000**
2nd Value:
Value Percent:
Continuous Index:
Within 8" of Joint:
Remarks:

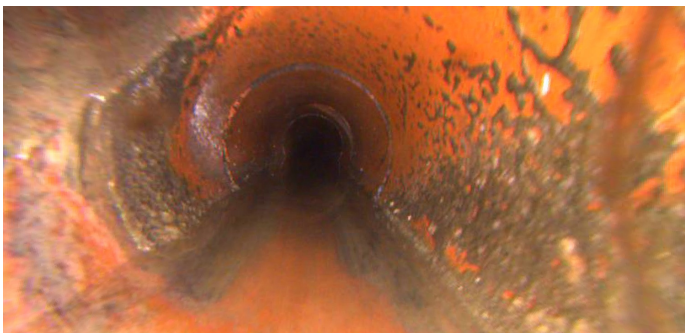
Code: **DAGS**
Description: **Deposits Attached Grease**

Distance (ft): **135.2**
Structural Grade: **0**
O&M Grade: **2**
Clock Start/From: **8**
Clock To: **4**
1st Value:
2nd Value:
Value Percent: **5.000**
Continuous Index:
Within 8" of Joint: **NO**
Remarks:

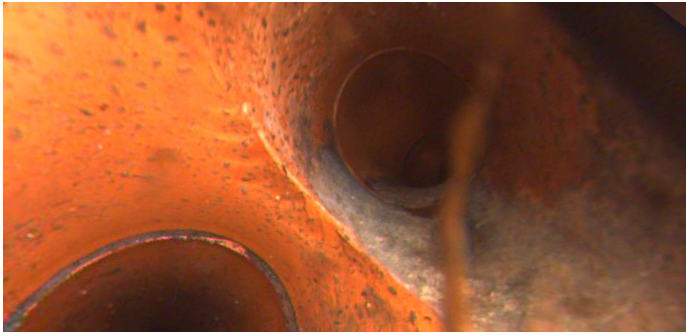
Code: **TF**
Description: **Tap Factory**

Distance (ft): **137.5**
Structural Grade: **0**
O&M Grade: **0**
Clock Start/From: **2**
Clock To:
1st Value: **4.000**
2nd Value:
Value Percent:
Continuous Index:
Within 8" of Joint:
Remarks:

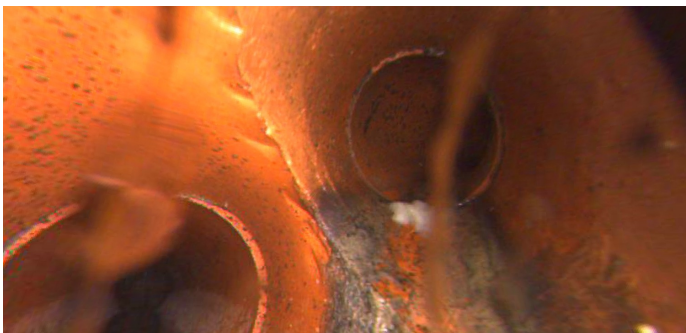
Code: **TFA**
Description: **Tap Factory Active**

Distance (ft): **183.5**
Structural Grade: **0**
O&M Grade: **0**
Clock Start/From: **2**
Clock To:
1st Value: **4.000**
2nd Value:
Value Percent:
Continuous Index:
Within 8" of Joint:
Remarks:

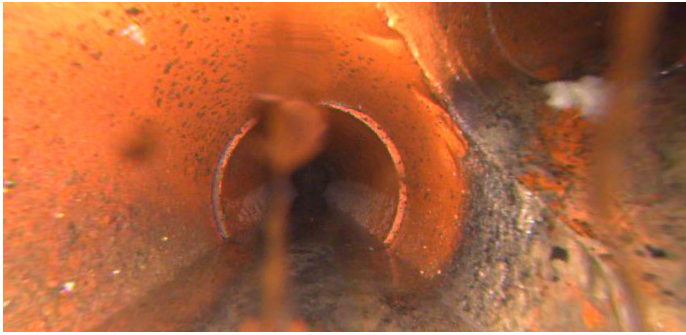
Code: **DAGS**
Description: **Deposits Attached Grease**

Distance (ft): **183.5**
Structural Grade: **0**
O&M Grade: **2**
Clock Start/From: **8**
Clock To: **4**
1st Value:
2nd Value:
Value Percent: **5.000**
Continuous Index: **F01**
Within 8" of Joint: **NO**
Remarks:

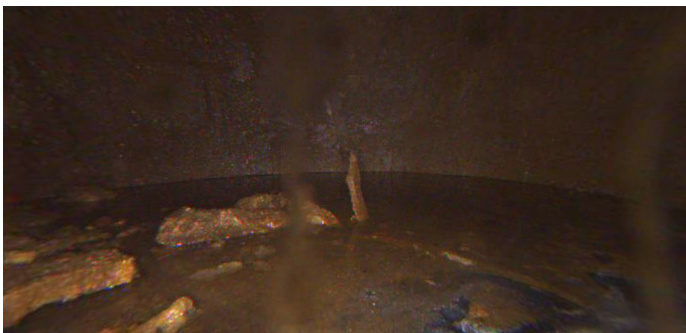
Code: **AMH**
Description: **Manhole**

Distance (ft): **190.1**
Structural Grade: **0**
O&M Grade: **0**
Clock Start/From:
Clock To:
1st Value:
2nd Value:
Value Percent:
Continuous Index:
Within 8" of Joint: **NO**
Remarks: **M-903-013**
