Profile/Photo Observation Report

Street:	N Shelby St.	Flow Control:	Not Controlled
City:	Hobart, IN	Year Renewed:	
Location:	Other	Tape/Media #:	
Purpose:	Not Known	Dia/Height:	8"
Use:	Sanitary	Material:	VCP
Drain Area:	NA	Lining:	
Category:	NA		
Comment:

Location Details:		Direction of Survey:	Downstream
US MH:	M-903-014	DS MH:	M-903-013
		Total Length Surveyed (ft):	190.1

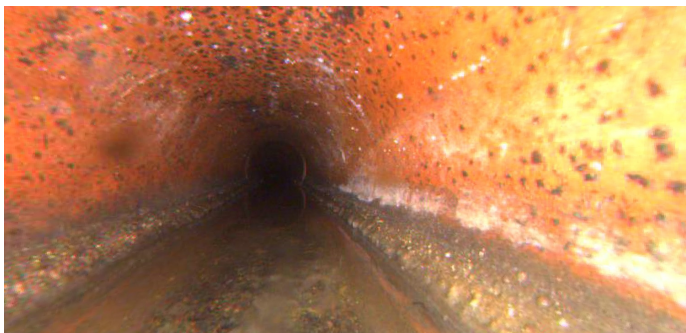
Code: **AMH**
Description: **Manhole**

Distance (ft): **.0**
Structural Grade: **0**
O&M Grade: **0**
Clock Start/From:
Clock To:
1st Value:
2nd Value:
Value Percent:
Continuous Index:
Within 8" of Joint: **NO**
Remarks: **M-903-014**

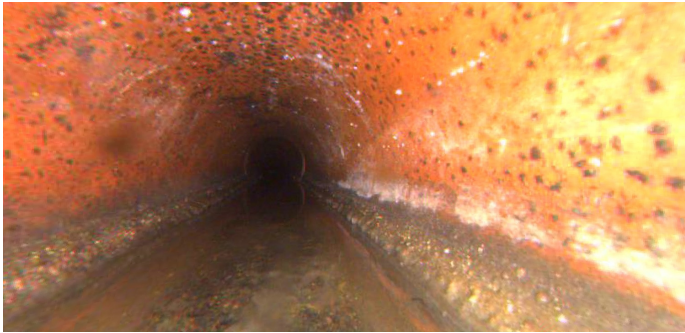
Code:	MWL
Description:	Water Level

Distance (ft):	.0
Structural Grade:	0
O&M Grade:	0
Clock Start/From:	
Clock To:	
1st Value:	
2nd Value:	
Value Percent:	5.000
Continuous Index:	
Within 8" of Joint:	NO
Remarks:

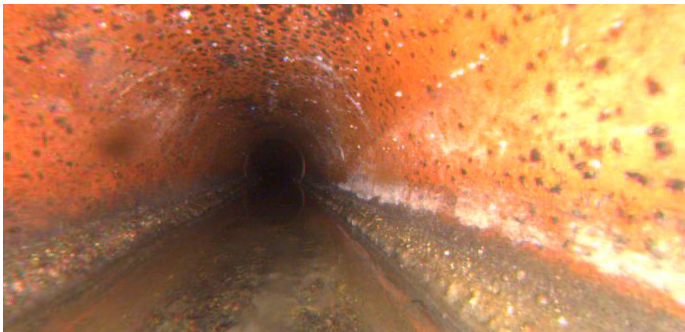
Code:	DAGS
Description:	Deposits Attached Grease

Distance (ft):	.0
Structural Grade:	0
O&M Grade:	2
Clock Start/From:	8
Clock To:	4
1st Value:	
2nd Value:	
Value Percent:	5.000
Continuous Index:	S01
Within 8" of Joint:	NO
Remarks:

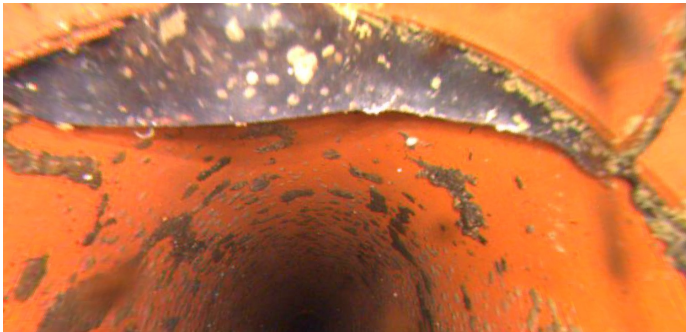
Code: **ISSR**
Description: **Intruding Sealing Ring**

Distance (ft): **20.6**
Structural Grade: **0**
O&M Grade: **2**
Clock Start/From: **10**
Clock To: **2**
1st Value:
2nd Value:
Value Percent: **10.000**
Continuous Index:
Within 8" of Joint: **NO**
Remarks:

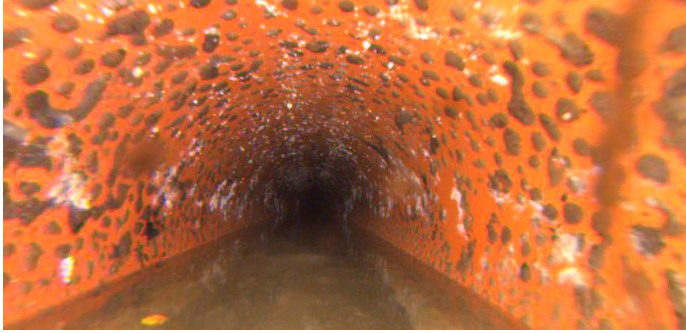
Code: **MWL**
Description: **Water Level**

Distance (ft): **59.3**
Structural Grade: **0**
O&M Grade: **0**
Clock Start/From:
Clock To:
1st Value:
2nd Value:
Value Percent: **30.000**
Continuous Index:
Within 8" of Joint: **NO**
Remarks:

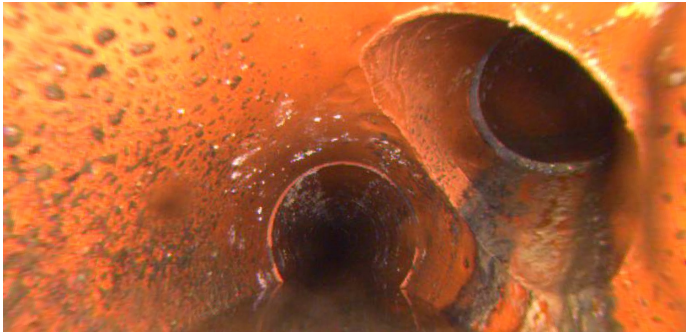
Code: **TF**
Description: **Tap Factory**

Distance (ft): **67.2**
Structural Grade: **0**
O&M Grade: **0**
Clock Start/From: **2**
Clock To:
1st Value: **4.000**
2nd Value:
Value Percent:
Continuous Index:
Within 8" of Joint:
Remarks:

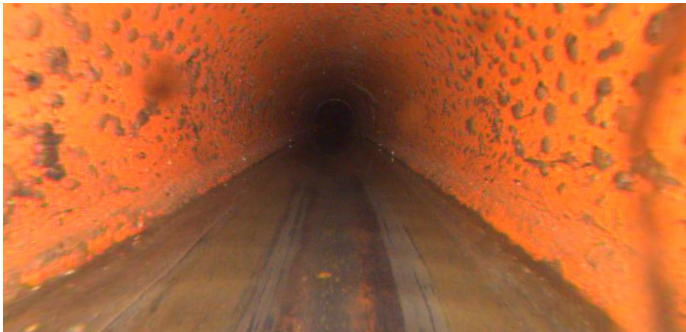
Code: **MWL**
Description: **Water Level**

Distance (ft): **91.1**
Structural Grade: **0**
O&M Grade: **0**
Clock Start/From:
Clock To:
1st Value:
2nd Value:
Value Percent: **20.000**
Continuous Index:
Within 8" of Joint: **NO**
Remarks:

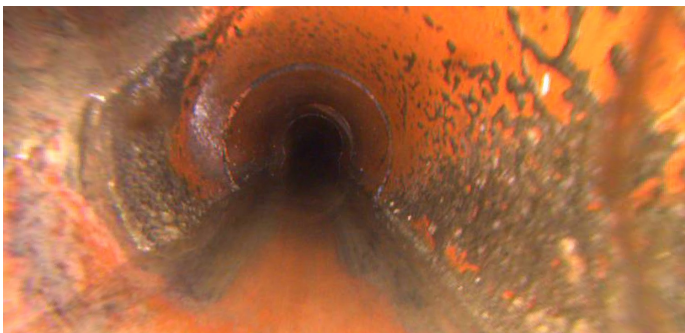
Code: **DAGS**
Description: **Deposits Attached Grease**

Distance (ft): **135.2**
Structural Grade: **0**
O&M Grade: **2**
Clock Start/From: **8**
Clock To: **4**
1st Value:
2nd Value:
Value Percent: **5.000**
Continuous Index:
Within 8" of Joint: **NO**
Remarks:

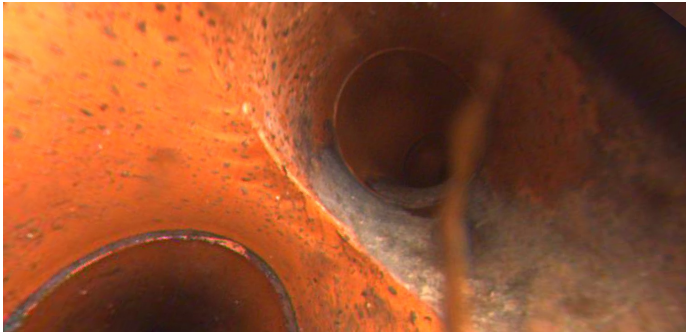
Code: **TF**
Description: **Tap Factory**

Distance (ft): **137.5**
Structural Grade: **0**
O&M Grade: **0**
Clock Start/From: **2**
Clock To:
1st Value: **4.000**
2nd Value:
Value Percent:
Continuous Index:
Within 8" of Joint:
Remarks:

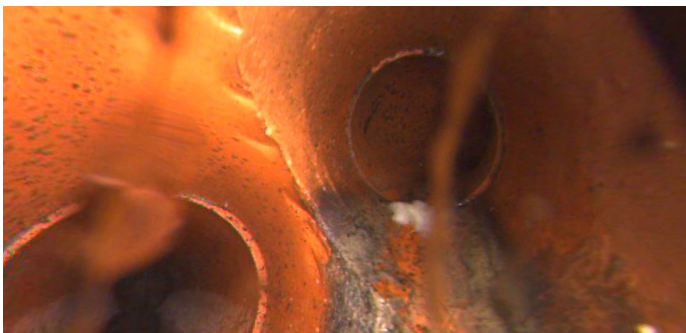
Code: **TFA**
Description: **Tap Factory Active**

Distance (ft): **183.5**
Structural Grade: **0**
O&M Grade: **0**
Clock Start/From: **2**
Clock To:
1st Value: **4.000**
2nd Value:
Value Percent:
Continuous Index:
Within 8" of Joint:
Remarks:

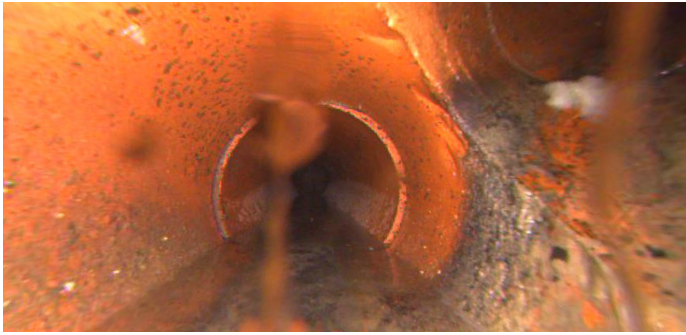
Code: **DAGS**
Description: **Deposits Attached Grease**

Distance (ft): **183.5**
Structural Grade: **0**
O&M Grade: **2**
Clock Start/From: **8**
Clock To: **4**
1st Value:
2nd Value:
Value Percent: **5.000**
Continuous Index: **F01**
Within 8" of Joint: **NO**
Remarks:

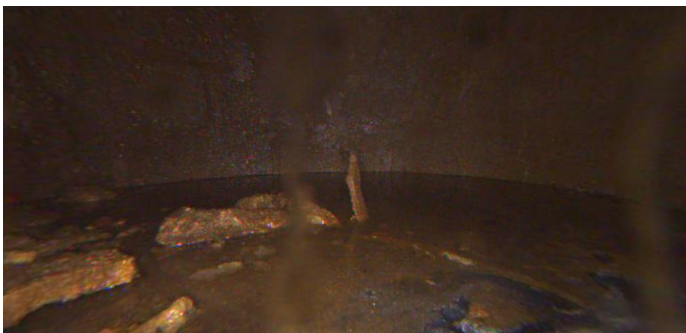
Code: **AMH**
Description: **Manhole**

Distance (ft): **190.1**
Structural Grade: **0**
O&M Grade: **0**
Clock Start/From:
Clock To:
1st Value:
2nd Value:
Value Percent:
Continuous Index:
Within 8" of Joint: **NO**
Remarks: **M-903-013**
