Profile/Photo Observation Report

Street:	E RAND ST	Flow Control:	Not Controlled
City:	Hobart, IN	Year Renewed:	
Location:	Other	Tape/Media #:	
Purpose:	Not Known	Dia/Height:	12"
Use:	Sanitary	Material:	VCP
Drain Area:	NA	Lining:	
Category:	NA		
Comment:

Location Details:		Direction of Survey:	Upstream
US MH:	M-903-015	DS MH:	M-903-016
		Total Length Surveyed (ft):	2.8

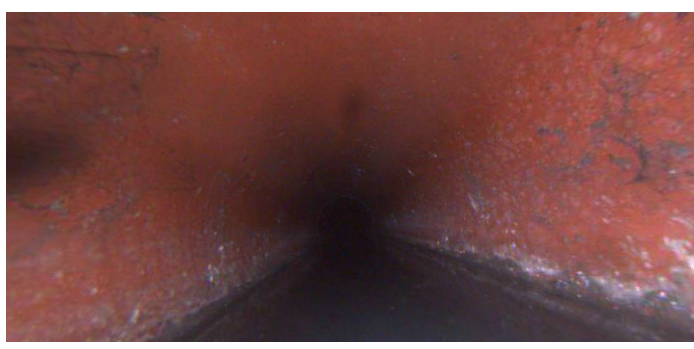
Code: **AMH**
Description: **Manhole**

Distance (ft): **.0**
Structural Grade: **0**
O&M Grade: **0**
Clock Start/From:
Clock To:
1st Value:
2nd Value:
Value Percent:
Continuous Index:
Within 8" of Joint: **NO**
Remarks: **M-903-016**

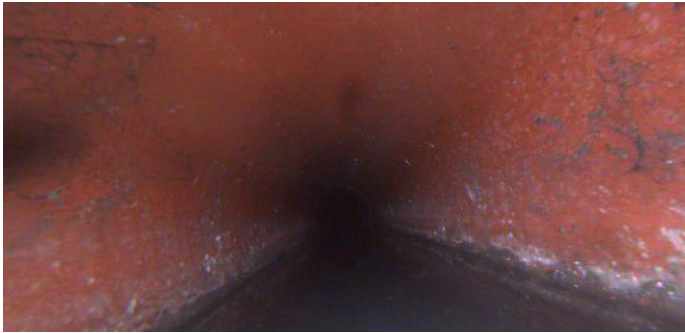
Code:	MWL
Description:	Water Level

Distance (ft):	.0
Structural Grade:	0
O&M Grade:	0
Clock Start/From:	
Clock To:	
1st Value:	
2nd Value:	
Value Percent:	30.000
Continuous Index:	
Within 8" of Joint:	NO
Remarks:

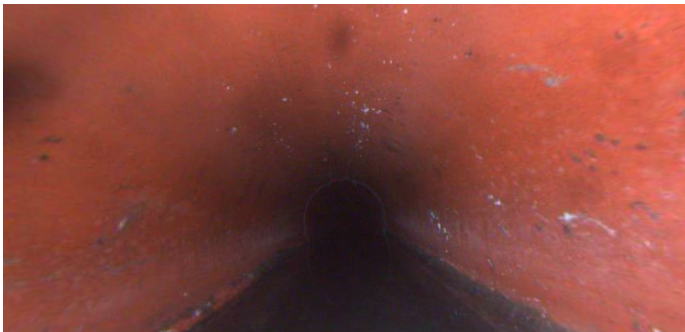
Code:	MSA
Description:	Abandoned Survey

Distance (ft):	2.8
Structural Grade:	0
O&M Grade:	0
Clock Start/From:	
Clock To:	
1st Value:	
2nd Value:	
Value Percent:	
Continuous Index:	
Within 8" of Joint:	NO
Remarks:	DEBRIS UNDER WATER
