Profile/Photo Observation Report

Street:	Rand St.	Flow Control:	Not Controlled
City:	Hobart, IN	Year Renewed:	
Location:	Other	Tape/Media #:	
Purpose:	Not Known	Dia/Height:	12"
Use:	Sanitary	Material:	VCP
Drain Area:	NA	Lining:	
Category:	NA		
Comment:

Location Details:		Direction of Survey:	Upstream
US MH:	M-903-015	DS MH:	M-903-016
		Total Length Surveyed (ft):	2.8

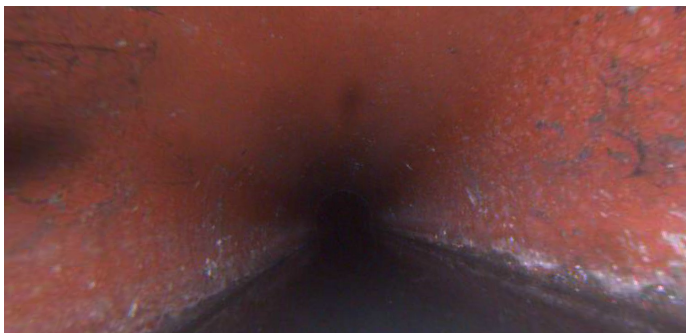
Code: **AMH**
Description: **Manhole**

Distance (ft): **.0**
Structural Grade: **0**
O&M Grade: **0**
Clock Start/From:
Clock To:
1st Value:
2nd Value:
Value Percent:
Continuous Index:
Within 8" of Joint: **NO**
Remarks: **M-903-016**

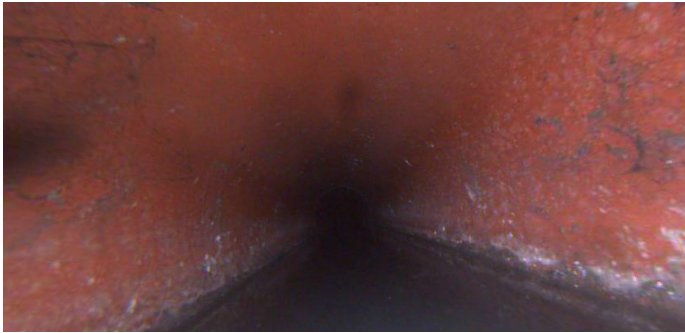
Code:	MWL
Description:	Water Level

Distance (ft):	.0
Structural Grade:	0
O&M Grade:	0
Clock Start/From:	
Clock To:	
1st Value:	
2nd Value:	
Value Percent:	30.000
Continuous Index:	
Within 8" of Joint:	NO
Remarks:

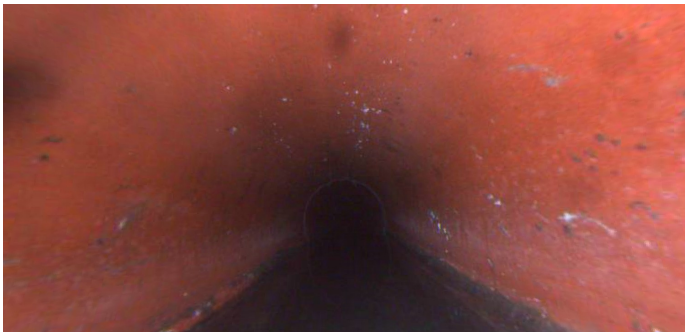
Code:	MSA
Description:	Abandoned Survey

Distance (ft):	2.8
Structural Grade:	0
O&M Grade:	0
Clock Start/From:	
Clock To:	
1st Value:	
2nd Value:	
Value Percent:	
Continuous Index:	
Within 8" of Joint:	NO
Remarks:	DEBRIS UNDER WATER
